Safety Alert

Number: 21-13

Subject: Hand Injury Sustained During Routine Checks

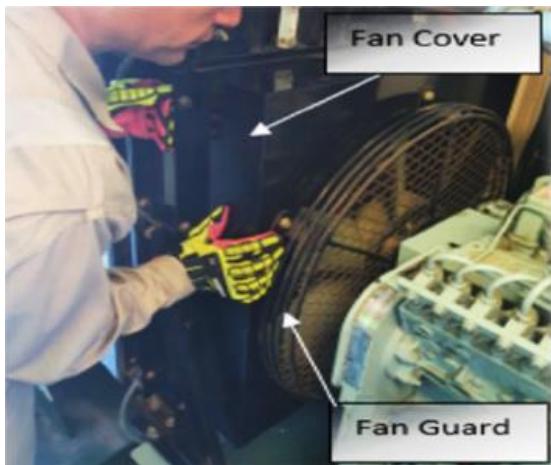
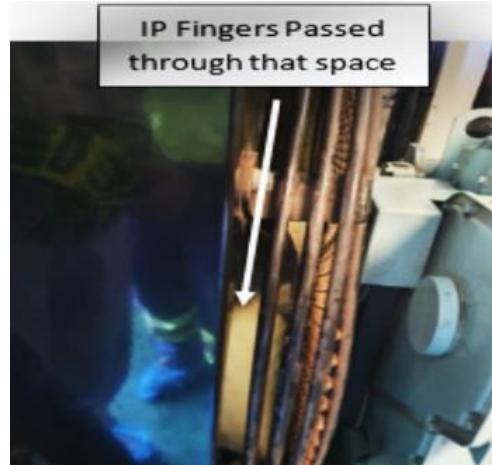
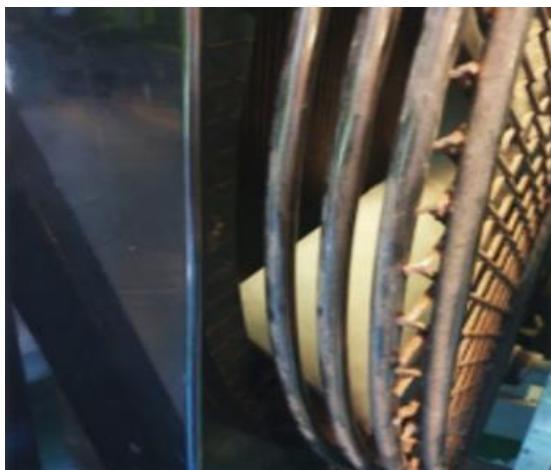
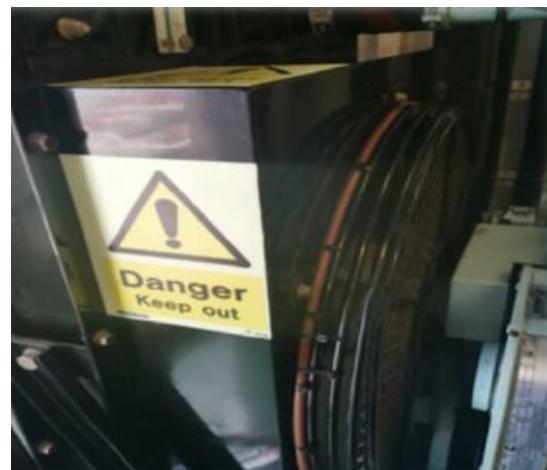
Photographs / Supporting Information

During routine weekly checks, the Injured Person (IP) was performing the weekly test for the Emergency Generator, he approached the generator to investigate an abnormal noise coming from the cooling fan, his fingers were struck by the fan blades and he sustained an injury to fingers 3, 4 & 5 (Middle, Ring, and little fingers) on his right hand.

- Unsafe behaviour due to complacency
- Lack of situational awareness by the IP as he placed his hands in an area with a partly exposed rotating part
- The IP was a lone worker
- Partly unprotected fan

- Modifications for the fan guard of the emergency generator to avoid any possibility of touching the fan and warning signs posted
- Situational Awareness training for all vessel crew
- Safety Stand Down/TOFS onboard all vessels addressing hand safety
