## Emergency escape hatch found blocked

Safety Flash Published on 20 August 2026 Generated on 20 August 2026 IMCA SF 15/26

Emergency escape hatch to the deck could not be opened.

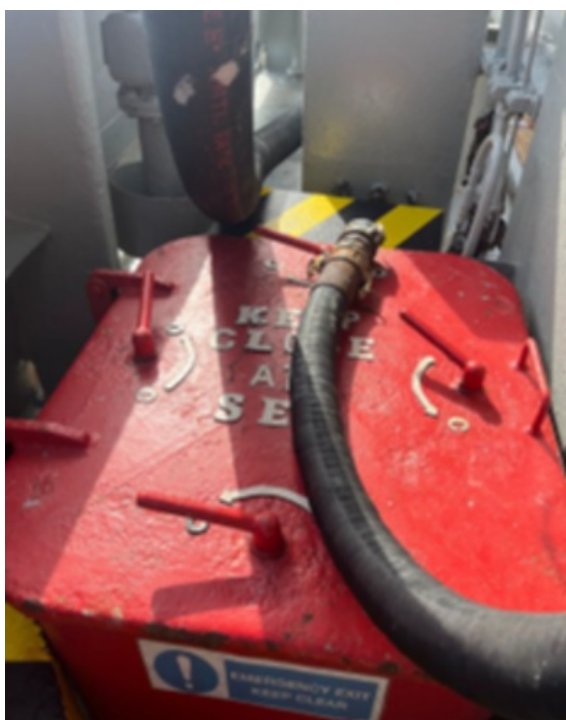
During a management visit walk-around, an attempt was made to exit the steering room through the emergency escape hatch to the deck. However, the hatch could not be opened. After checking the hatch from the deck side, it was found that a fuel hose had been left on top of the emergency exit hatch and obstructed the hatch cover and prevented it from being opened. This created a serious unsafe condition, as personnel inside the steering room may have been unable to escape quickly in the event of an emergency.

- Post-operation housekeeping and checks were not effective or sufficient.
  - Routine activity was carried out without sufficient thought to the follow-up safety requirements. After offshore transfer, the fuel hose was left on top of the emergency hatch instead of being returned to its designated storage location.
- Temporary placement of equipment on the hatch was accepted without considering emergency escape access.
- Previous regular walk-arounds had not identified this unsafe condition, indicating they were not effective.

- A routine job is not complete until all equipment is removed, secured, and the area is restored to a safe condition.
- Temporary placement of hoses or equipment can become a serious emergency-access hazard if not challenged.
- Walk-arounds and audits must be purposeful and thorough: check critical safety barriers such as escape routes, hatches, firefighting equipment, and access ways.
  - Emergency escape arrangements should be verified practically on regular basis, not only visually. Open the hatch!
- Clear ownership is required after transfer operations: it should be clear who is responsible for confirming hose recovery, stowage, and area clearance. Small housekeeping failures can create high-consequence risks during an emergency.
