## MAIB: Catastrophic engine failure and subsequent fire

Safety Flash   Published on 23 July 2026   Generated on 23 July 2026   IMCA SF 13/26

The UK's Marine Accident Investigation Branch (MAIB) has published [Accident Investigation Report 10/2026](#) into a catastrophic failure of a diesel generator engine on board the vessel *Kommandor Susan*.

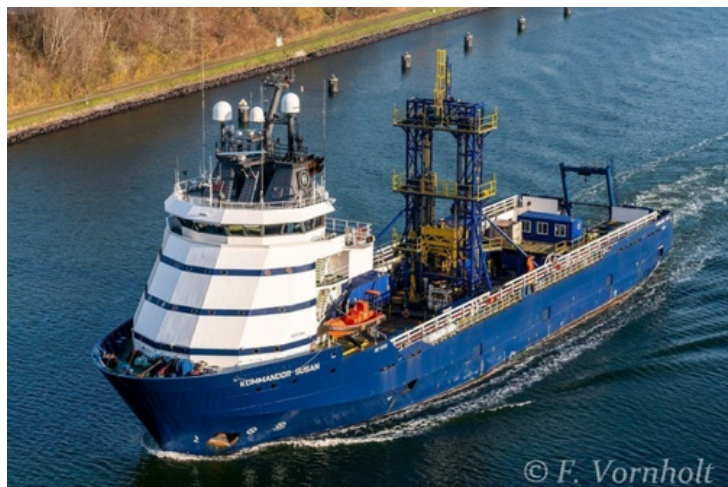
The site investigation vessel *Kommandor Susan* suffered a catastrophic failure of a diesel generator engine while conducting sea trials. The failure resulted in an engine room fire and a complete power blackout. The crew responded promptly, extinguishing the fire and mustering safely. The vessel lost propulsion and began drifting eastwards. Attempts to deploy anchors were unsuccessful because the anchor winches required electrical power to operate. *Kommandor Susan* was eventually returned to harbour with limited propulsion restored. There were no injuries.

- The investigation found that the engine failure was caused by premature wear of bearings fitted during a major overhaul in 2019.
- These components were not approved by the engine original equipment manufacturer and exhibited weaker material bonding than genuine parts.
- The extended service intervals applied to the engines were valid only for original equipment manufacturer components, making the use of substitute parts a critical factor in the failure.
- The vessel's former owner had minimal oversight of the overhaul process and assumed that original equipment manufacturer parts were used. This lack of verification meant that the presence of substitute components remained undiscovered and was not communicated to subsequent owners.
- Additionally, the vessel's anchoring procedure did not account for the risk of

power loss, leaving the anchors inoperable during the emergency.

The MAIB notes that there was “a shortfall in oversight and contractor assurance by the vessel owner during overhaul, which allowed the non-genuine components to be installed.”

- Are parts and components used in critical systems approved by the original equipment manufacturer?
- Could there be unseen or unnoticed gaps in oversight or assurance of parts, components, processes and procedures?
  - This may be particularly important where there has been a change of ownership, change of contract, or where responsibility and liability is shared by multiple entities – for example on a chartered vessel.
- Are risk assessments thorough enough to cover less likely but potentially very serious scenarios?
