Safety Alert

ALERT 14 - 01

INTERNAL EXPLOSION RUPTURES CROWN MOUNTED COMPENSATOR PIPING

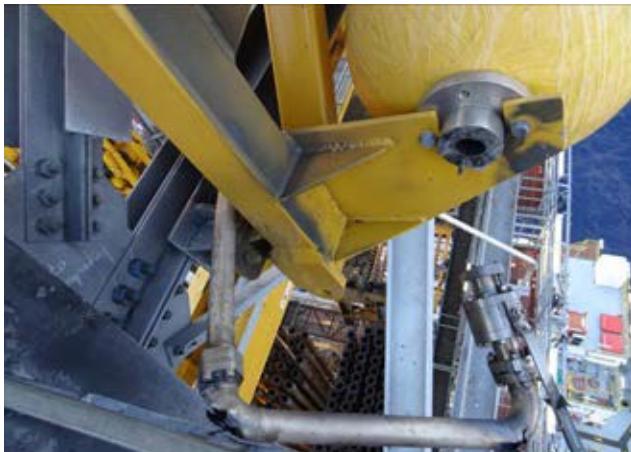
Two employees were in the derrick equalizing the internal pressure between Composite Air Pressure Vessels (CAPV) on the Crown Mounted Compensator (CMC) when an ignition occurred inside the system. Either heat generated by adiabatic compression or static generated by the air transfer led to ignition inside the CAPV. Thereafter, the associated raise in pressure and temperature resulted in the interconnecting piping rupturing. Two employees received non-life threatening injuries and were subsequently transported to a shore-based medical facility for further treatment.

Failed CAPV and Interconnected Pipe

- Combustion occurs because of a combination of three elements: heat, fuel, oxidizing agent (e.g. oxygen).
- High temperature is a result of rapid pressure increase in a pressurized air system. The CAPV Bottle that was being brought on-line was at a much lower pressure than the operating system pressure.
- A fuel source in the CAPV Bottle ignited due to the high temperature generated by the air transfer or static that was caused by the rapid air transfer.
- The temperature rise generated by the air transfer exceeded the melting temperature of the CAPV liner.

- The company notified the manufacturer of the event to assist in the investigation.
- The company held safety stand-downs to review the incident and discuss the lessons learned.
- The company developed specific work instructions to bring CAPV online in accordance with manufacturer's recommendations which included following a cool down cycle while filling CAPV bottles with air.

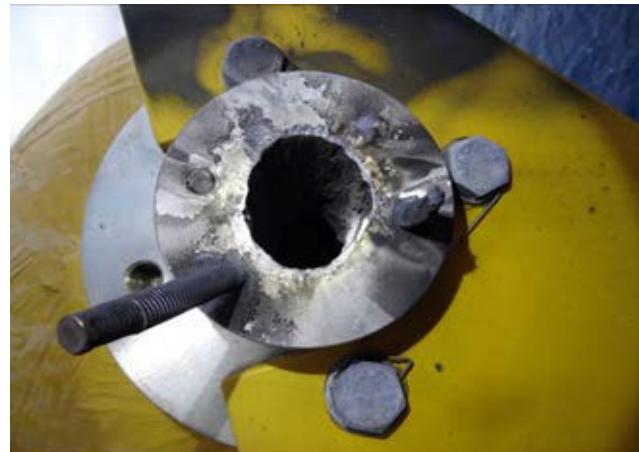
CAPV Outlet Flange

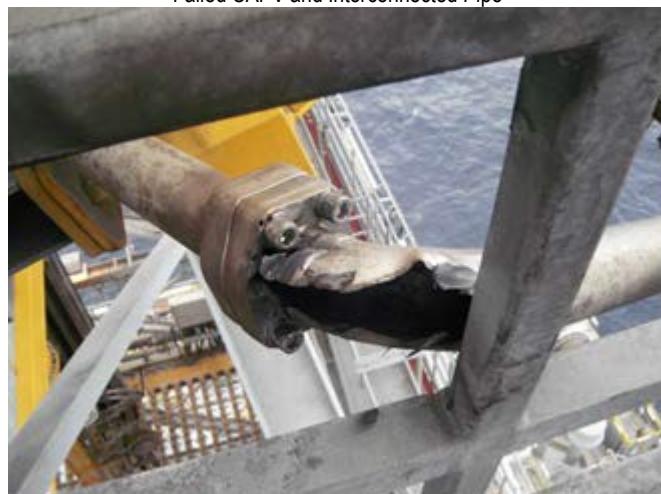
Ruptured Interconnected Pipe

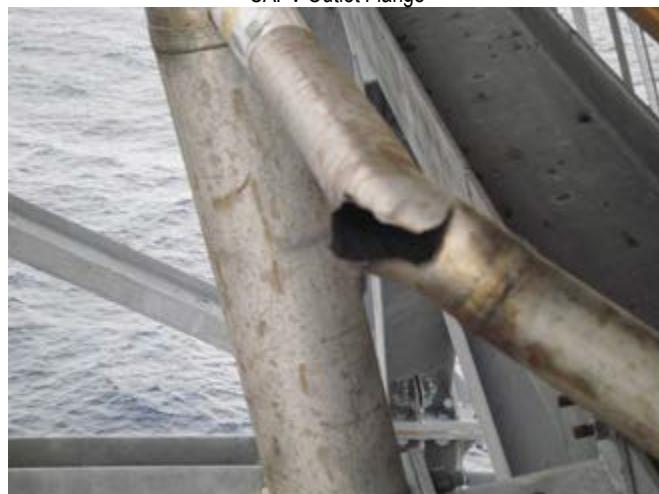
Ruptured Interconnected Pipe
