PDO Identified during rope access operations

SAFETY ALERT

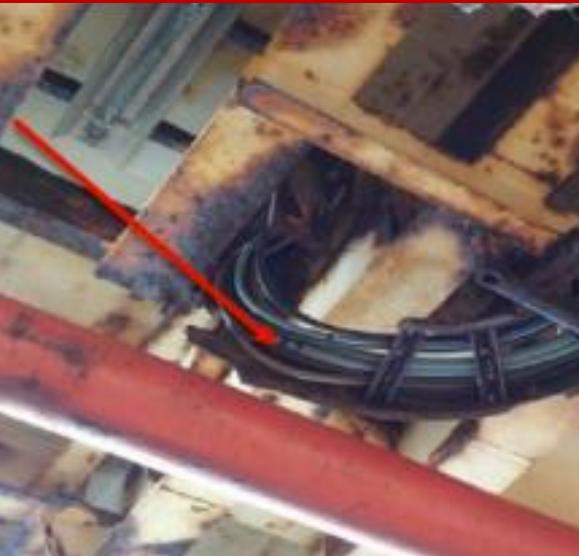
Whilst completing equipment checks via rope access on an offshore installation, a Technician noticed a potential dropped object (PDO) at a height of approximately 10 meters. The object was still attached, but was easily removed by hand, and could have dropped to the deck below.

The object, a piece of heavily corroded ladder rack, was approximately 1 meter in length and weighed 3kg. Using the Drops calculator, this indicates that if the object had fallen and struck somebody it would have likely resulted in a fatality.

The area below the object was not a walkway, so the likelihood of anyone being below would be low, however the potential for personal harm and equipment damage is still significant.

Location of corroded racking and missing section. Note pipework below which would have been impacted.

- Complete regular dynamic risk assessments / 20 second scans to identify potential hazards
- If you identify potential hazards, raise them for rectification and / or stop the job
- Ensure a systemic process of PDO identification and removal is in place at your site and consider areas that might not be immediately accessible and visible

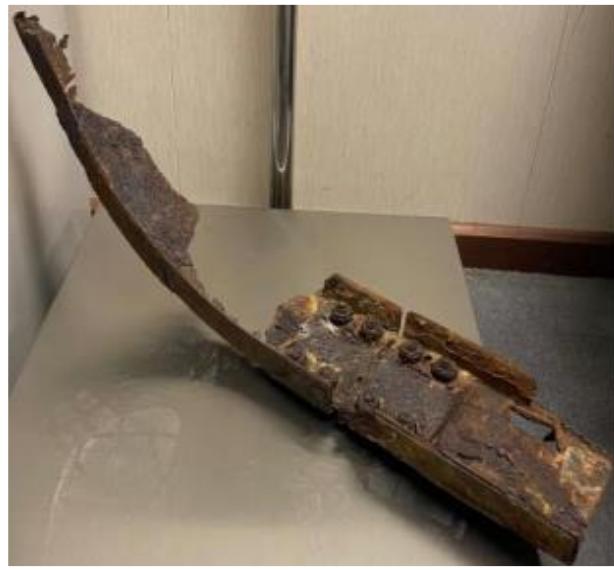
Potential dropped Object: – Piece of ladder rack weighing 3kg
