Positive: Worn mooring lines spotted and replaced before they parted

Safety Flash Published on 2 October 2025 Generated on 13 October 2025 IMCA SF 18/25

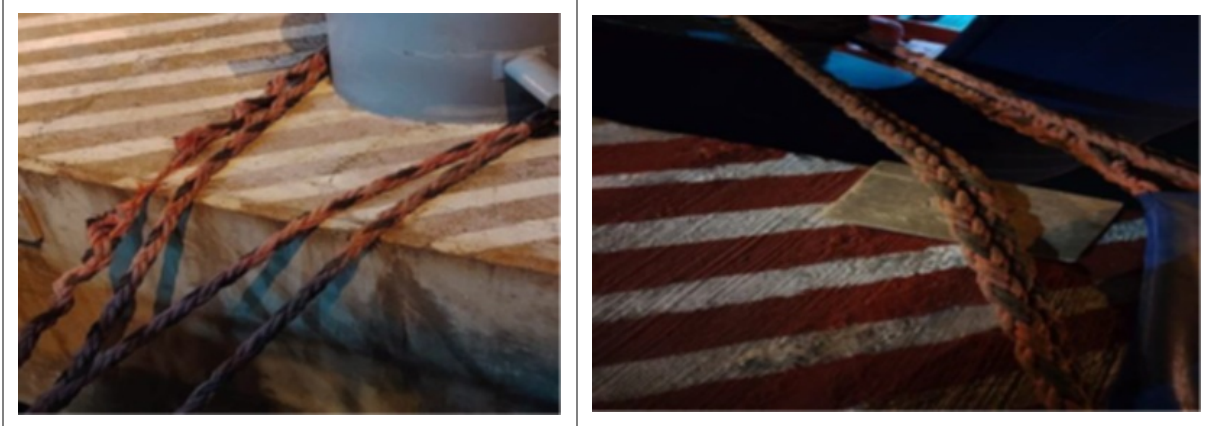
It was observed that mooring ropes had nearly reached breaking point.

On a vessel alongside on a windy night, hourly walkarounds were being conducted as instructed by the Officer of the watch. During one of these inspections, it was observed that one of the mooring ropes had nearly reached its breaking point due to the strong wind and the structural characteristics of the berth.

The crew member spotting the problem informed the Officer of the watch and the Bosun. The mooring rope that was at risk of breaking was replaced with a new one. Additionally, wooden boards were placed under the ropes that were rubbing against the bridge structure to minimize friction and prevent further wear.

In adverse weather conditions, even the provision of additional mooring ropes cannot fully guarantee the vessel's safety—particularly when no measures are taken at certain berths where friction may be a particular issue and ropes are likely to be in contact with rough surfaces.

Timely detection of such issues is crucial for ensuring the safety of the vessel. To prevent similar situations, it may be necessary to increase the frequency of vessel walkarounds—especially during adverse weather conditions—and for the crew to exercise heightened vigilance.

The most effective preventive measure, however, would be the installation of protective equipment on the jetties by the port authorities to minimize rope friction and reduce the risk of mooring line damage.
