Swollen Laptop Battery – Fire Risk

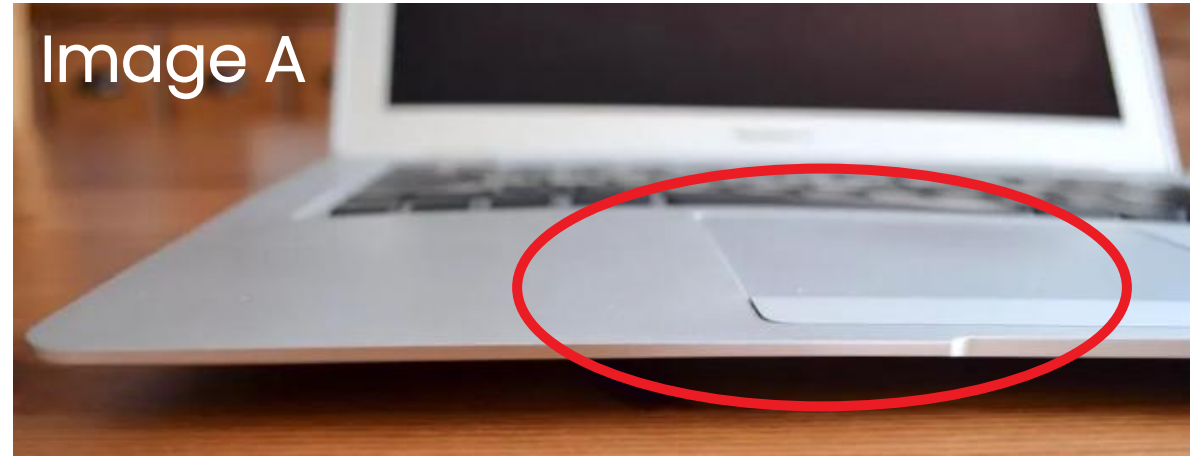
Whilst installing a program onto a spare laptop, the engineer noticed that the keyboard was bulging (Image A).

This is a typical sign of battery swelling inside the laptop. The swelling of the battery is caused by gas build-up from internal battery degradation, which can lead to fire or toxic gas release.

The engineer immediately powered off the laptop and handed it over to the shift supervisor.

- > The laptop was an old laptop that had been utilised for a previous project – the degradation of the battery was due to age
- > Recognising that other similar laptops were still in use, these were also inspected. One additional laptop exhibited the same issue and was handed over to the shift supervisor
- > The engineer's attention to the task and equipment led to early detection and mitigation
