## 421: Waste Food Disposal

## 422: Risk Assessment

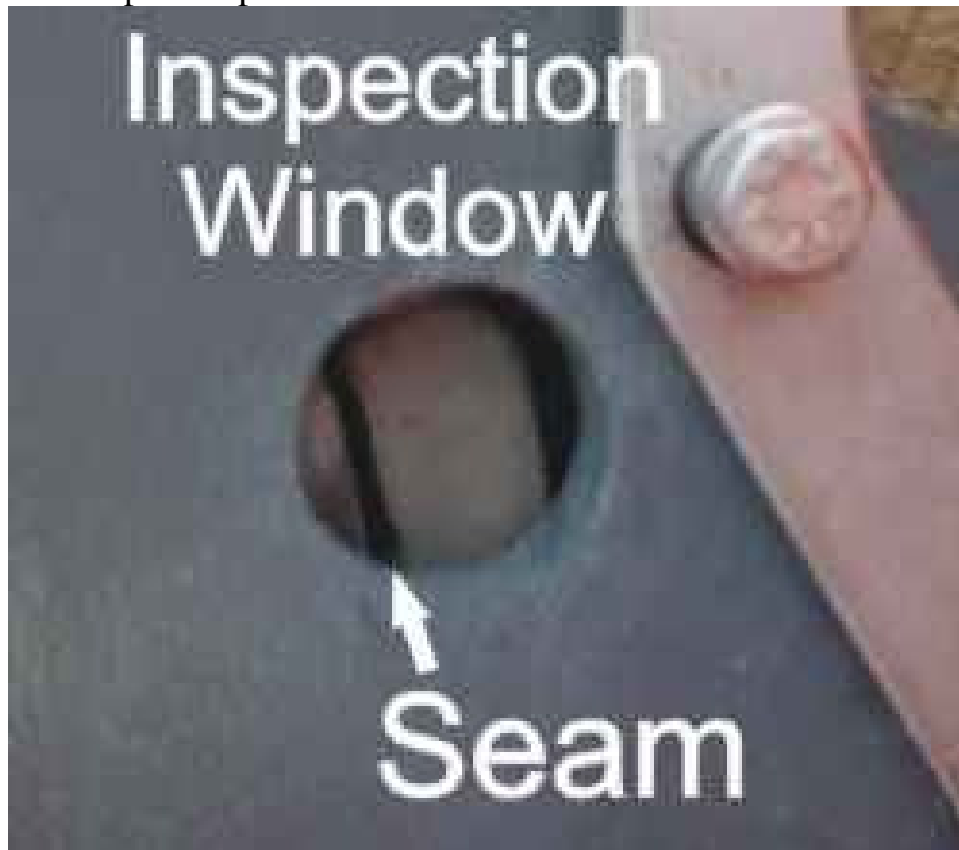
Close-up of Inspection Window and Seam

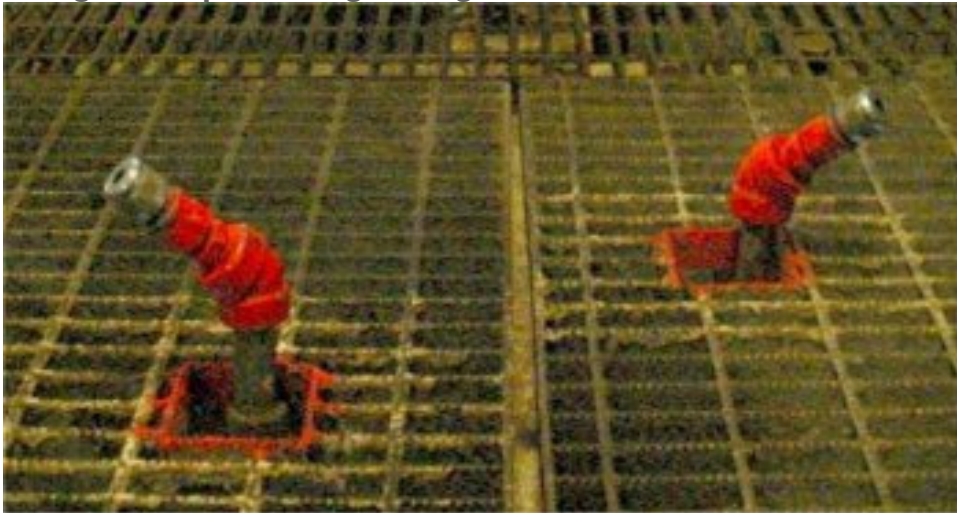
**Deluge head protruding through deck**

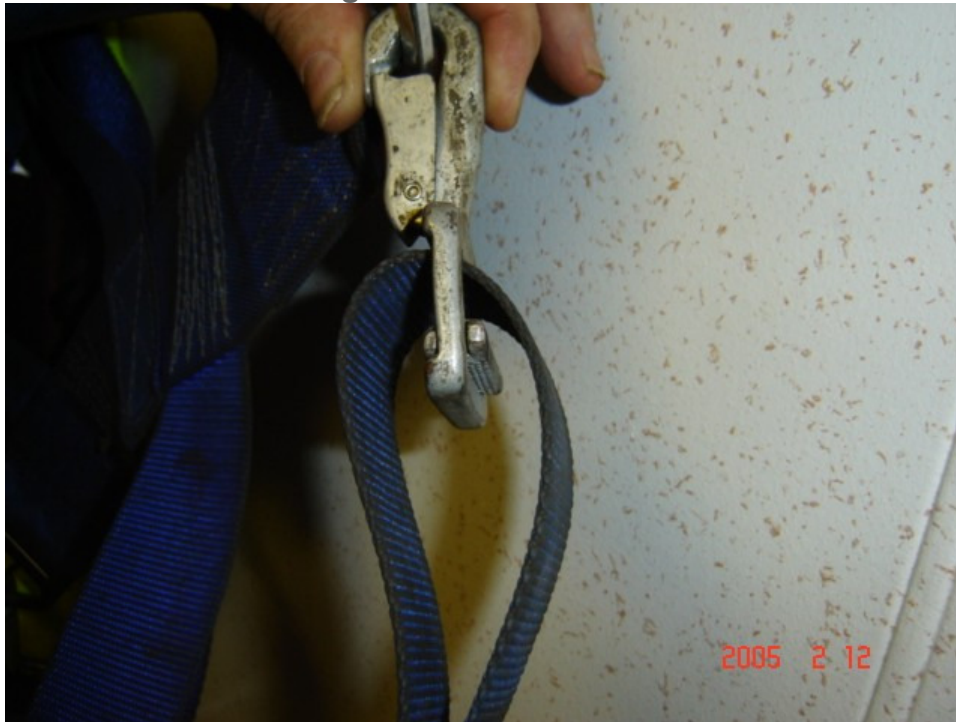
**Incorrect buckle arrangement**

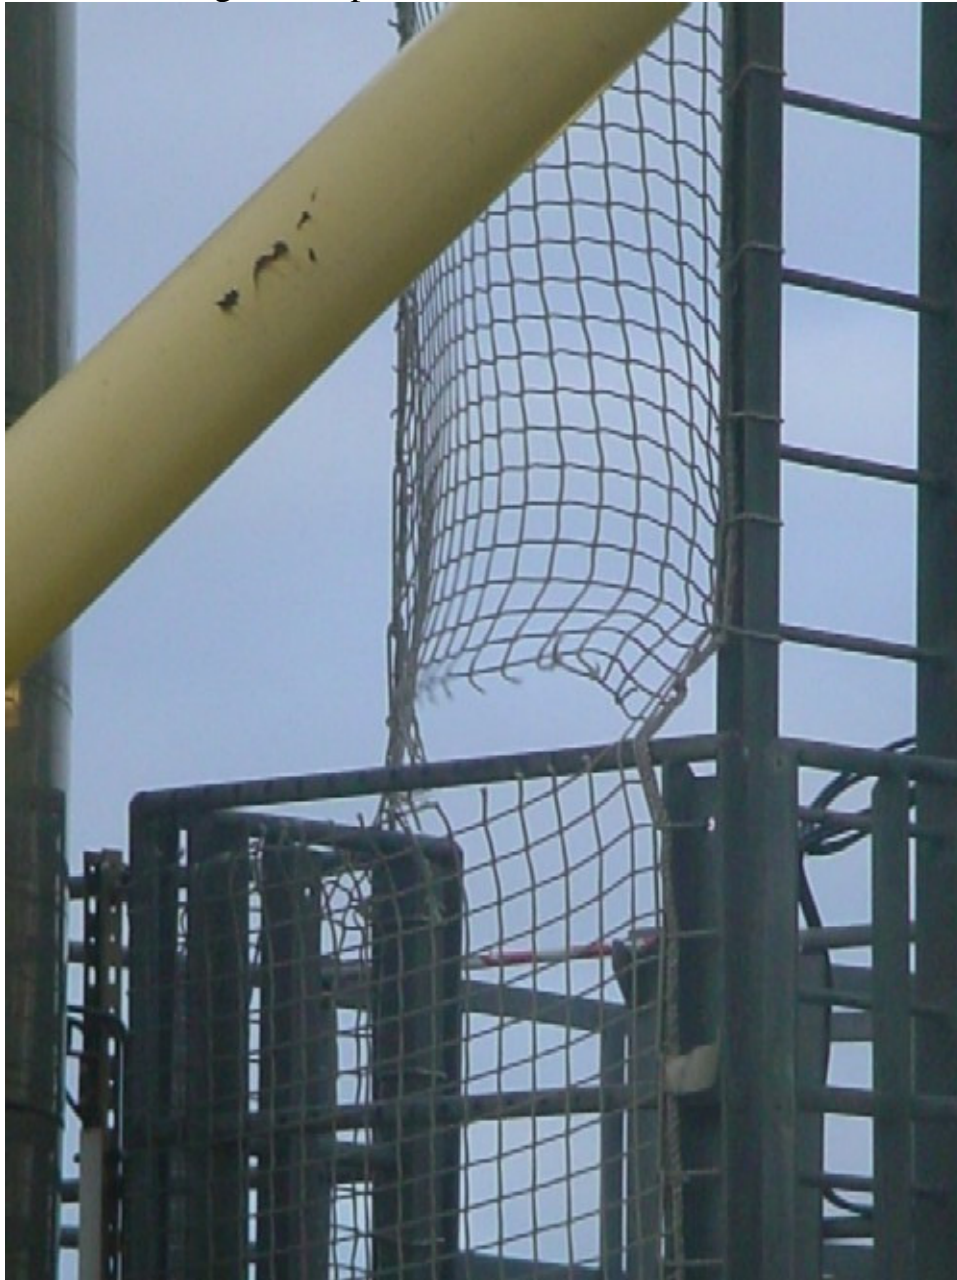
Summary: An issue has been raised regarding the use of netting as an extension to the back-scratcher on vertical ladders. On a number of locations, nets were installed as extensions where the back-scratcher did not reach the level of the handrail.

Tear in Netting - Example 1

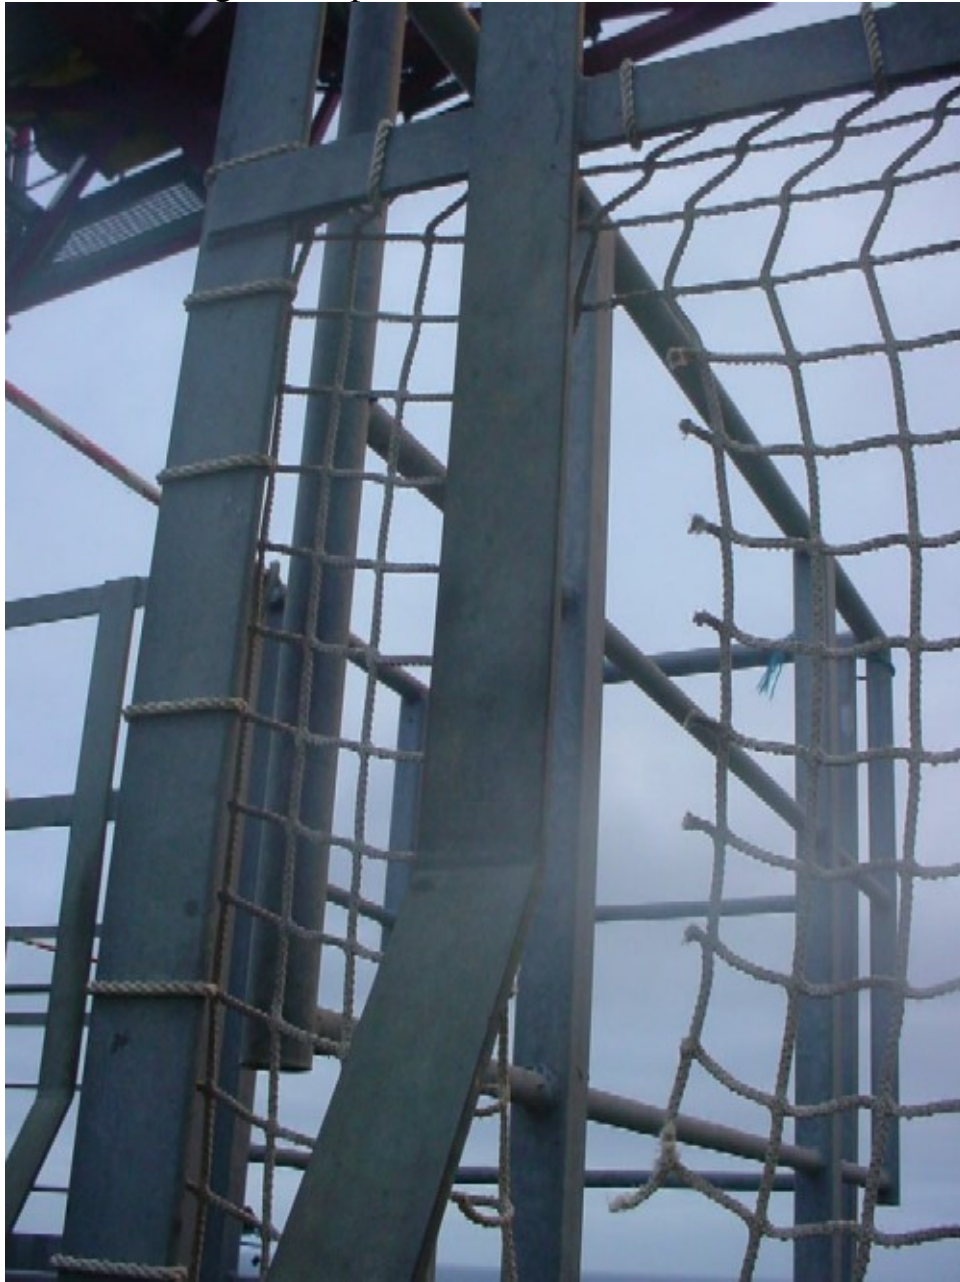
Tear in Netting - Example 2

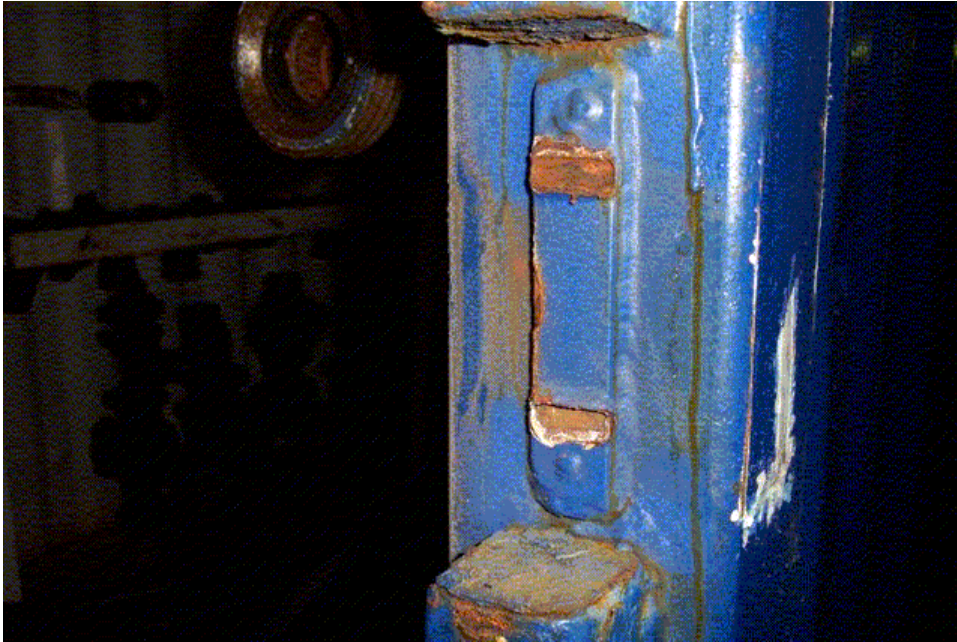
Description: A 10' x 8' container was returned from Offshore. On opening the container doors, the right hand door fell to the ground narrowly missing the operative. The initial cause of the failure was identified as fatigue and fracture of the door hinges (3) on the right hand side of the right hand door. Further inspection of the container revealed a severe indentation on the left hand under structure framing consistent with a collision during transit. The internal contents of the container, mainly chickens were scattered across the floor of the container. These had been secured in a racking system and "locked" into position by means of a securing bar and drop nose toggles. The force of the impact significantly damaged internal welded arms and resulted in the chickens breaking away from their securing.

Site of one of the Failed Welds

Recommendations: The welds on the door hinges of all similar design Containers should be inspected for cracking

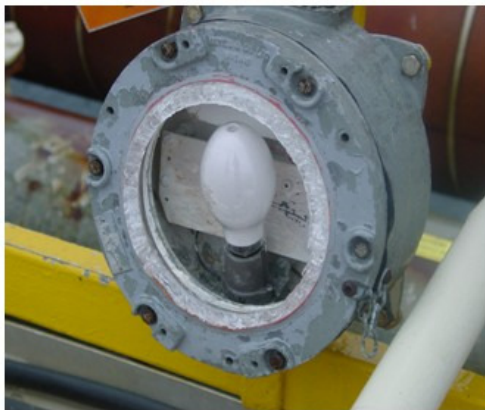
confirmed their experience of this type of failure. The glass in fittings manufactured prior to the year 2000 used a cement to fix the glass to the body of the fitting which could cause a stress point having dissimilar expansion/contraction characteristics and result in cracked/damaged glass. Fittings manufactured post 2000 have the glass bowl fitted using a silicone material which allows for expansion/contraction.

Typical failed fitting

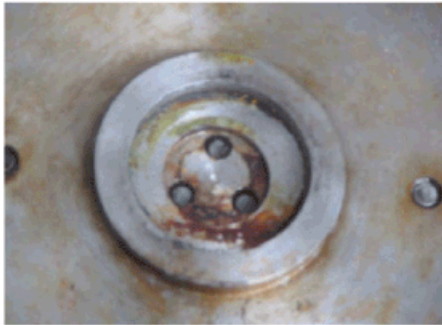
Pict. 11 The Ex Camera body

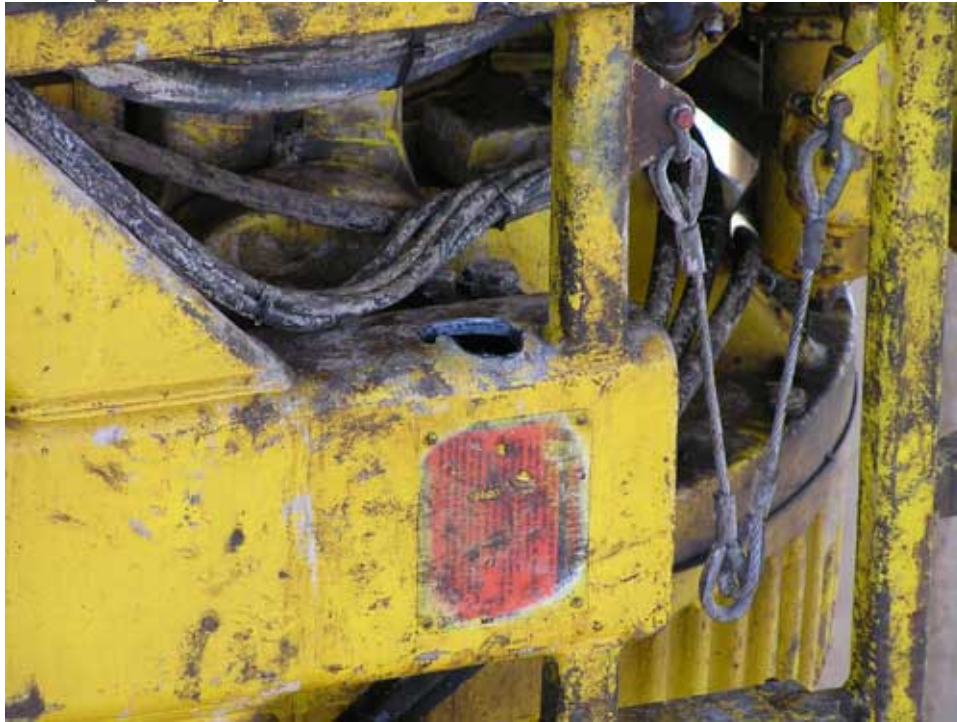
Damage to Top Drive #2

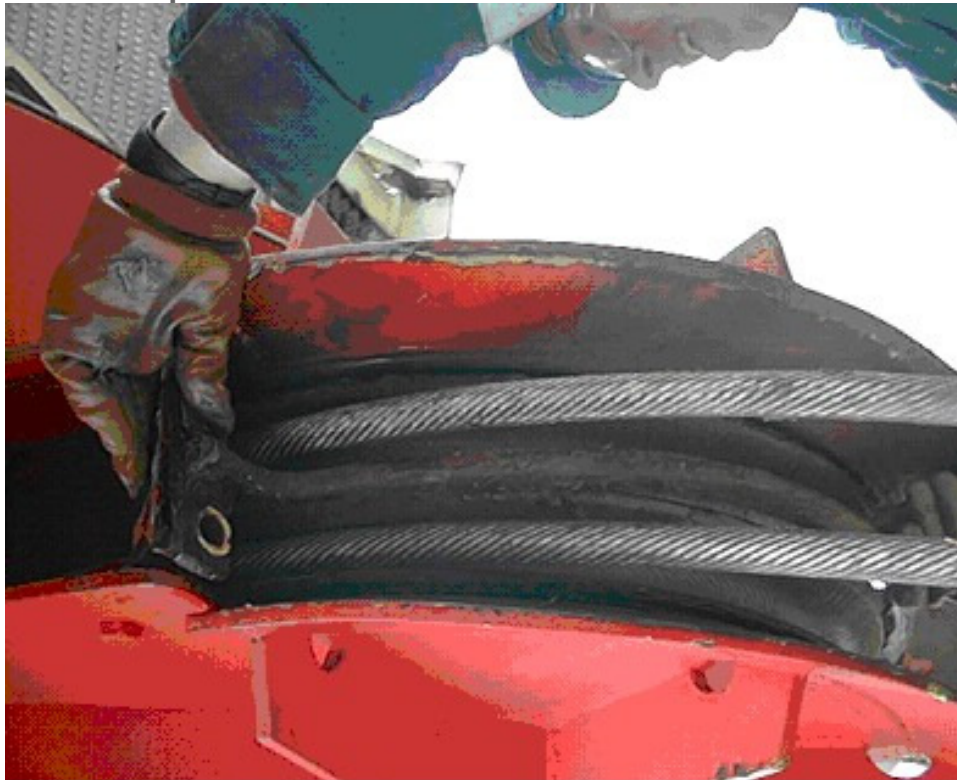
Bracket in place on sheaves

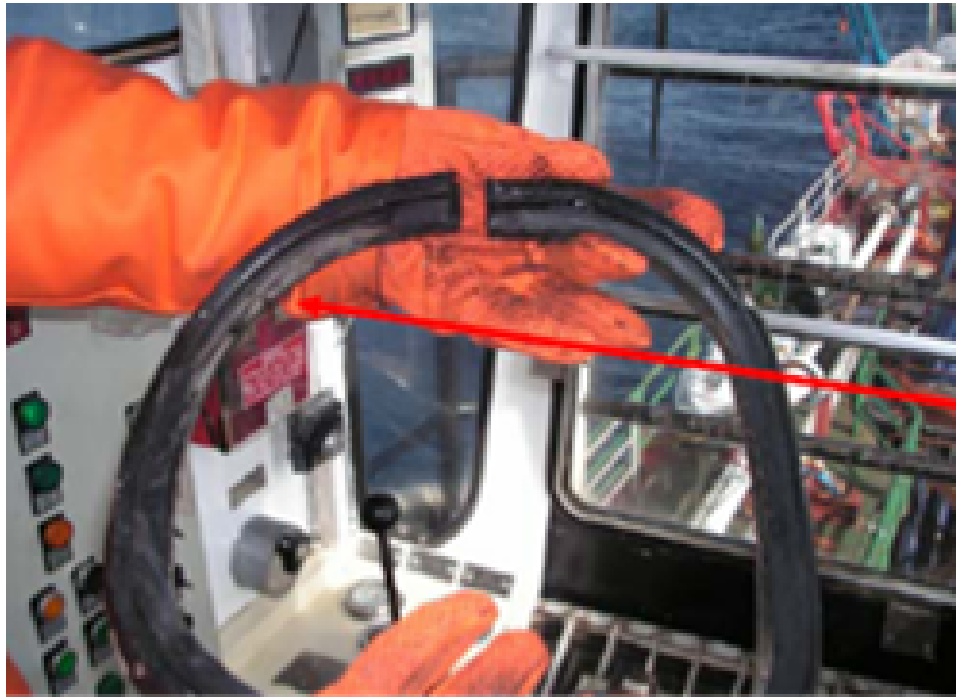
Picture of perished rubber window seal

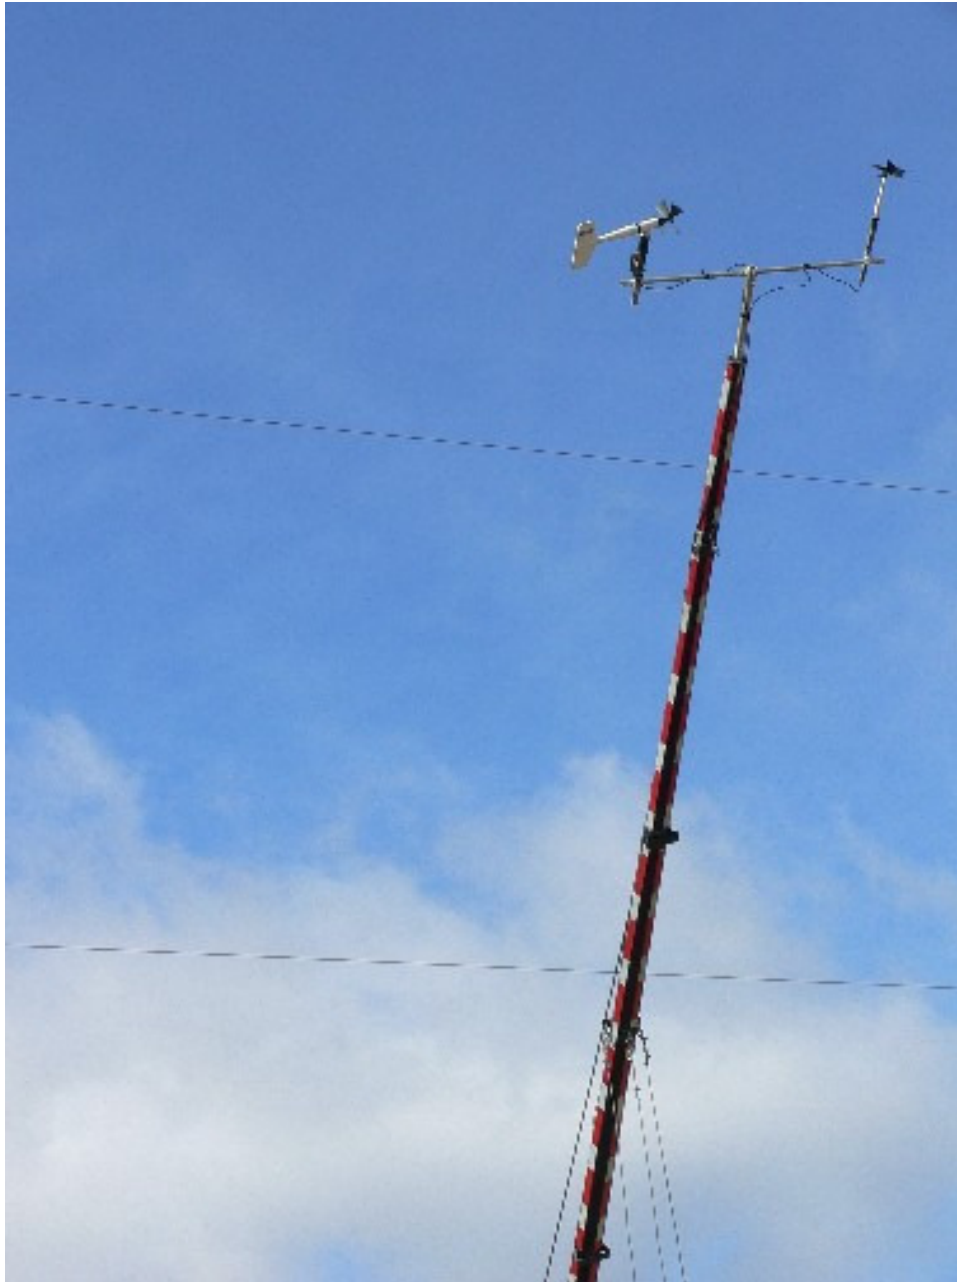
**MET Tower in Contact with Power Lines**
