SAFETY ALERT

Gas leak from a manual ball valve (adjacent to a grease injection channel)

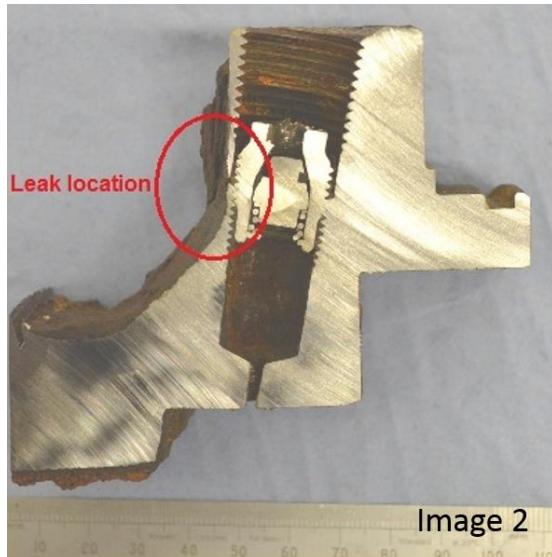
The investigation revealed that a leak had occurred on the flange adapter (see Image 2). The leak site was adjacent to a grease injection channel drilled into the flange adapter. The investigation revealed that the grease injection channel was drilled at an angle to the flange adapter, and not orthogonal as shown in the original general arrangement drawing for the valve.

It was confirmed that the angled drilling was as per original supplier design, and the original wall thickness at the location of the leak was estimated (by the operator) as 1.5-2.0 mm only. The wall loss from the valve, due

to external corrosion, was estimated at 0.5-1.0 mm overall. The angled grease channel was confirmed to be standard detail for full bore valves up to 12".

Image 1: the failed valve during onshore hydraulic test, to show the leak location.

It is recommended that this alert is used to review inspection and fabric maintenance procedures for valves, highlighting the possible risk of areas of low wall thickness by design and therefore potential additional hazards during mechanical preparation for painting.
