# Safety Alert

ALERT 08 – 36

## TRAVELING BLOCK HITS CROWN RESULTING IN A FATAL INCIDENT

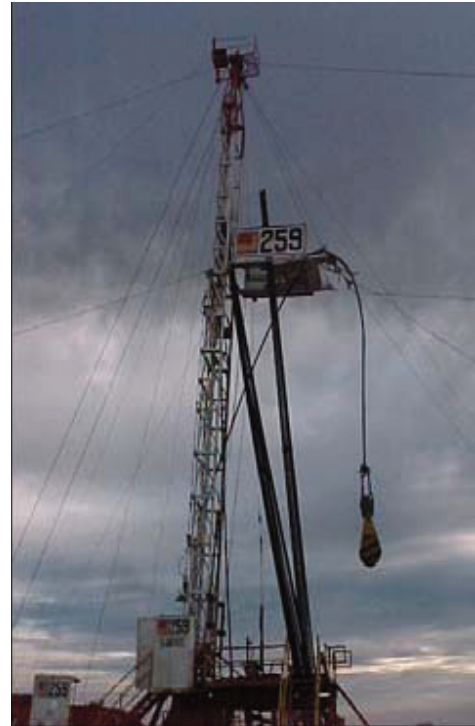
The elevators were at the monkey board and the Derrickman had just latched the stand of pipe. The relief driller shifted into gear and picked up the stand. The traveling block hit the crown and the drilling line parted resulting in the traveling block with stand of pipe falling across the monkey board. The Derrickman was struck by the falling equipment and was killed.

- Inspection records indicated proper functioning of the crown saver device but the safety margin for setting the crown saver device did not allow for enough distance to stop the blocks from striking the crown.
- The drawworks was put in highest gear, not allowing sufficient control of traveling block.
- The selection of the relief driller was not done according to company procedures.

- Rig personnel are to comply with all procedures. If it is not possible to comply, **stop the job**, contact the Operations Manager.
- In the event procedures cannot be complied with immediately, it becomes **the responsibility** of the Managers, Supervisors, and Safety Supervisors **to stop the job**, review and modify the standards and procedures as needed to complete the job while ensuring safety.
- To assure personnel competency, personnel qualifications for all positions both permanent and relief should be verified with the area Human Resources department.
- Supervisors are to ensure that company procedures are followed regarding relief employees.

- Drillers are to ensure that the crown saver device is set in the correct place so there is sufficient stopping distance to the crown.
- Drillers are to test the crown saver device system as per company procedures.
