**SAFETY ALERT - #14-2009**  
**BALL VALVE IN RELIEF LINE OVER PRESSURED**  
**RELEASE DATE: JUNE 1, 2009**

<b>Function:</b> Drilling Operations	<b>Incident Date:</b> June 6, 2008
<b>Incident Type:</b> Equipment Failure	<b>Country and Region:</b> Western Canada

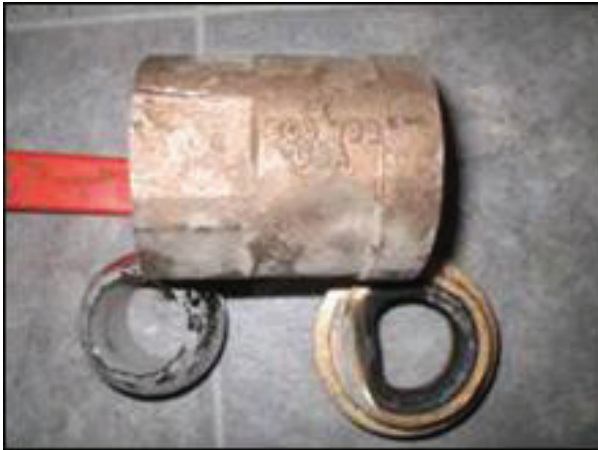
1. **Equipment Pressure Ratings:** All the components of pressure piping system did not meet the maximum pressure rating. In this case, the ball valve that failed was rated for 1725 kPa (250 psi) and was incorporated into a 20,685 kPa (3000 psi) system. Even though the bleed off system is open ended into the mud tank, a sudden surge of pressure, along with the column of fluid in the system, pressures can easily exceed 1725 kPa (250 psi). Surge pressures close to the rating of the pop off valve are possible until the system is bled off.

3. **Material Specifications:** The brass valve incorporated into the bleed off system had gone unnoticed during previous inspections. The brass valve was the original valve direct from the manufacturer. Brass fittings were not appropriate for this application.

Above is a photo of the failed 250 psi valve. This valve was replaced with the appropriate 3000 psi valve

1. All piping-hosing and valves materials must be suitable for the application and consistent with the pressure rating of the system in which they are installed.
2. Maintain consistent diameter piping in a relief pressure system; do not swage down piping in the system.

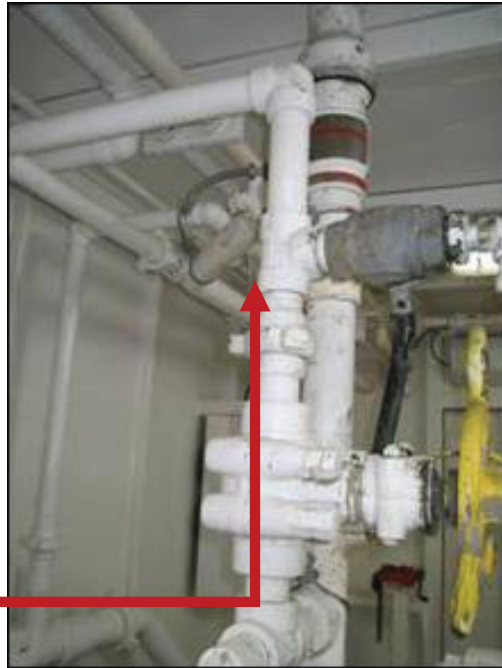
2. **System Design:** The pop valve and bleed off line is 3 inches and the high pressure hose from the outside of the building leading to the high pressure hose is 3 inch steel line; going into the tank is 2 inches in diameter. This reduction in diameter will cause an increase in the pressure in the bleed-off line. It is critical not to create any bottlenecks in a pressure relief system. Manufacturer's specifications normally require all piping downstream of the relief valve to be equal size or greater in size than the outlet of that relief valve.

3 inch bleed off line swages down to a 2 inch hose. The 2 inch hose was replaced with a 3 inch hose to eliminate the piping restriction.
