# Safety Alert

From the International Association of Drilling Contractors

**ALERT 10 – 04**

## LARGE CONTAINER LIFTED BY HELICOPTER DOWNDRAFT

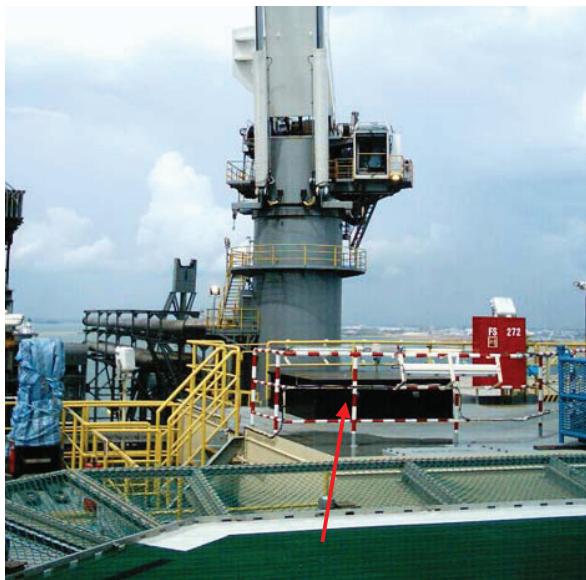
Location prior to the incident

During a scheduled helicopter landing, the helicopter's downdraft caused a large container weighing around 200 kilograms (440 pounds) to be lifted over handrails and then fall around 10 metres (33 feet) to the deck below. The container had been in place for some months and had experienced several similar helicopter landings without incident. The container was placed on the roof of a structure adjacent to the helipad on wooden battens and was not secured. The container was damaged in the fall. While no injuries were sustained, there was significant potential for serious injury.

The container was placed adjacent to the helipad and 35 metres (115 feet) from the helipad centre. The container was mounted on battens, but was not fastened to the structure. These factors promoted the conditions for the rotor wash (air flow created by rotor system) to cause lift and move the container to a point where it fell over the handrail to the deck below. The helicopter in use had a significantly greater rotor wash (air flow created by rotor system) than the other helicopter types that visit the rig.

- The container was immediately removed from the location.
- The container will be replaced and installed with a designed restraint system.
- Lessons can be learned on the hazards that can be created by placing unsecured items, irrespective of their weight, in areas such as helidecks where there is intense airflow.
