Safety Alert

ALERT 10 – 11

CUTTINGS AUGER AMPUTATES LEG OF RIG CREWMEMBER

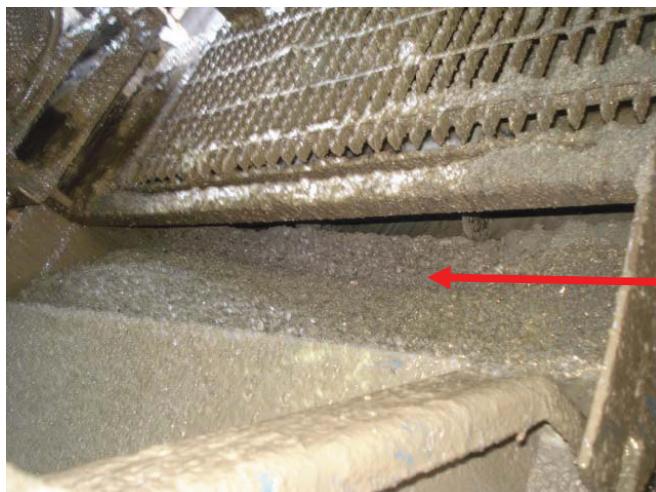
A crewmember was helping to change out shaker screens. The shaker had been isolated and the crewmember was working in the front of the shaker assembly. He had one foot in the shaker and the other foot in the cuttings slide. As he leaned toward the shaker in an effort to remove the shaker screen, his foot slipped and was caught in the auger. The auger amputated his right leg at the knee joint. The auger was shut down and the medical team was immediately notified.

The cuttings auger was installed by a third party. By design, the area between the auger and the shaker was left open to allow the cuttings to fall into the ditch. The remainder of the auger was protected, but the existing hazard was not recognized by the crew or the company who installed the system.

Open area where employee's leg was trapped.

- Instructed operations personnel that all rigs must immediately conduct a hazard hunt on the shaker areas, ensuring that all machinery is effectively guarded. Where deficiencies are identified the machinery should be flagged or locked out and repaired as soon as practicable.
- Instructed rig supervisors to inspect the entire auger system (where applicable) ensuring that no one can access any portion of the auger.
- Rig maintenance personnel or third party auger provider are to provide an emergency shutdown for the auger system (where applicable) so that it can be accessed from any position along the entire length of the auger.
- Corporate HSE personnel will develop procedures for properly guarding of augers and related systems.
