Event Brief

CHAIN BLOCK FAILED ITS STATUTORY INSPECTION

Event Date: 07/06/11 Hinkley Point A Event Brief: EBHPA000037

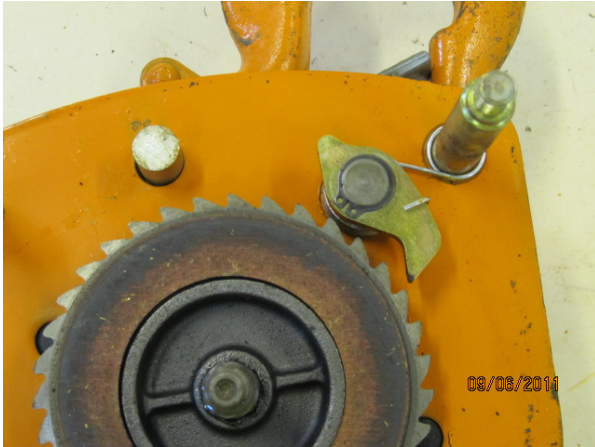
Summary: Following the recent failure of BL9337 during its statutory inspection, the block was taken apart to establish the mode of failure. Photo 1 shows the pawl disengaged from the ratchet which will account for the block free running when a load was applied during the examination. The load which was applied was simply the Inspector pulling on the load chain.

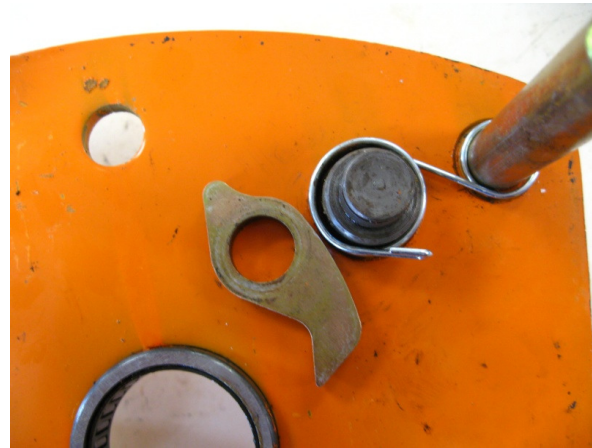
The Pawl has since been removed and two further problems identified:-

1. The pawl has a number of tight spots when rotated in its working position
2. The pawl spring appears to be of a poor design because very little force is being applied to the pawl

Photo 2 shows the pawl and spring, the spring is in its relaxed position. The hook part of the spring which applies the force onto the pawl, when assembled only gives a few degrees of rotation. It is not possible to rotate the hook end of the spring to apply more force on the pawl because the coil section tightens on the pawl mounting post.

A second block BL9336 from the same batch has been removed from service. BL9336 is currently working correctly and will be stripped to reveal the pawl and spring. The spring will be removed and compared with the one on BL9337.

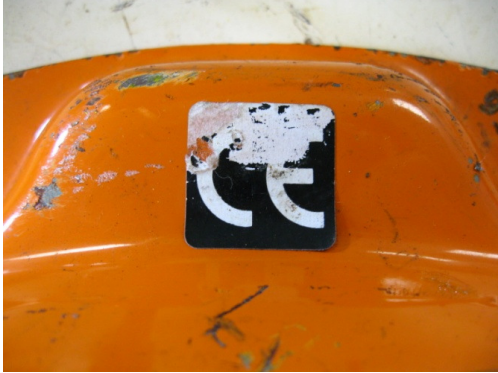
Photo 3

BL9336 and 9337 were given a general visual check and it was noted the CE marking was not to standard – Photo 3. It appears the CE marking on both chain blocks is the one used for Chinese Export.

Hinkley 'A' has 13 Lloyds Vital Chain Blocks of various sizes, all are in the process of being removed from service until further notice.

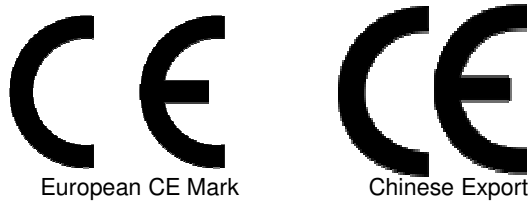
The issue of Chinese exporters using the CE logo incorrectly was raised at the EU parliament in 2008 and as far as I am aware is still not resolved.
