SAFETY ALERT

Failure of carbon steel piping due to methanol stress corrosion cracking

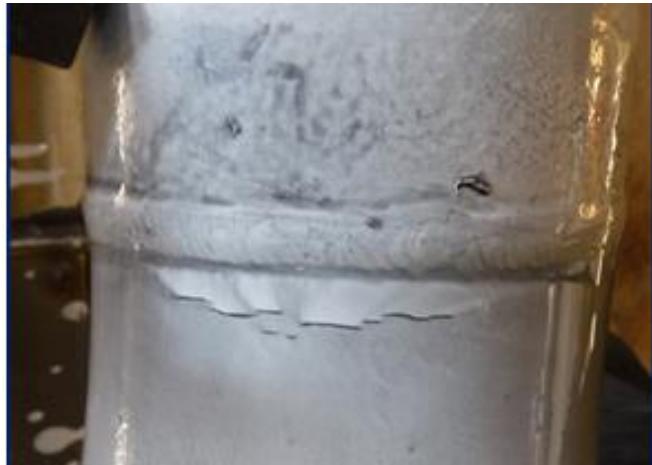
After approximately 18 months in service, a pinhole leak was observed on a carbon steel line from the methanol storage vessels to methanol transfer pumps. Further examination revealed multiple leaks and weeps at various locations throughout the low-pressure carbon steel bunkering, storage and transfer piping. All of the leaks and weeps were due to cracking associated with welds.

Although the welds were mechanically sound and had passed QC inspections, it is suspected that there may have been some deviation from the weld procedure, which resulted in individual welds having high residual stresses.

- Identify whether they have carbon steel piping or equipment exposed to methanol that contains less than 1% water by volume

- Ensure that the risk-based inspection assessment for such piping or equipment addresses the threat of methanol stress corrosion cracking. The risk assessment should consider:
 - the water content of the methanol (specified and actual measured values)
 - imposed stresses (adequacy of supports, evidence of misalignment etc.)
 - residual stresses (confidence in compliance with welding procedures, measured values etc.)
 - time in service without failure
 - employ appropriate non-destructive evaluation (NDE) techniques to inspect for cracks at susceptible locations such as welds, i.e. where the risk-based inspection assessment identifies the requirement
