# SAFETY ALERT

## Lost Time Injury (LTI) – Finger Injury While Using Safe Hands Tool

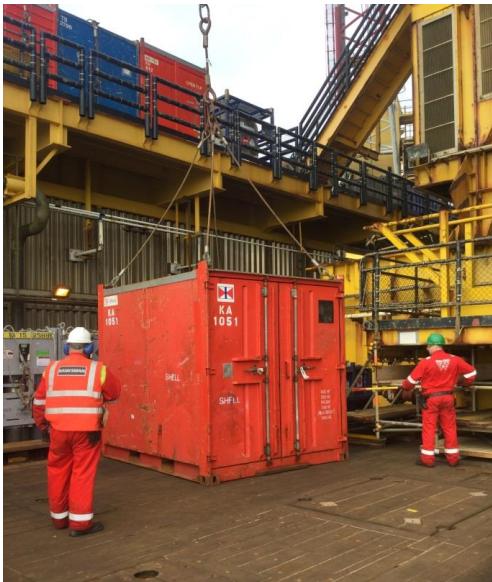
Finger injury sustained while using a Safe Hands Tool to manoeuvre container into place.

Services team were working a vessel, load handling containers onto the skid deck using a safe hands tool (blind lift).

The container was landed onto the skid deck, to remove stored energy, as it was being manoeuvred into position against the back skid rail the container moved to the right.

The IP moved towards the side of the container and during this process the IP's hand, which was placed at the back end of the safe hands tool, came into contact with a scaffold rack. IP's finger was nipped between the scaffolding rack and the butt of the safe hands tool.

The IP's resulting injury was the loss of the tip of one of his fingers.

Deck crew operations were suspended and the load made safe.

Time out for Safety held with the deck crew to review practices and the Risk Assessment.

- The safe-hands tool should be held in both hands at the recommended points i.e. one hand on the forward grip and the other on the rear hand grip. A good stance should be adopted and the operator should insure the safe-hands tool is being held in a manner that will not cause personal injury should circumstances change. Do not stand directly behind the tool or use your torso to impart leverage during operations.
