SAFETY ALERT

Uncontrolled Descent – Near Miss

Lifting of a hydraulic control unit.

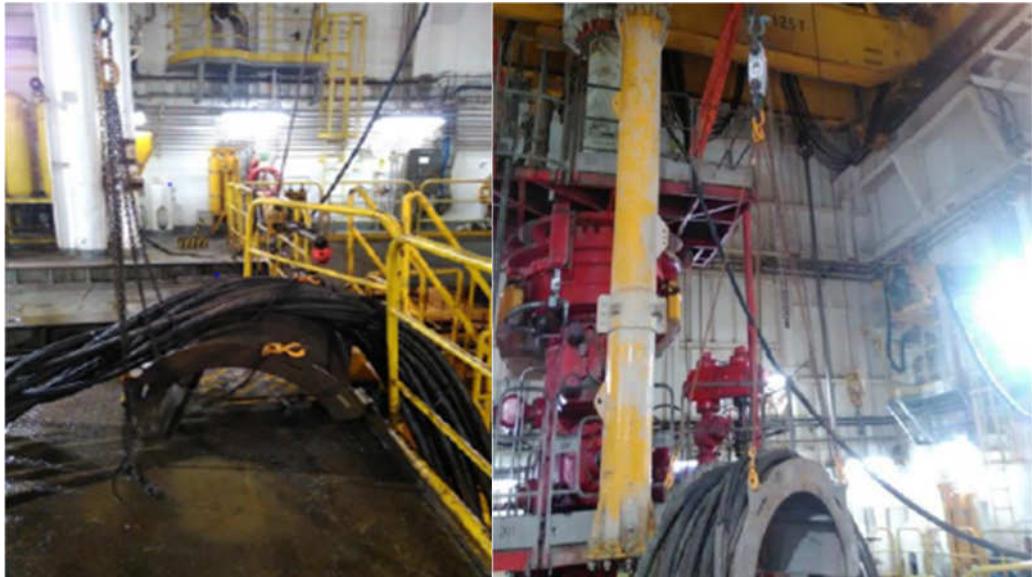
Prior to lifting a hydraulic control unit, it was observed that the saddle and Blow out Preventer Control hose arrangement would obstruct the planned lift.

The saddle and control hoses were suspended approx. 1m from the deck by a Yale Lift 360 manual chain hoist.

The operator proceeded to use the chain hoist to raise the saddle arrangement another 1 metre off the deck to provide a clear path for lifting the hydraulic control unit. Whilst lowering the load, it paid out freely, lowering the saddle and hoses onto the deck. No one was injured and it was found that there was no equipment damage.

Due to the load (saddle and blow out preventer control hose) being suspended for an extended period of time, the brake hub had stuck in the "open" position on the pinion shaft.

- Ensure chain hoists are not used for suspending loads
- Ensure appropriate lifting equipment is used for long term suspended loads
- Ensure there is a method of routinely inspecting lifting equipment
