# SAFETY ALERT

## Gas Release from Small Bore Tubing

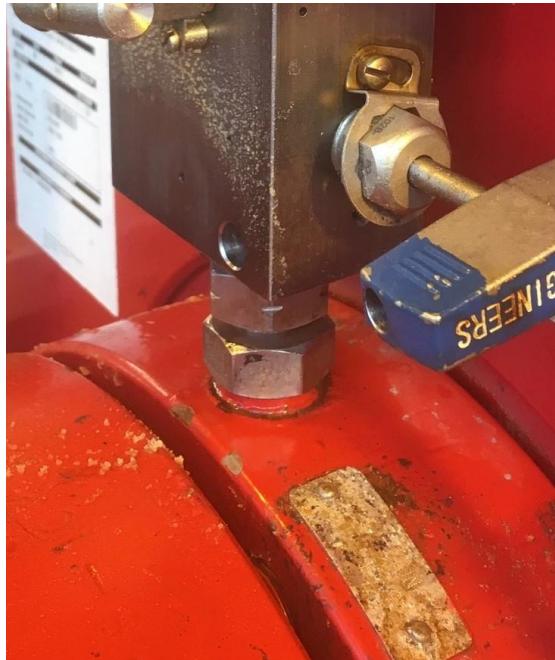
The wellhead pressure transmitter is tied into a Xmas tree flange that is installed upstream of the production wing valve. The double block and bleed valve (DBB) is installed directly into Xmas tree flange.

The DBB was fitted during the well construction phase, with an adapter fitting designed specifically. This DBB connection was tested during the completion operation and was exposed to the well pressure and hydrocarbons during the well test.

The DBB forms part of the primary barrier when the well is flowing and allows the impulse line and instrumentation to be fitted during the well hook up phase. The impulse line and DBB, including connection to the flange were tested with nitrogen during the commissioning phase of the project.

Autoclave installation competence and assurance: when impulse lines are fitted to small bore fittings, then the vibration on the impulse line should be measured with the well flowing. If vibration is noted, then additional support should be installed to the impulse line.
