## LTI – Shoulder strain when crew member was descending the stairs

Safety Flash    Published on 20 August 2026    Generated on 20 August 2026    IMCA SF 15/26

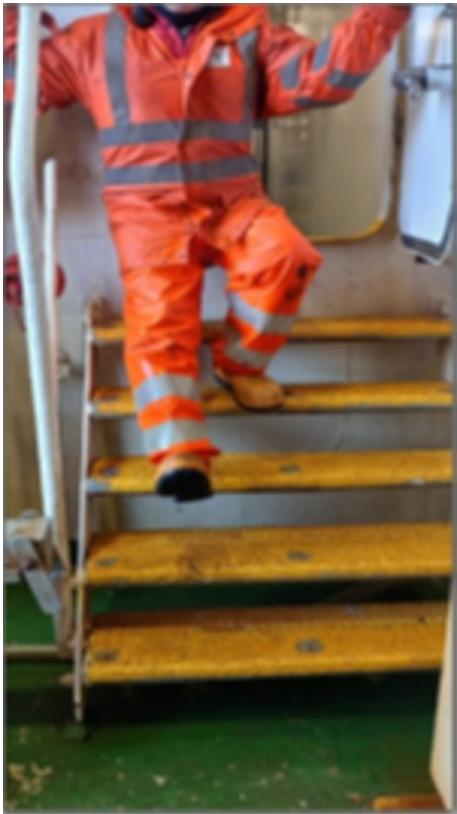
Whilst stepping over the coaming of the weather tight door, they lost their footing on the top step at which point they reached out grabbing the door mechanism to try and stabilize themselves. As their hand remained fixed to the mechanism, both legs and lower body slipped off the top step. This resulted in their entire body weight pulling abruptly against their stationary left arm. The sudden drop created stress and a severe "wrenching" force on the shoulder joint, resulting in the injury.

- **Task Demands** – Perceived time pressure (in a hurry) – A request was made for the individual to investigate a burst freshwater line. The crew member was rushing – even with good intentions, this increases exposure to hazards.
- **Work Environment** – The ROV hanger is open to the external elements. As a result of this, the area gathers condensation, contributing to slippery conditions. Slippery conditions in open hangars are a known persistent risk.
- **Work Environment** – Changes / Departures from routine. The crew member

entered the ROV hangar by a route not routinely used during operations.

- Don't rush, even during urgent tasks
  - Could urgency affect your judgement and behaviour?
- Be aware of the hazards of stepping over high coamings while coming down the stairs
- Maintain three points on contact when using stairs
- Be aware of how environmental conditions (condensation, moisture) can make surfaces slippery
- Do you know all the different ways in and out of your workplace, and are you aware of any possible hidden risks?
