Grenfell Tower

DATE OF EVENT: 14th June 2017

OUTCOME: 72 Fatalities, 70+ injuries

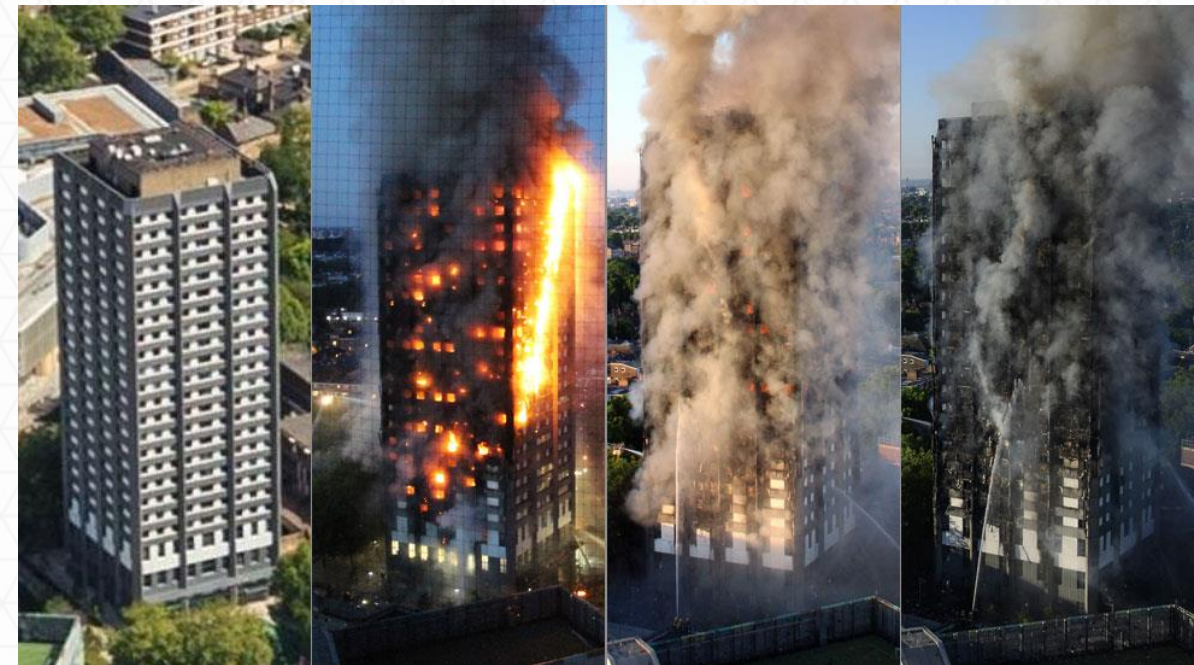
- A fire broke out in the 24 story tower block.
- The fire was started by a malfunctioning fridge-freezer on the fourth floor. It spread rapidly up the building's exterior, bringing fire and smoke to all the residential floors.
- Residents in the tower block were initially advised to stay put, as tower blocks fires are typically contained.
- Within 40 minutes of the fire starting, the fire had reached the roof and was out of control.
- Smoke spread from flats into the lobbies & stairs.
- The smoke in these areas resulted in people being trapped in their flats.
- The firefighters struggled to coordinate the response as communications between the on-scene commander, the crew and the emergency services call handlers were hampered.
- The fire spread around the faces of the building, engulfing it.

- Construction standards such as concrete and fire-resistant doors typically contain fire within one flat, however the external cladding facilitated the spread of the fire.

- The cladding added during the refurb was not fire retardant – it did not comply with building standards.

- The primary (and only) escape route was compromised by smoke and heat ingress, likely because fire doors were propped open or did not self-close.
