## 421: Waste Food Disposal

## 422: Risk Assessment

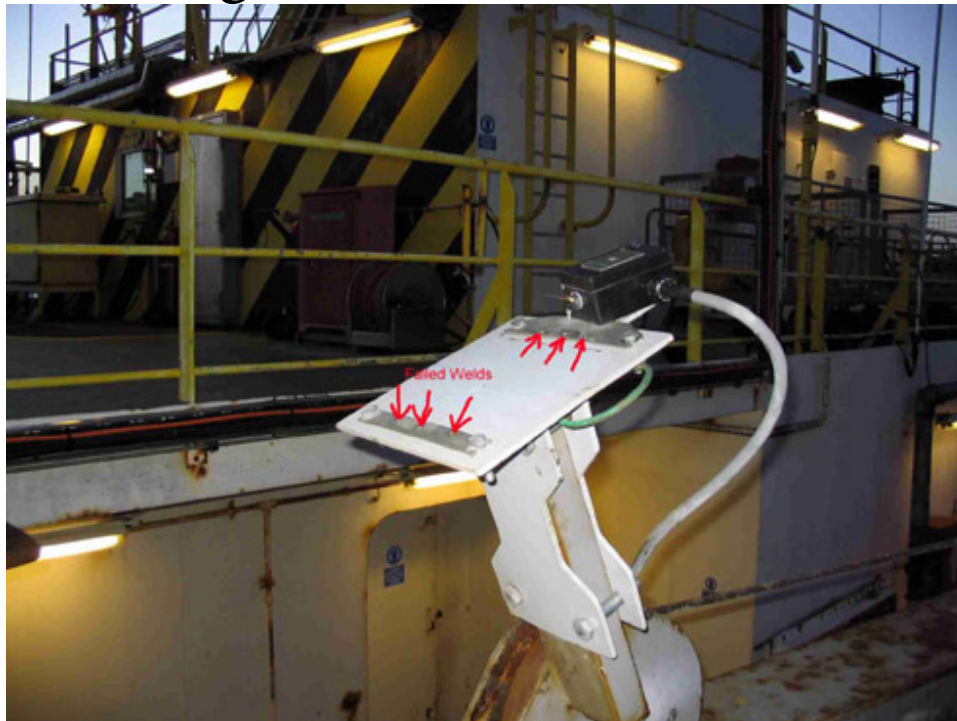
## Aircraft warning device crane boom mounting bracket

Damaged aircraft warning light

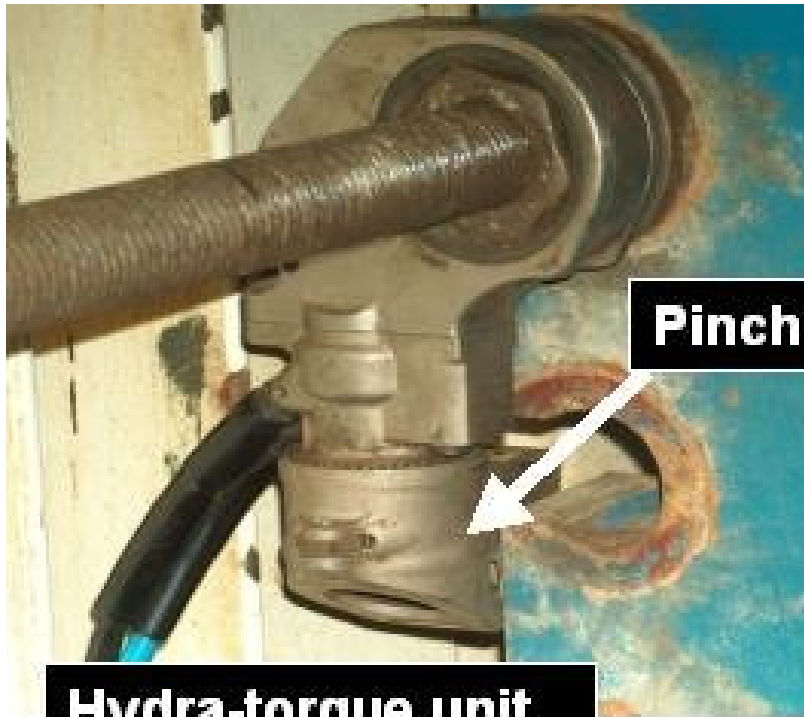
Hydratorque kit in position

**Pinch Point**

**Hydra-torque unit  
In working position**

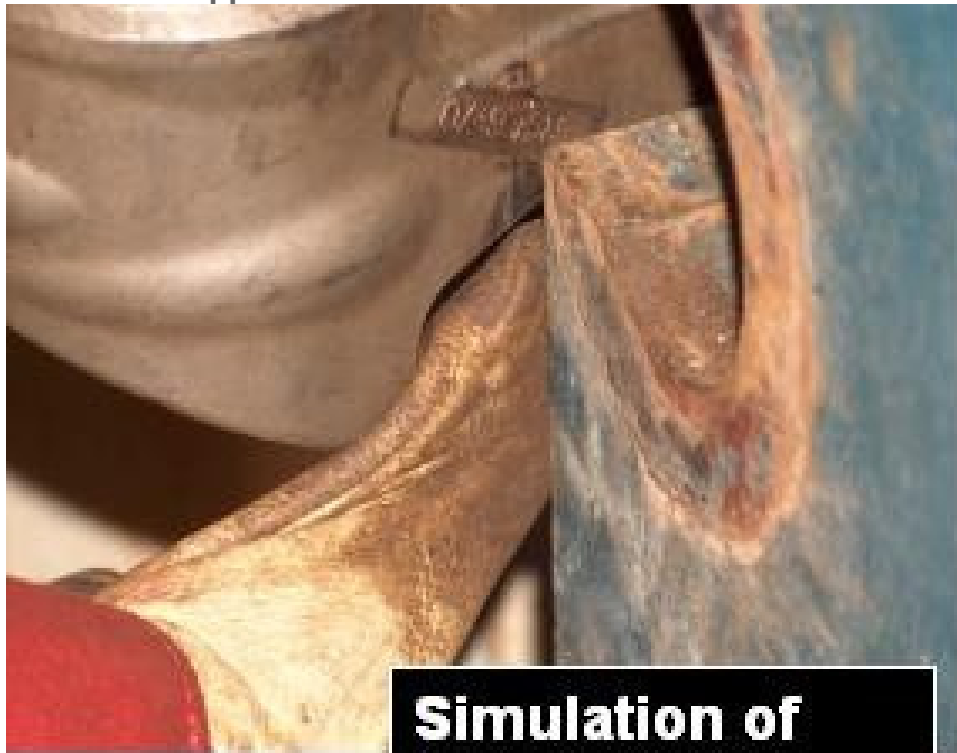
Simulated trapped thumb

**Simulation of  
thumb trapped  
between reaction  
arm and cooler  
end plate**

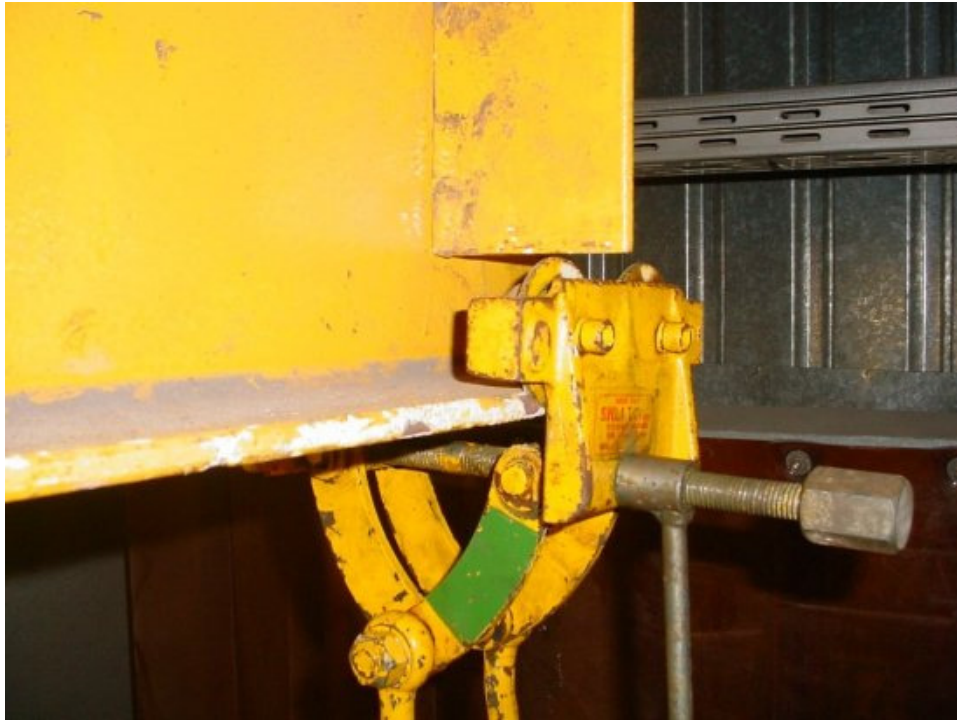
Beam trolley underneath end plate and partially off the end of the runway beam

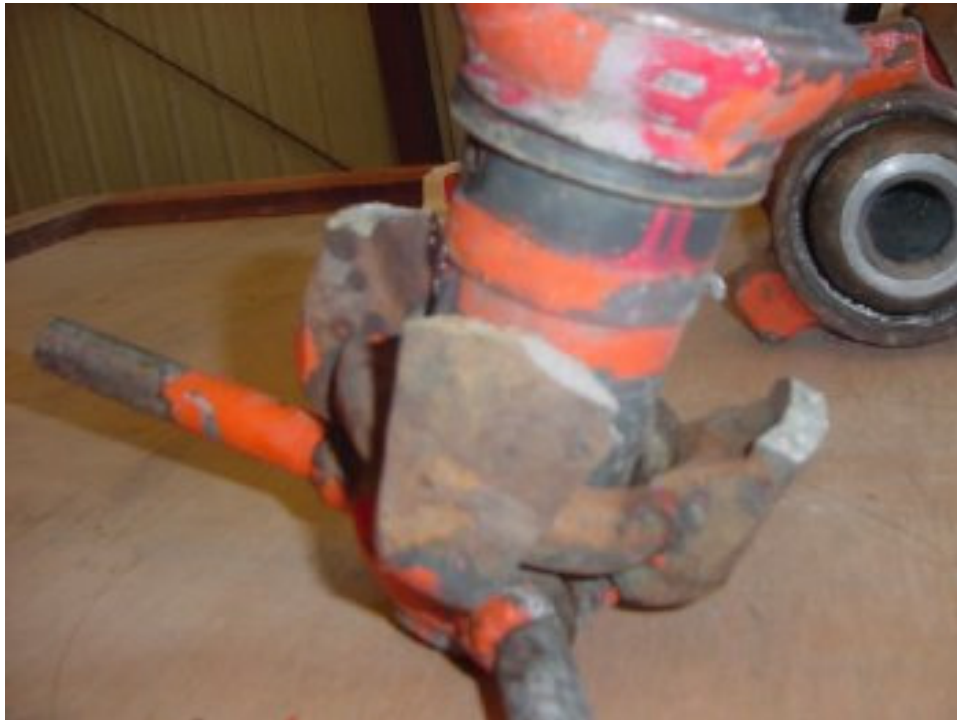
failed valve

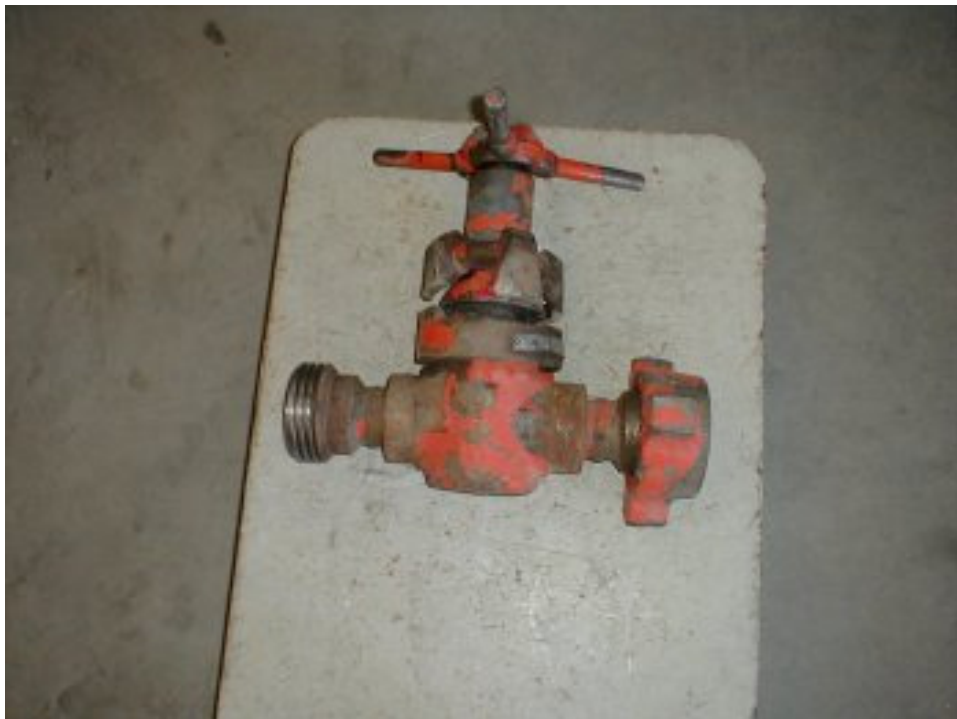
failed valve

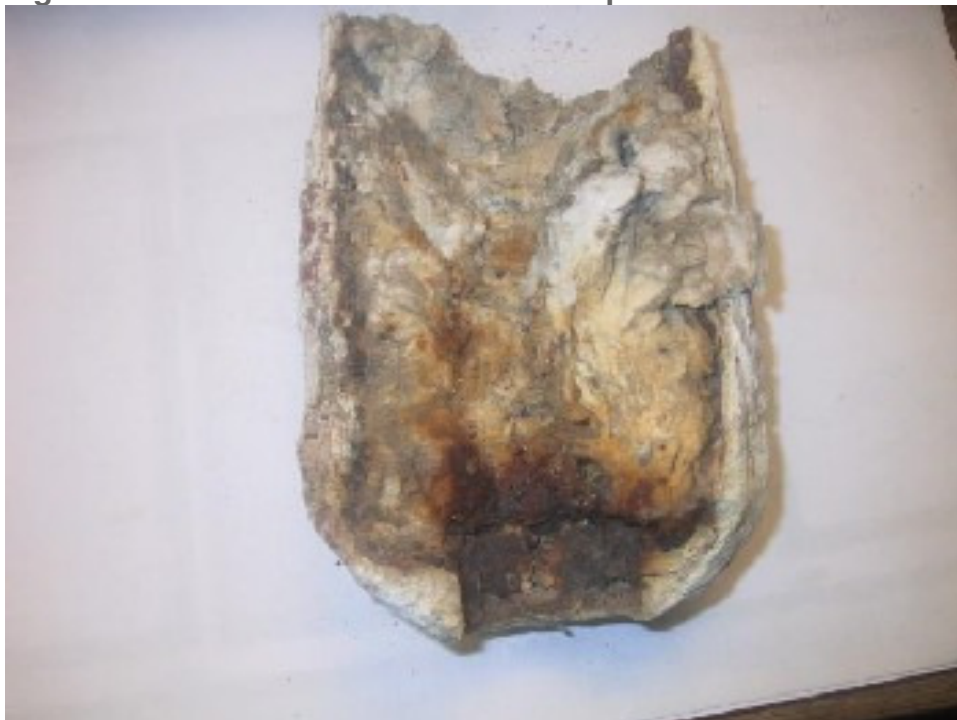
**Summary:** A gas leak occurred when a 2" relief line failed during a compressor blowdown on a production platform. External corrosion was found under a passive fire protection sleeve of a deck penetration. Sometime during the lifetime of the penetration, water ingress is likely to have occurred, creating corrosion under insulation. This particular type of penetration was found to be rare, nevertheless a number of prudent actions are recommended.

**Figure 2 - Remains of the Mandalite "cup"**

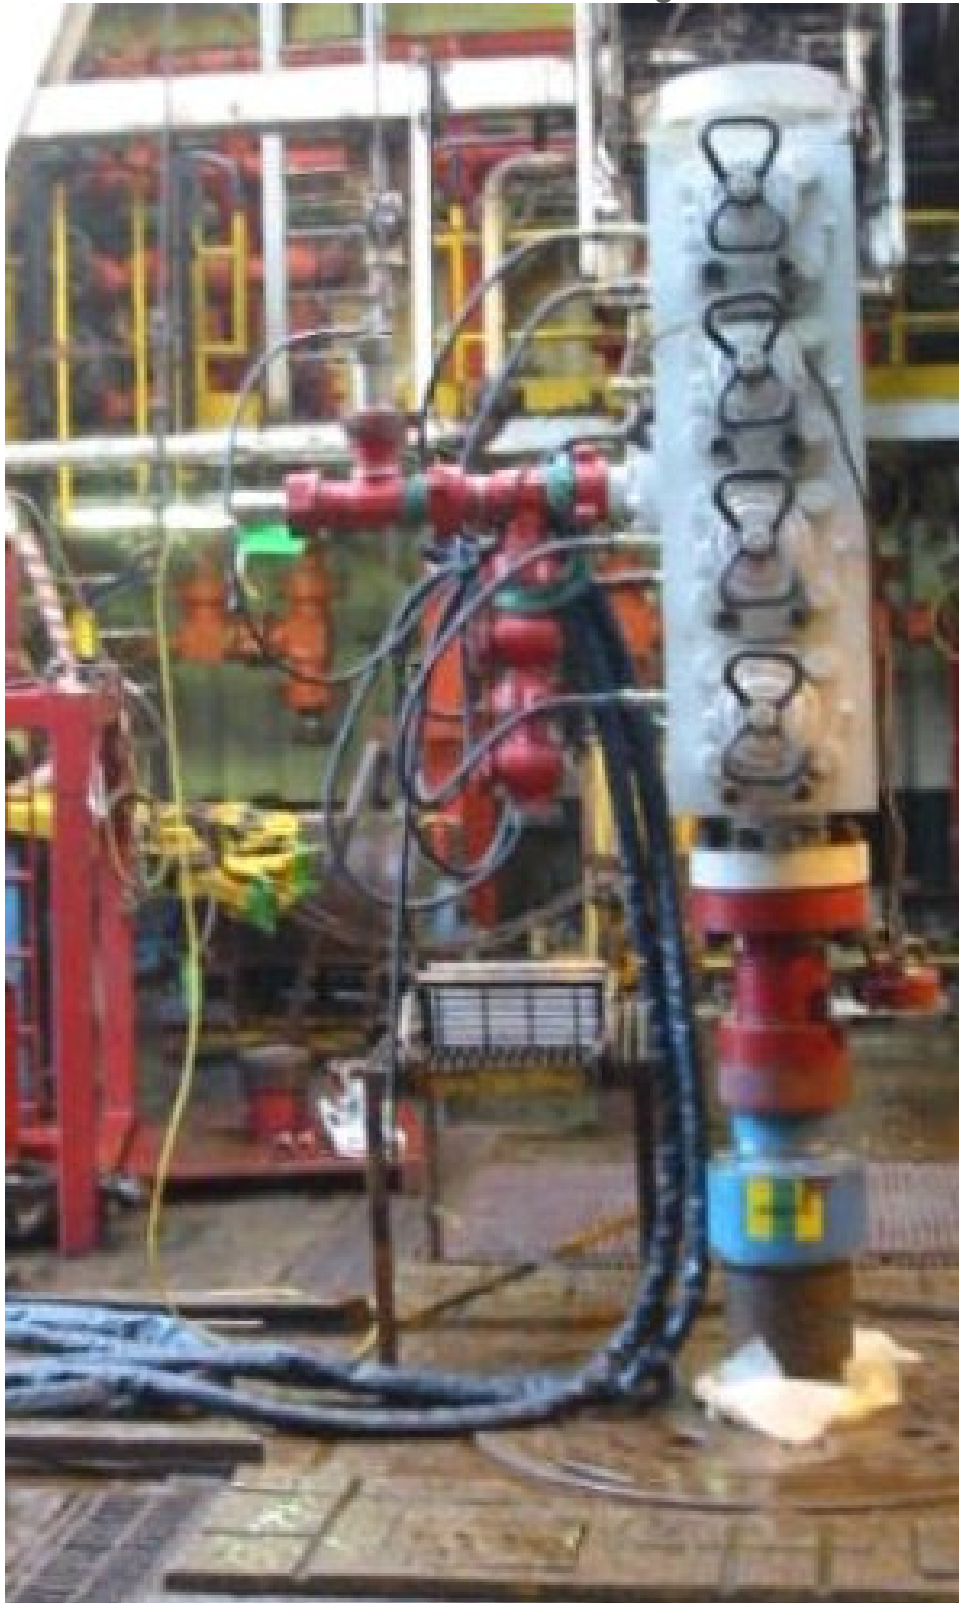
This picture shows the BOP and the pressure test lines leading up to it. The pressure test lines lead down to the wellhead deck 118 feet and across the well head deck 30 feet before it gets to the NRN.

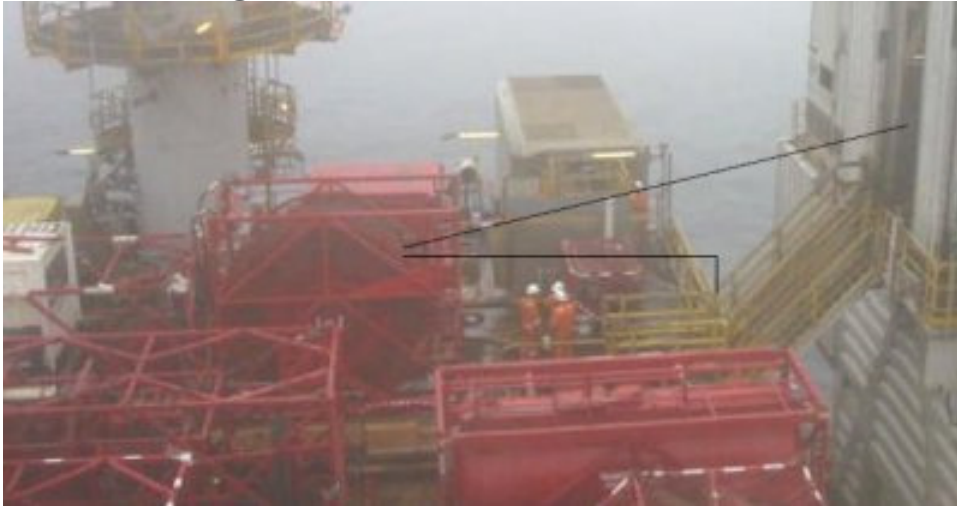
The arrows demonstrate the path taken by the ejected test bar which

was 10 feet long and 1 3/4" in diameter

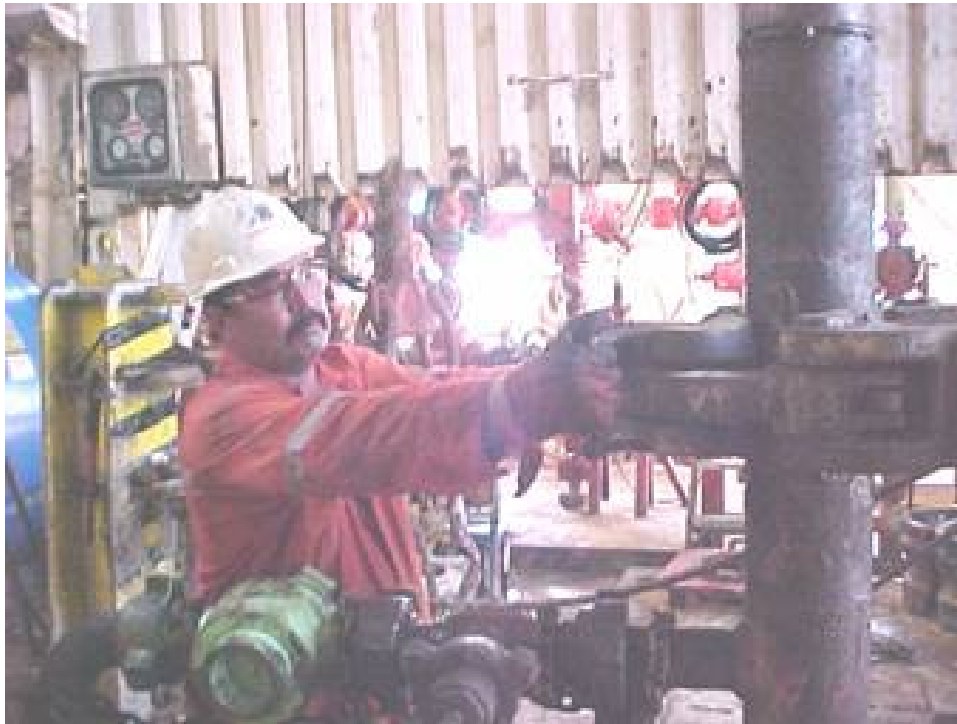
Picture 1

Summary: June 14, 2004 Flexible hose parted from fitting during operations, due to the ferrule of the hose assembly being incorrectly fitted.

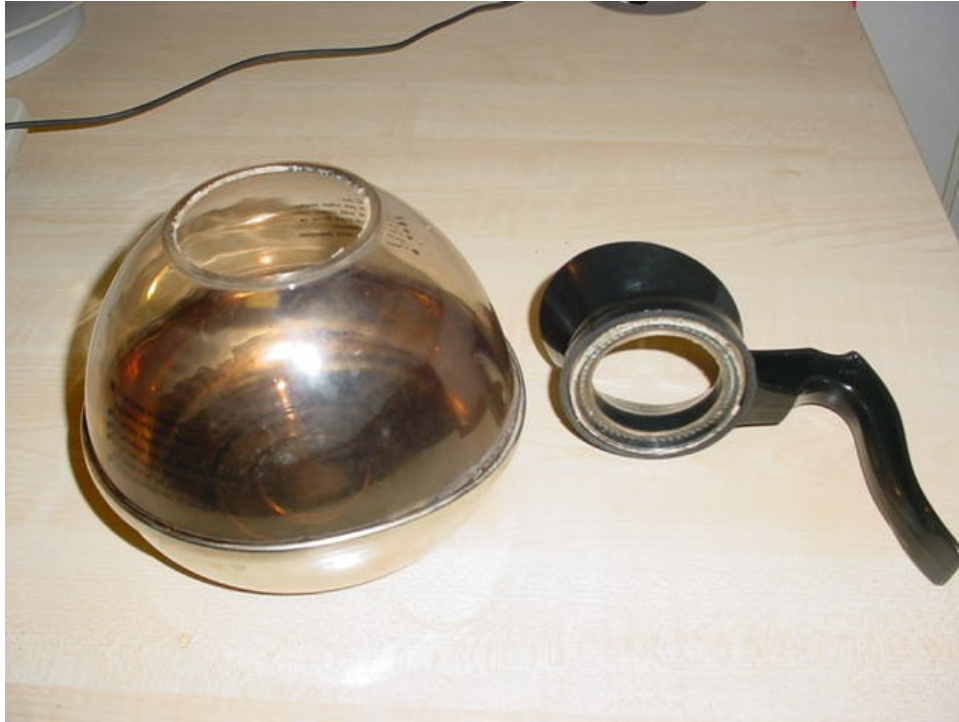
| Recommendations: | Remove shatterproof perspex and stainless steel coffee jugs from use and replace with dishwasher safe (glass or |

stainless steel) models. All handles should be checked for wear and tear as a matter of course.

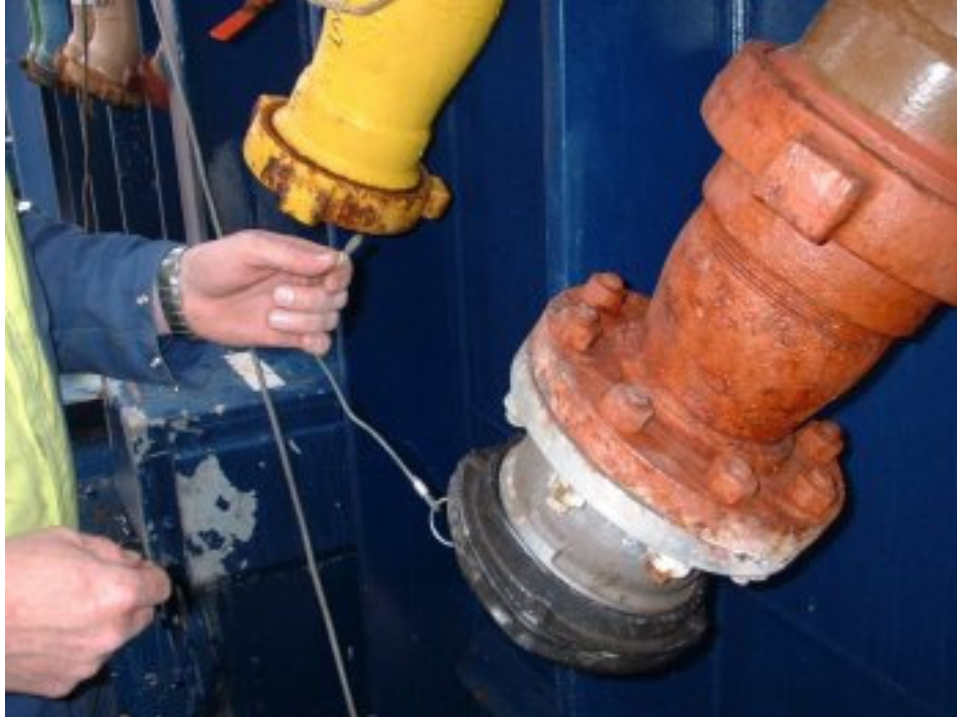
Observations: • The blanking cap of the avery-hardoll had a safety line fitted but it was NOT attached to the connection. • The blanking cap differed from the more 'normal' design, being of a type locked by the use of four retractable balls (ToDo cap), instead of the more usual three pin locking arrangement. It appears that the cap was initially affixed but not securely, and did not lock on fully. This resulted in a failure when anyone or anything came into contact with the cover. • The positioning of the persons involved exposed them to danger from 'falling objects'. • All those persons involved were wearing correct PPE, which reduced the possibility of serious injury. • Risk Assessment and Permit to Work documentation had been completed but failed to 'spot' the rogue cover.

**Avery-Hardoll cover connected**

Recommendations: • All covers for bulk connections should be checked immediately, and at regular intervals with regard to locking mechanisms and security lanyards, to ensure their integrity. • Risk assessment and Permit to Work should be in place for all tank entry. It is usual to concentrate on conditions within the tank; this incident highlights the need to address ALL areas, including the entry point, with special emphasis on possible falling objects. • Periodic checks by the those parties involved, including responsible member of the ships crew should be undertaken to ensure that the controls within the PTW are adhered to, throughout the operation.

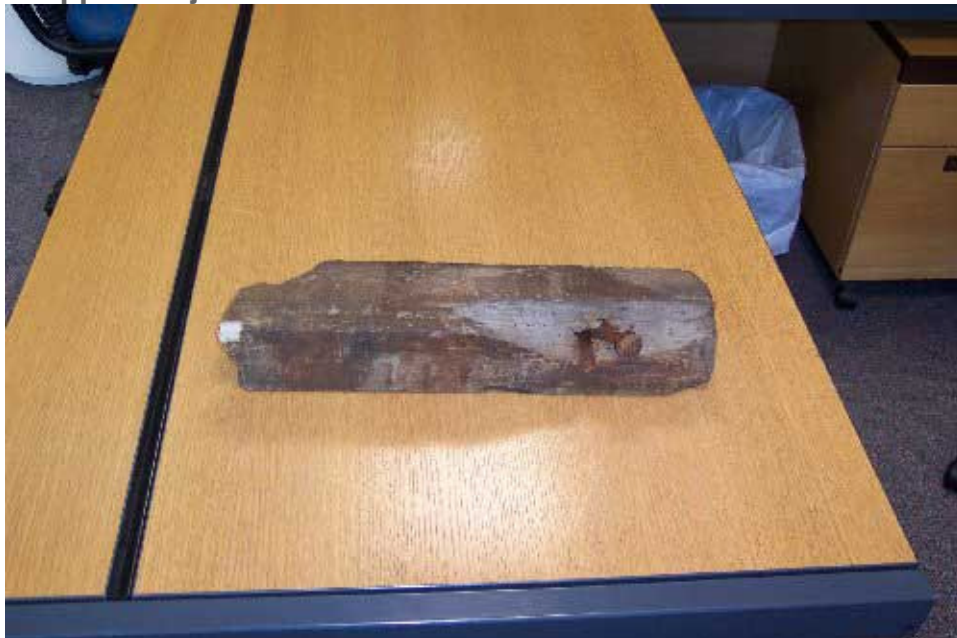
### **Dropped Object**

Description: A Supply Vessel was alongside an Offshore Installation backloading deck cargo, a wooden piece of dunnage dropped onto the deck from a methanol tank. The height of the fall was approximately 12 metres above deck, the size of the piece of wooden dunnage was 4"x3" and 45 cm in length weight approximately 2.2 kgs, there was also rusty bolt attached to the wood. AB's were in the safe havens at the time the object dropped on deck. It is evident however that this object may have passed through many inspection processes in the supply chain. The installation does not hold Methanol Tanks on deck as the procedure is for the tanks to be lifted from the vessel decanted and sent back down to the vessel immediately.

Recommendations: Initial investigation again proving difficult to ascertain where the dropped object originated from. All processes within the supply chain have a responsibility to ensure that pre-lift inspections are carried out, to ensure the

integrity/security of hatches, possibility of loose items e.g. tools, foreign objects etc. as per the UKOOA Guidelines for the Safe Packing and Handling of Cargo to and from Offshore Locations. This near miss is to be highlighted/discussed at all up and coming Safety Meetings onboard PSV's and throughout the supply chain to include vendors, cargo inspection and quayside staff for lateral learning purposes.

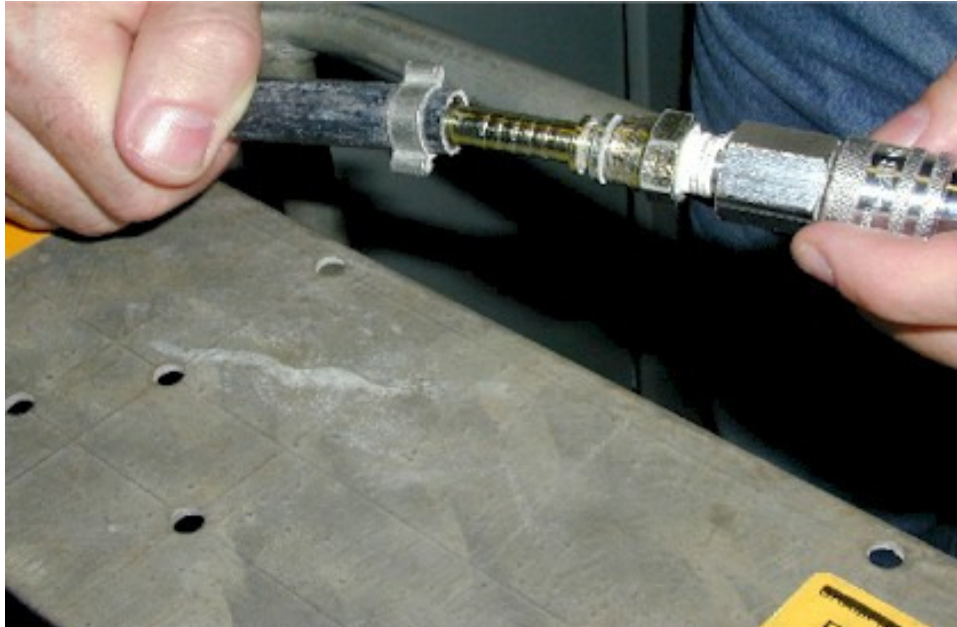
| Description: | Whilst carrying out work within a vessel using airline breathing apparatus the air supply hose to the wearer failed causing a loss of air supply to the mask. The wearer was working close to the entry point at the time and was quickly recovered from the vessel by other members of the workteam. On inspection it was discovered that the hose had slipped off the hose tail on the female side of the CEJN coupling. Further examination revealed that the coupling was not a standard manufacturers spare part and did not provide for secure fitting of the hose. |
| Lessons Learnt: | Use of spare parts not approved by the equipment manufacturer can lead to failure of the system. The use of alternative parts must be fully assessed and approved by competent personnel and must not lead to a deterioration of system integrity. Maintainers of BA equipment must |

### **Failed Airline Hose**

Recommendations: Confirm that maintenance of BA equipment has been carried out to manufacturers recommended standards and ensure that robust safeguards are in place to prevent unauthorised use of alternative part

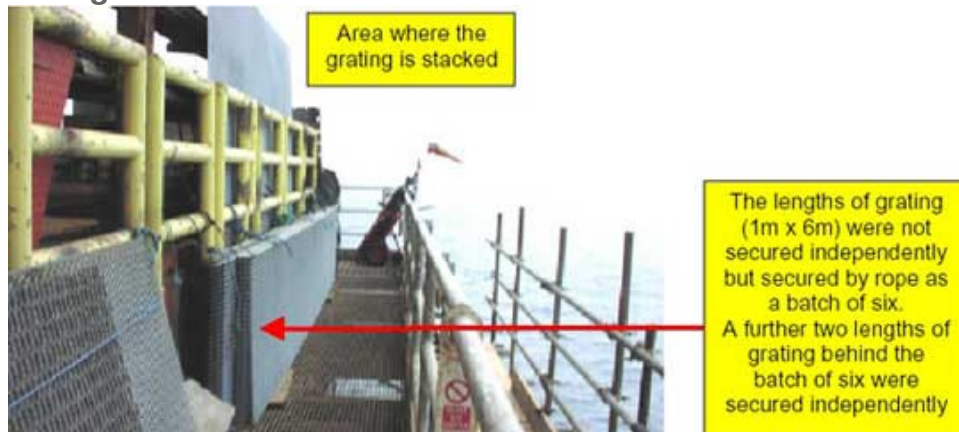
### Storage Area

| Lessons Learnt: | Grating panels were tied and secured as a batch of six instead of each panel being secured independently. Lack of potential hazard awareness / appreciation in relation to task performed. Inadequate Risk Assessment. Due to limited storage space the grating panels were stored in this manner. |

Recommendations: Alternative storage areas for the grating panels require to be identified. These are to be clear of walkways. The construction of a storage rack/station area Use of stanchion racks to avoid this and enable safe access and handling. Consideration to be given to ordering the grating panels in shorter lengths.

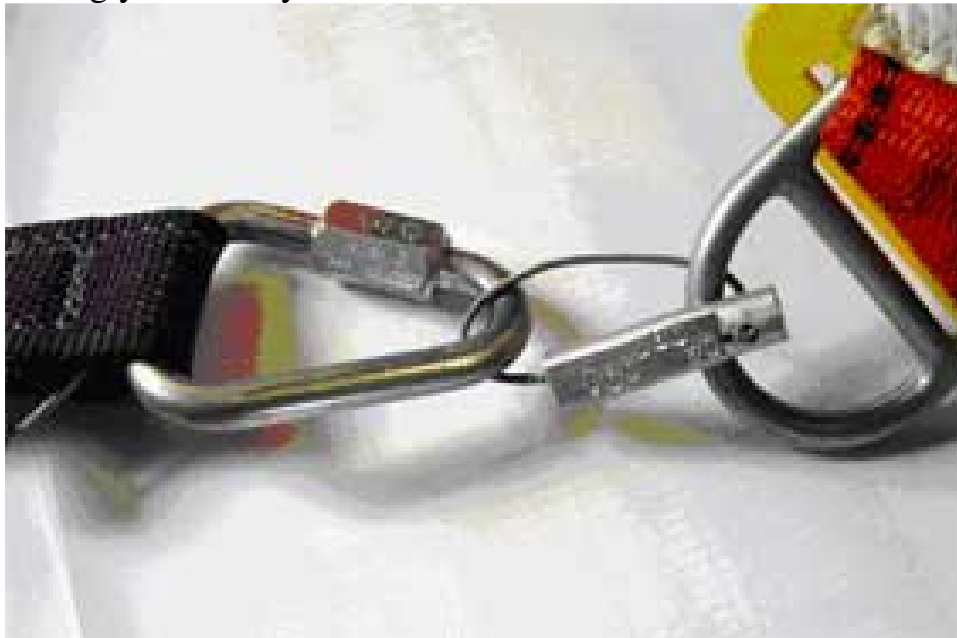
### Wrongly fitted lanyard

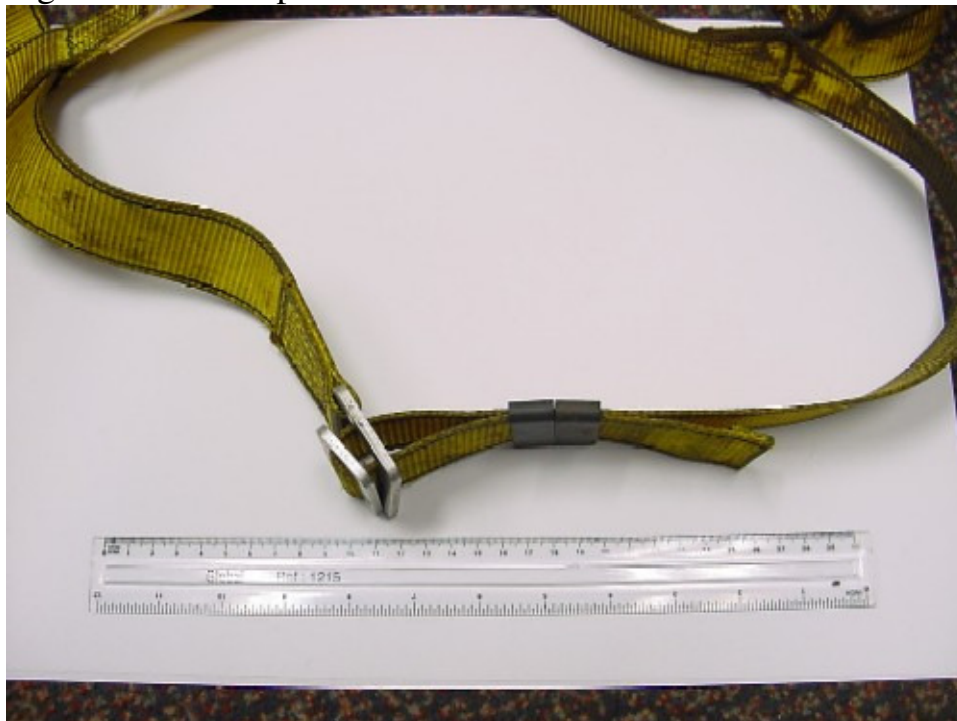
Fig 1 Normal Strap Position

Attached photos show normal position (Fig 1), position as found with end of strap having passed through plastic blockers (Fig 2) and with the end of the strap through one slot of the buckle (Fig 3).

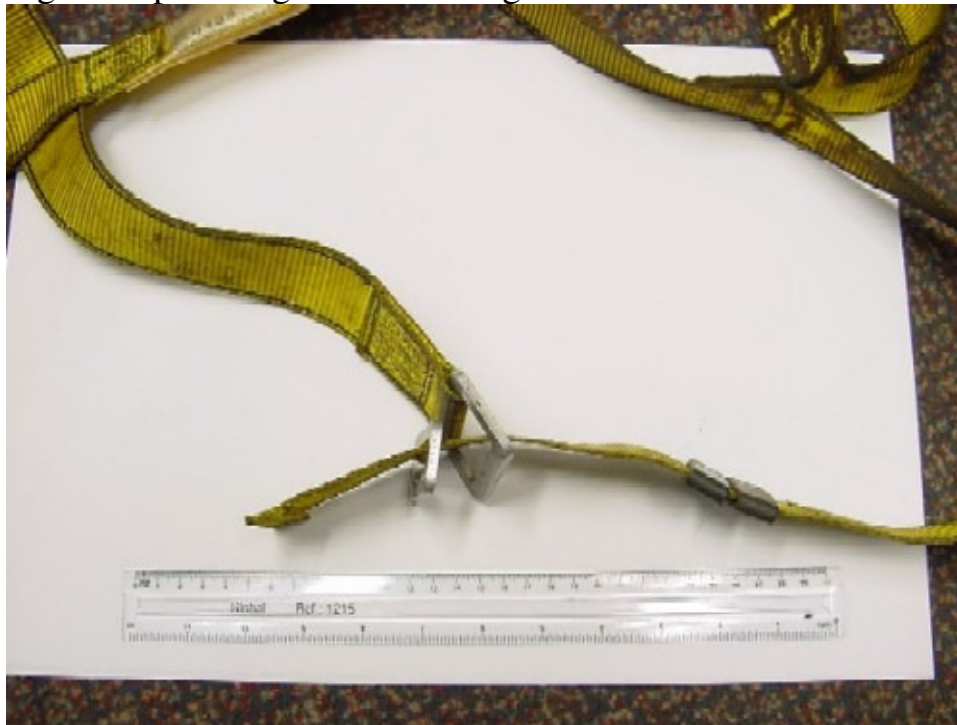
Fig 3 Strap Having Passed Through Buckle

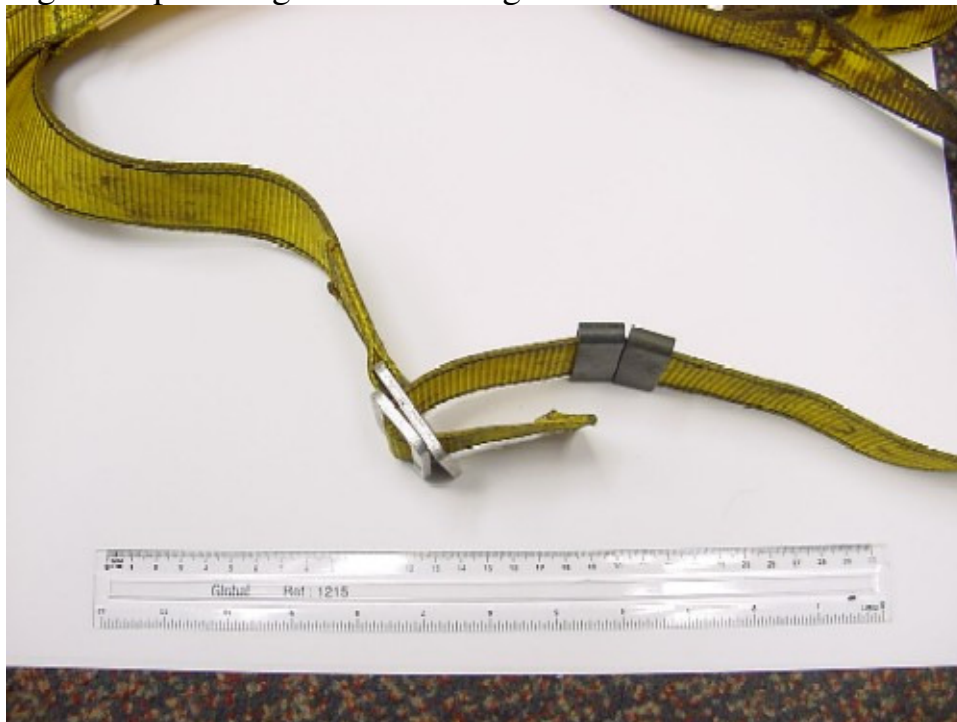
Fig 2 Strap Having Passed Through Plastic Blockers

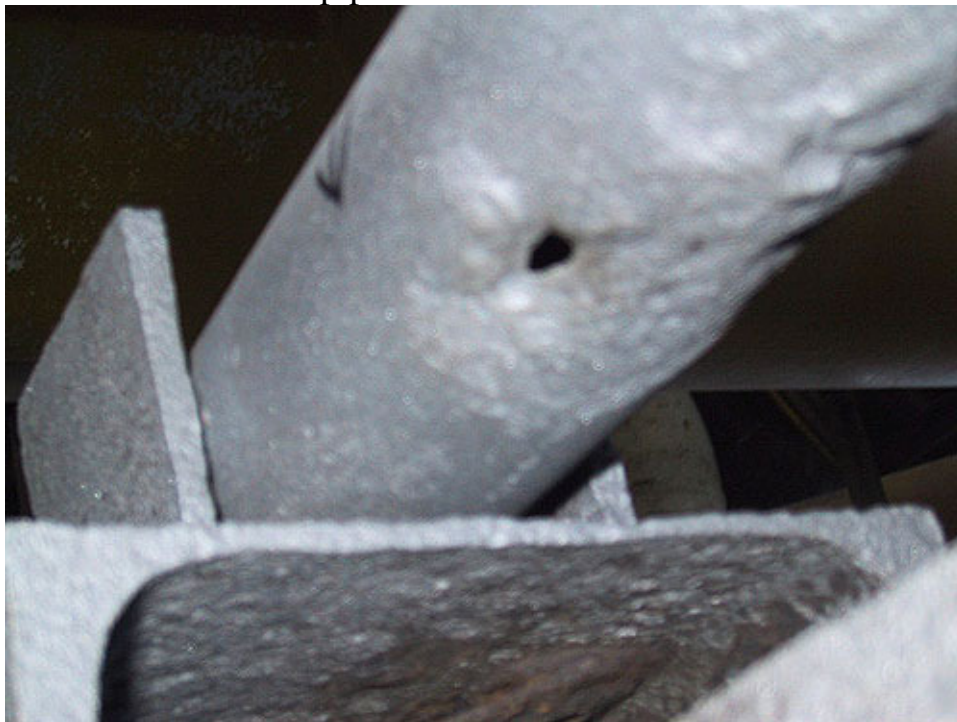
Summary: During coating repair preparation, which included process pipework, the operator of the grit blaster detected a hydrocarbon odour in the area where he was working.

### Hole in underside of pipework

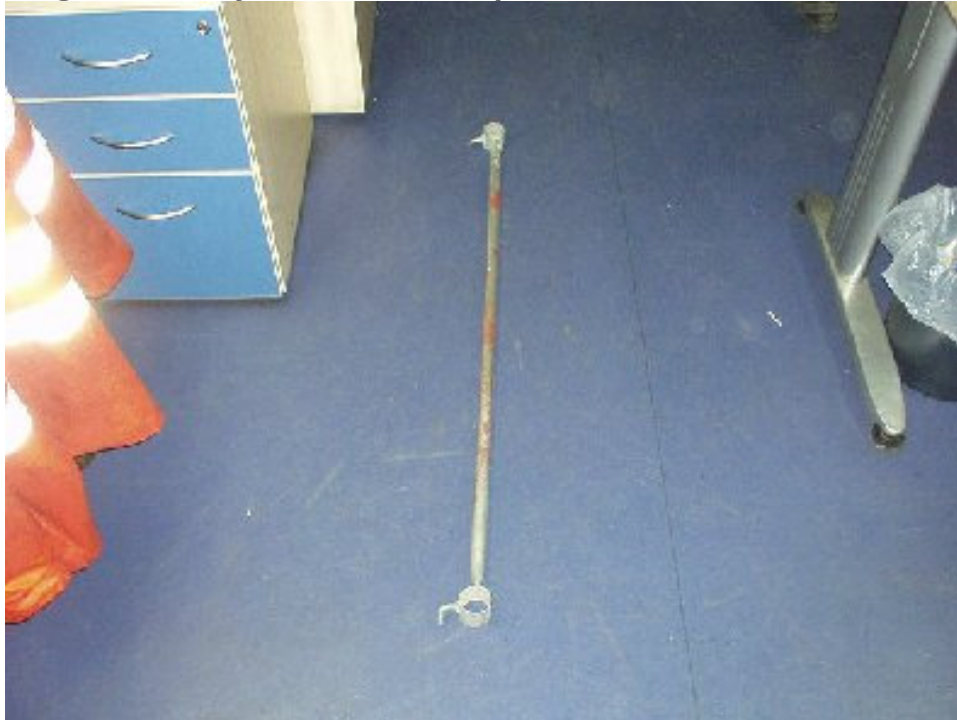
**Large Metal Object Found on Top of Container**

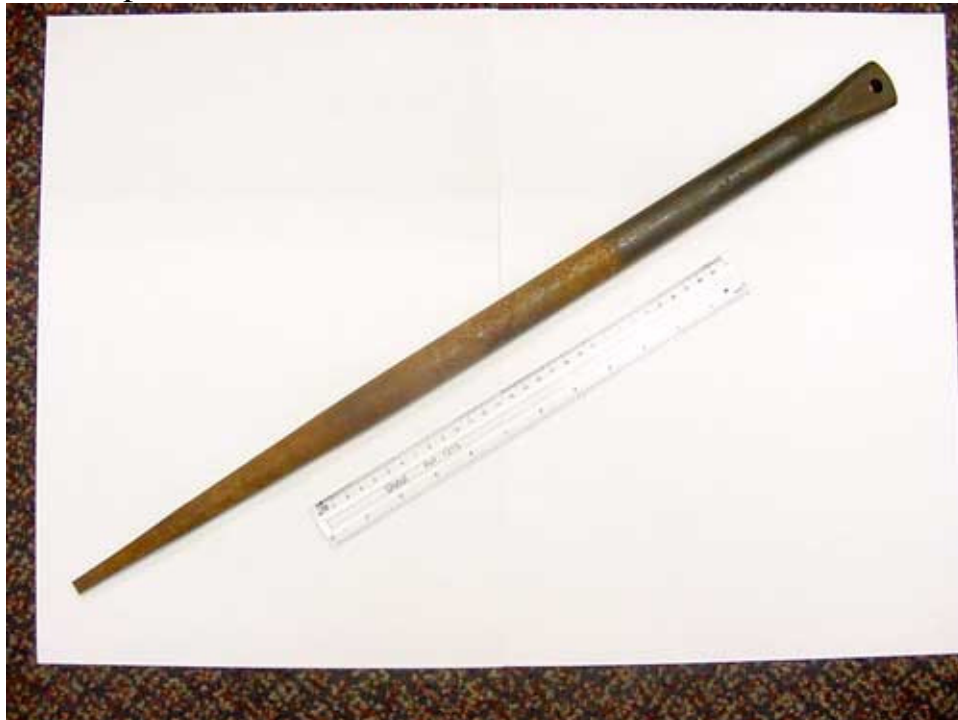
### Metal Spike

| Summary: | During the dismantling of scaffold a scaffolder was lowering a length of scaffold tube when a metal spike fell from the inside of a tube and landed on the deck. |

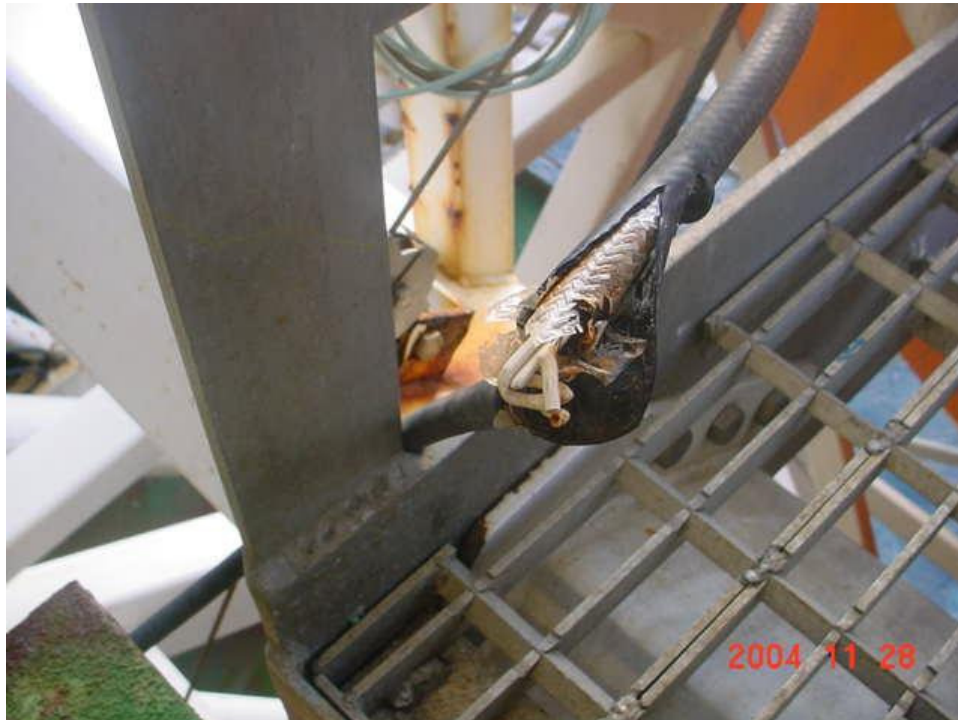
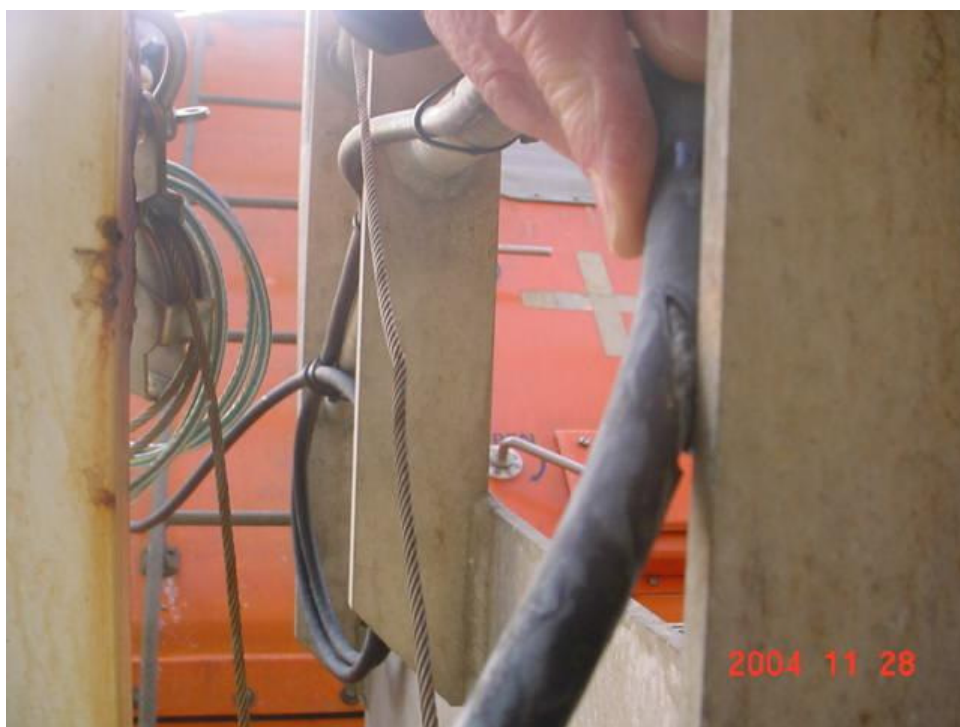
| Summary: | 48volt AC feed cable to the lifeboat armoured braiding had corroded, the cores inside had parted within their individual insulation. |

Recommendations: To prevent recurrence the cables are to be re-routed slightly and dressed away from the source of the damage on all of the lifeboats. Manufacturer/Installer to be advised of this platform installation issue.

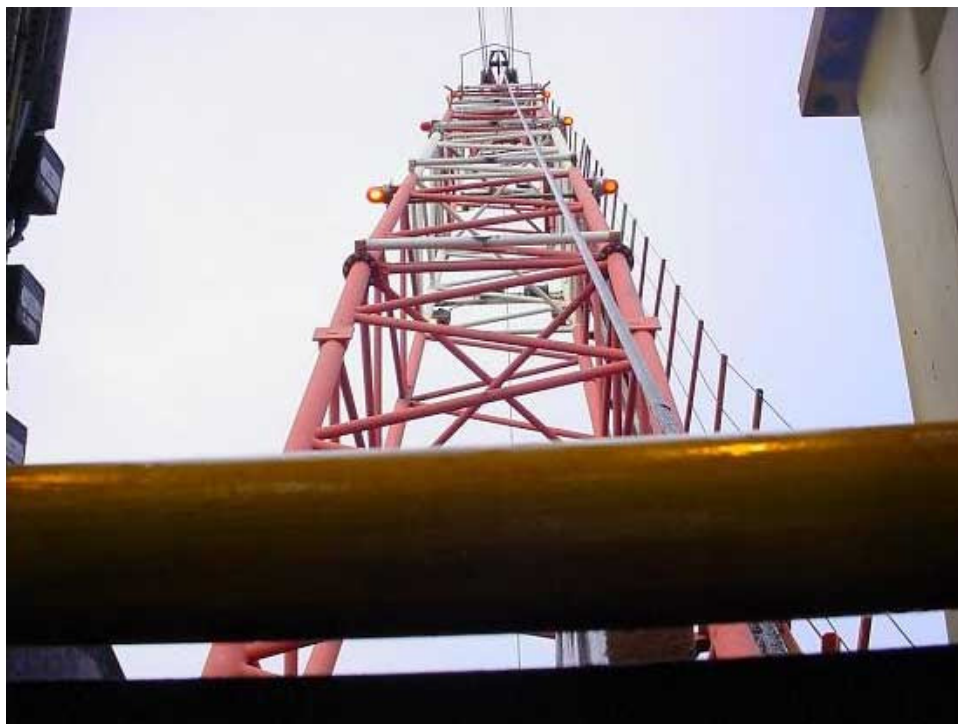
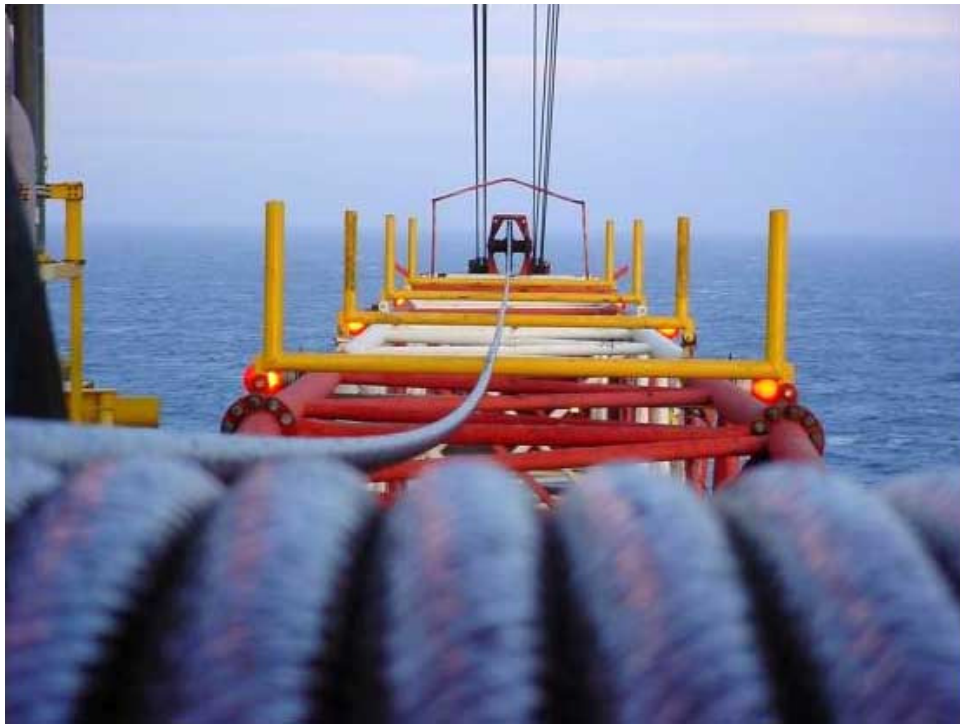
| Summary: | On the 2nd November 2004 while off-loading a supply vessel, a near miss incident occurred with the East Crane on the Kittiwake Platform. A container was being hoisted from a supply vessel and when the boom was manoeuvred to bring the load inboard, the load descended by approximately 3m and it was noted that the hoist rope had come off the winch drum. |

Recommendations: In order to prevent such a re-occurrence we have fitted to our cranes a redesigned boom saver arrangement to retain the rope within the top section of the boom so that if during normal operations the rope slackens off and slides across the boom, it will not fall over the edge and snag

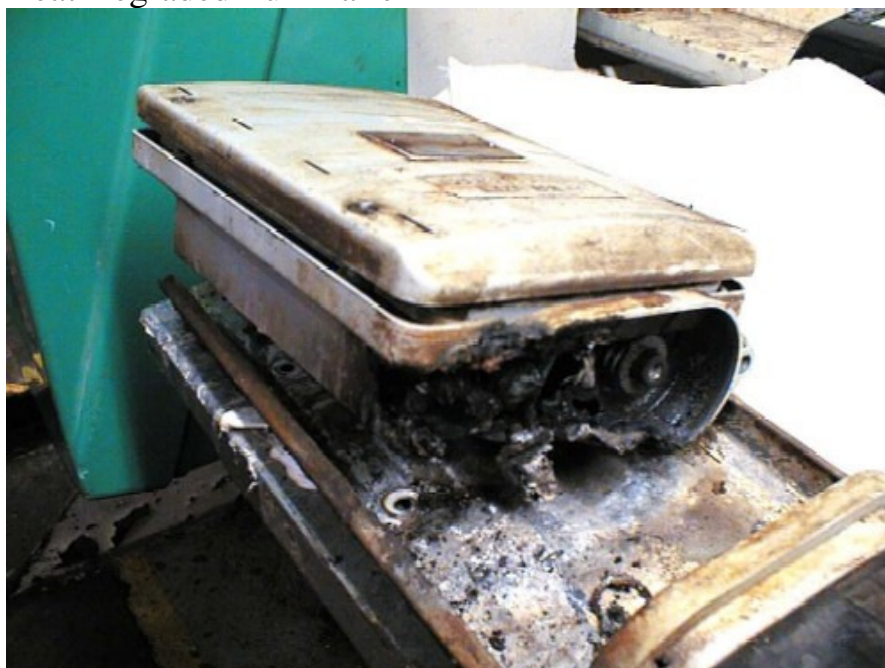
Summary: In 2004 a severely damaged light fitting was reported. On investigation, the light fitting was found to have suffered from excessive heat degradation.

### Heat Degraded Luminaire

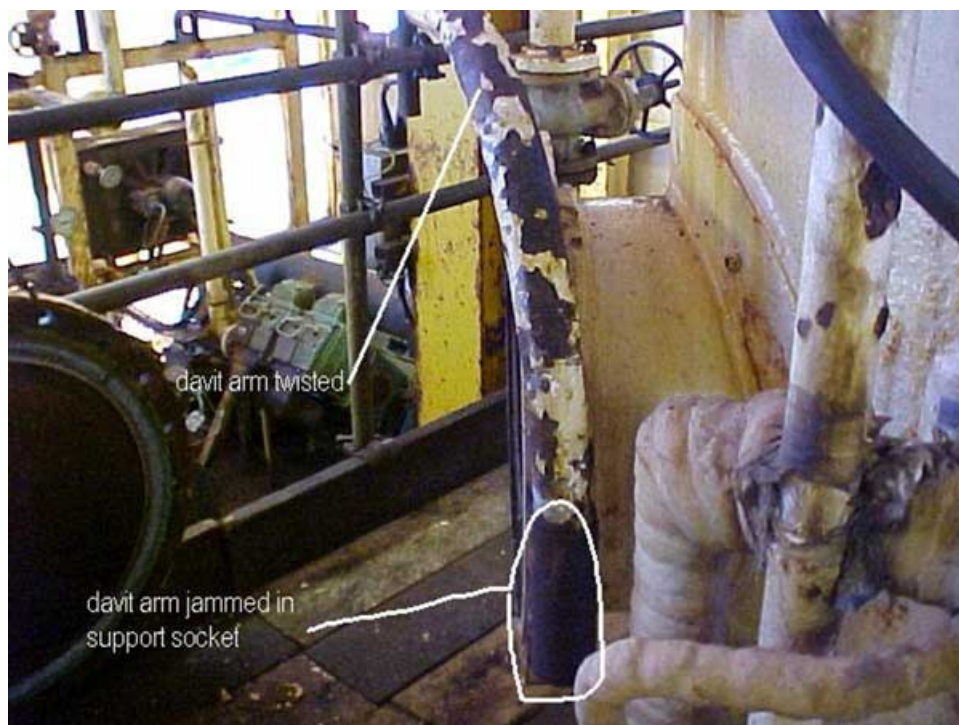
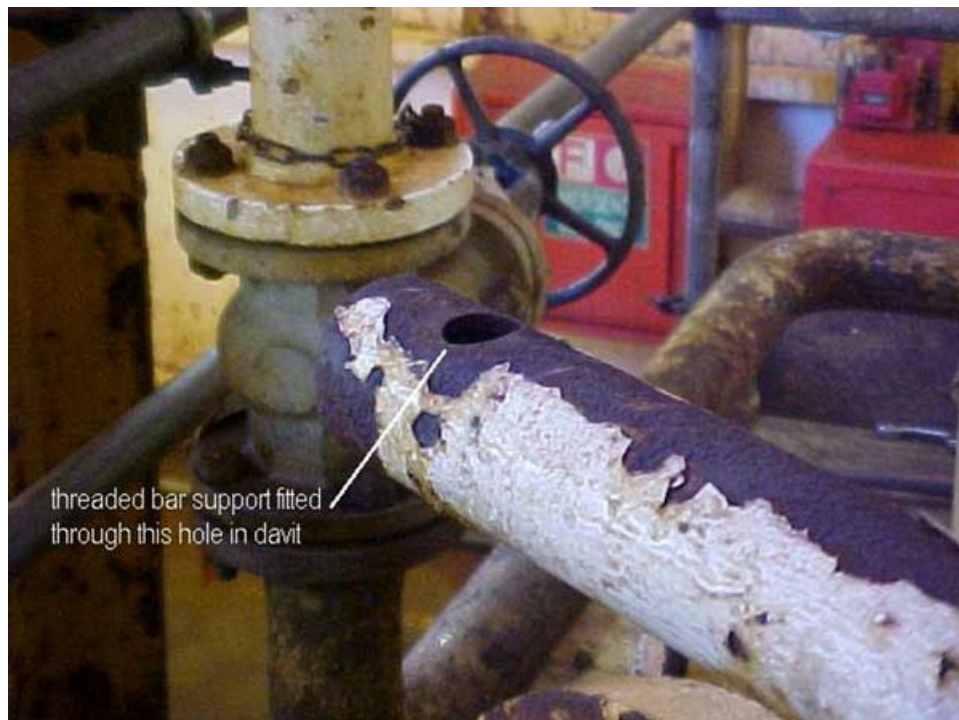
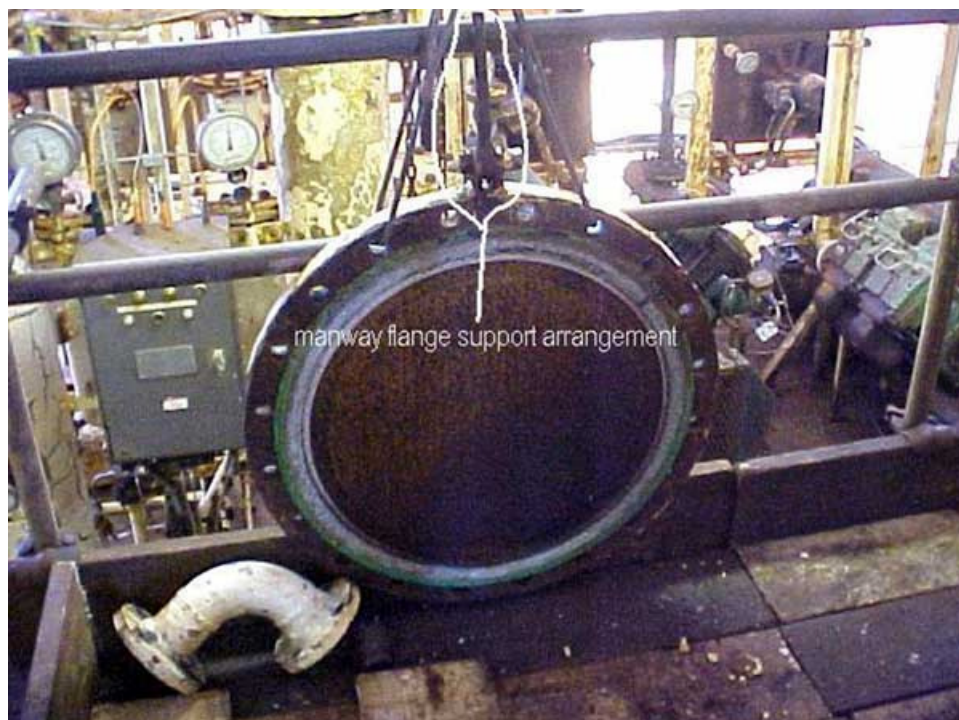
Description: During the removal of a man-way door from a vessel, the connection between the man-way door and the swinging davit arm (threaded bar/bolt) failed, resulting in the door falling approximately 10 inches onto the landing below.

Recommendations: Prior to opening vessels, pay close attention to the condition of the davit support arrangements during man-way removal activities. Secondary rigging arrangements should be installed where there is any doubt on the davit integrity.
