## 421: Waste Food Disposal

## 422: Risk Assessment

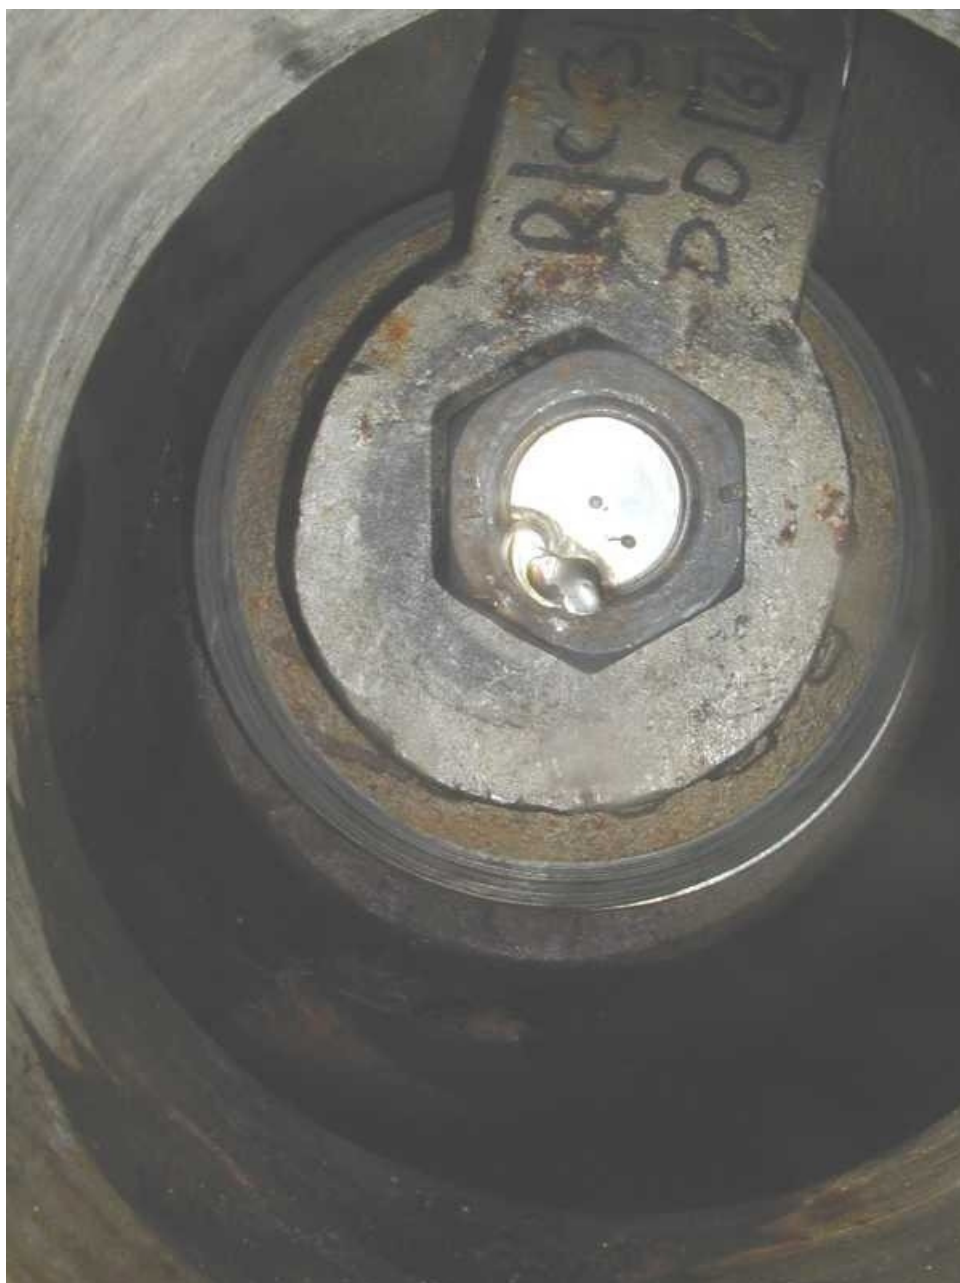
| Description: | <p>A pinhole leak was noted immediately downstream of a Non Return Valve (NRV) on an oil production flowline, and further investigation revealed that there was a highly localised area of erosion on the outlet of the valve. The root cause of this was pinpointed to the NRV and following strip down and inspection of the Non Return Valve (VITAS) it was evident that the sealing disc had detached from the hinge. It is concluded that this is due to the failure of the spot weld between the nut and cotter pin which allowed the nut to back off and ultimately fall off. The sealing disc is a loose fit in the hinge assembly to allow some play to ensure an effective seal in the body seat ring in a reverse flow situation. This loose fit along with the considerable mass of the sealing disc puts significant stress on the spot welds, which are not considered to be robust enough for the service they see. Figure 1 shows the valve internals and figure 2 shows the spot welding on a new NRV. Figure 3 indicates a representative sketch from a radiograph of an in-service NRV and shows that the detached sealing disc obstructs approximately 80% of the valve outlet inner diameter. This severe restriction explains the source of the local high fluid velocities which erode the outlet piping.</p> |

Lessons Learnt: A site survey was completed on all production flowline NRV's and the results show widespread valve failures. From the radiographs it is clear the failure mechanism is the same in all cases with nut failure and little damage to the sealing disc or hinge. In all cases the sealing disc is retained in the valve body with its position causing varying degrees of blockage to valve outlet.

Recommendations: Regular maintenance should be carried out on all NRV's to verify integrity of internals. Radiography can be used to assist with this. Integrity of downstream piping should be also monitored to verify integrity

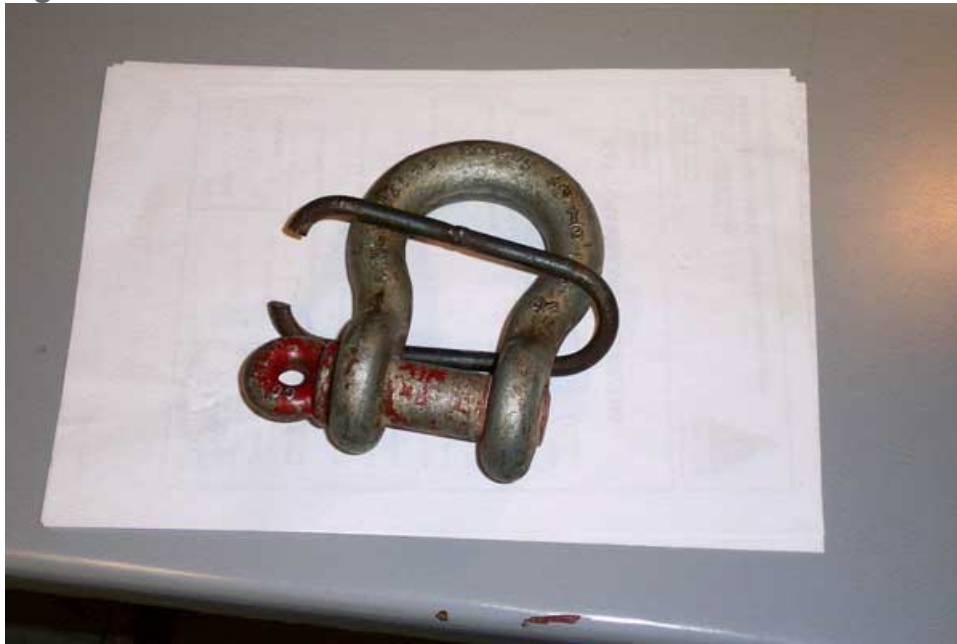
Fig1

Description: Whilst the HP riser was being pulled, the Assistant Rig Manager noticed that a 6.5 ton shackle did not have a retaining ring attached. As he was removing the shackle the floorman appeared on the drill floor with the missing retaining ring stating that it had fallen and struck his left shoulder (Fig.1). No injury was sustained. The weight of the retaining ring was checked and found to be 122 grams (1.25 Lbs). Height of the fall was 16 metres (50 Ft). The lifting arrangement for the HP riser formed part of the newly certified lifting equipment. The lifting equipment had been examined and accepted 4 weeks previously. Corrosion of the break indicated that the ring had been broken for some time before this incident.

Recommendations: *Recommendations* All similar lifting configurations require to be inspected as soon as is practical and before each use. Where equipment is in unsatisfactory condition they should be removed from service.

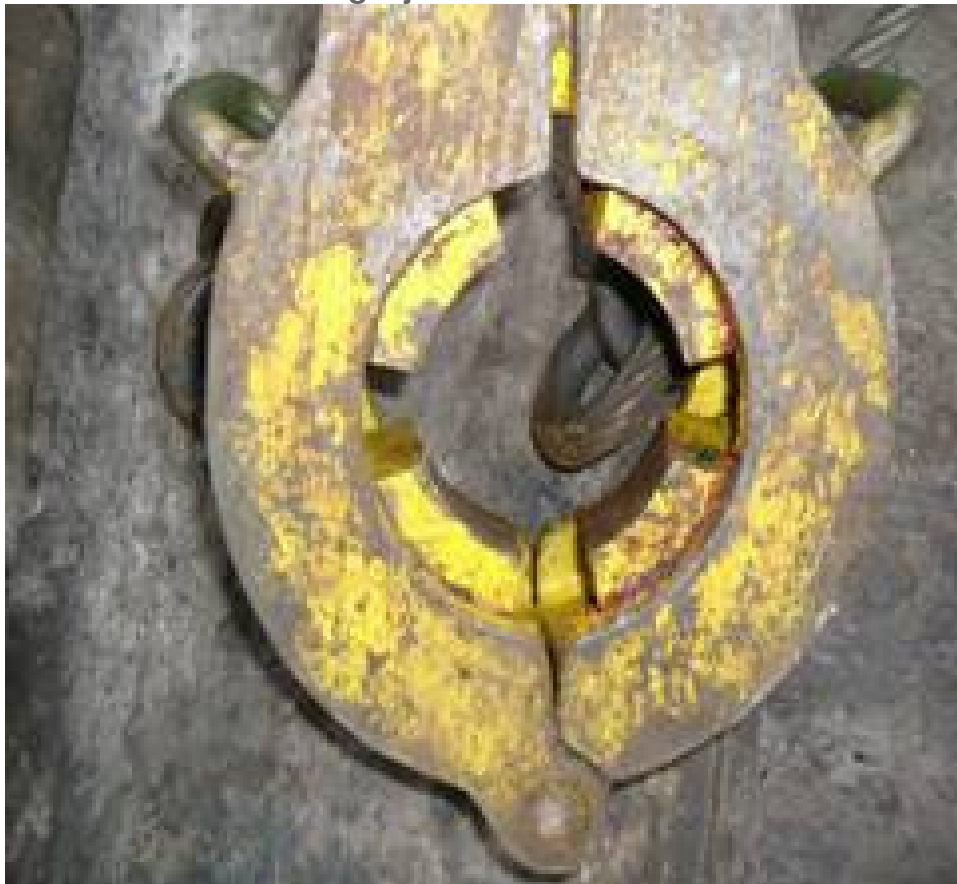
#### **Incorrect inserts in single joint elevator**

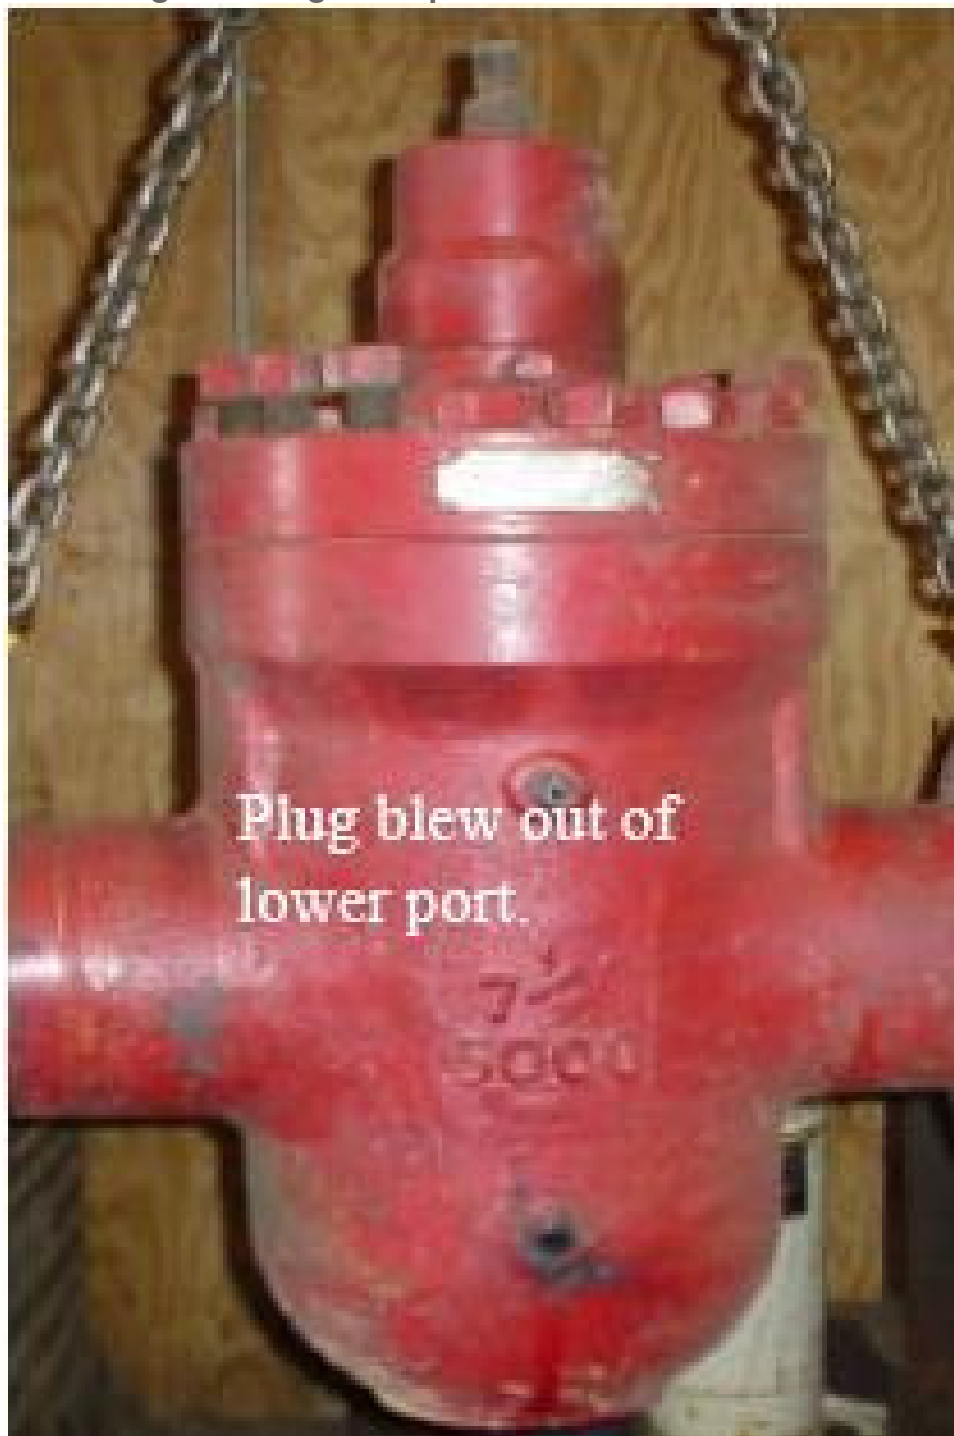
Valve Image showing lower port

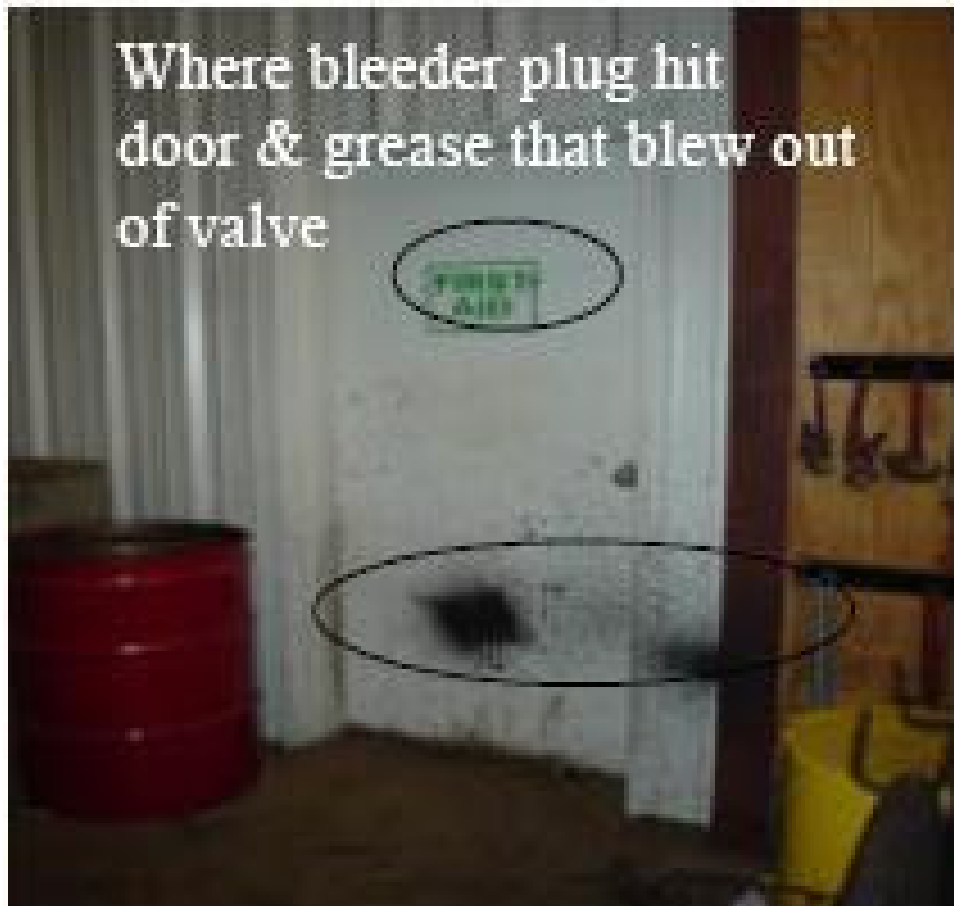
plug impact on door

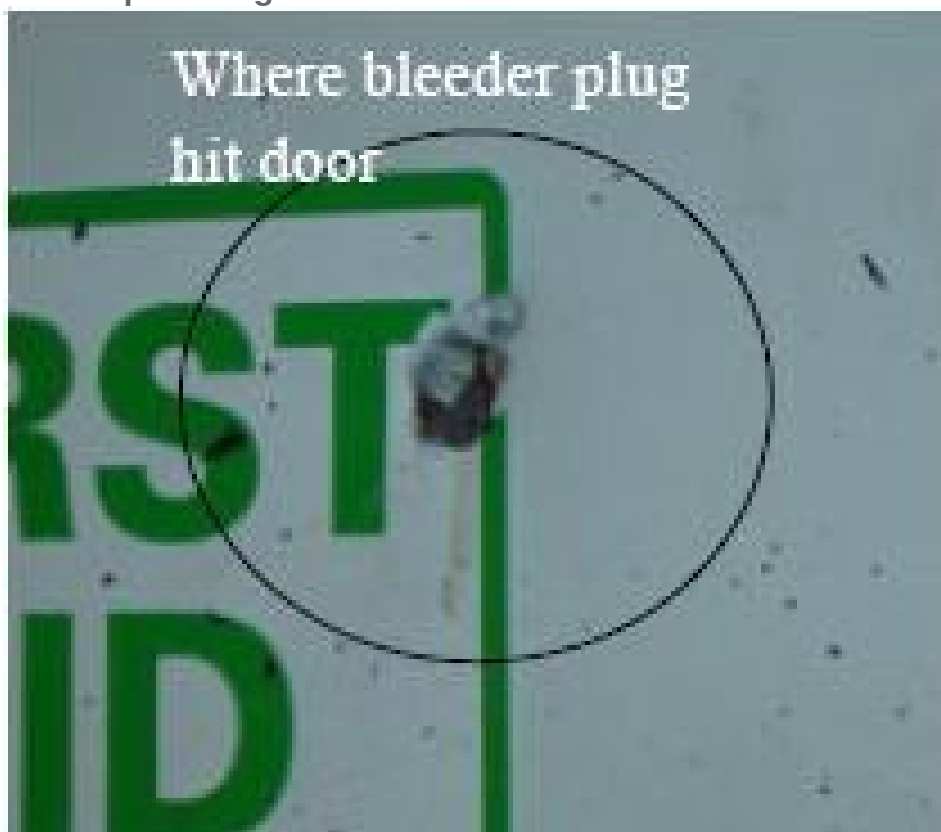
Door impact Image 2

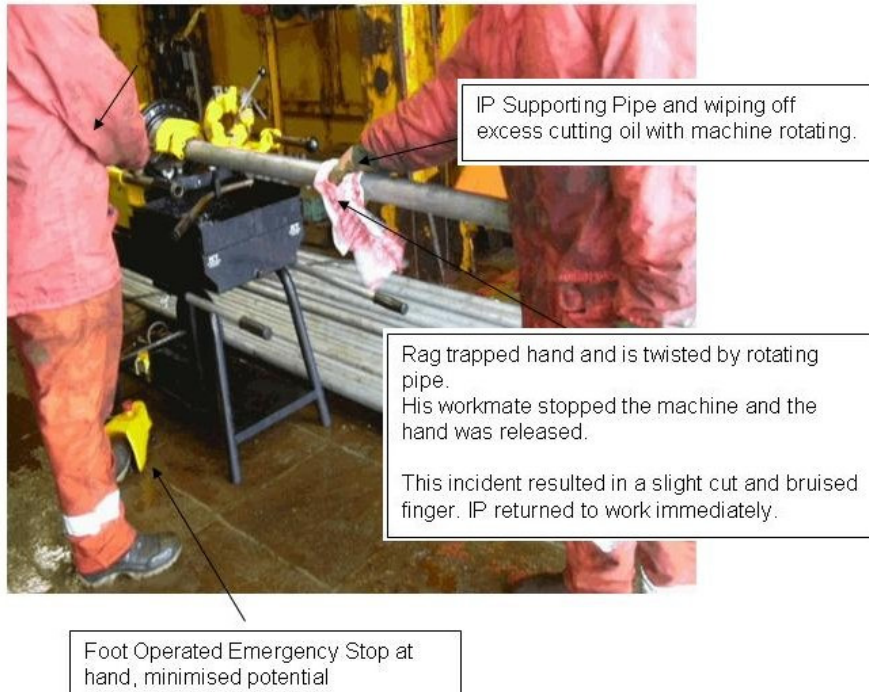
Threading Machine - Electrically driven, high torque, slow (53-50RPM) and powerful.

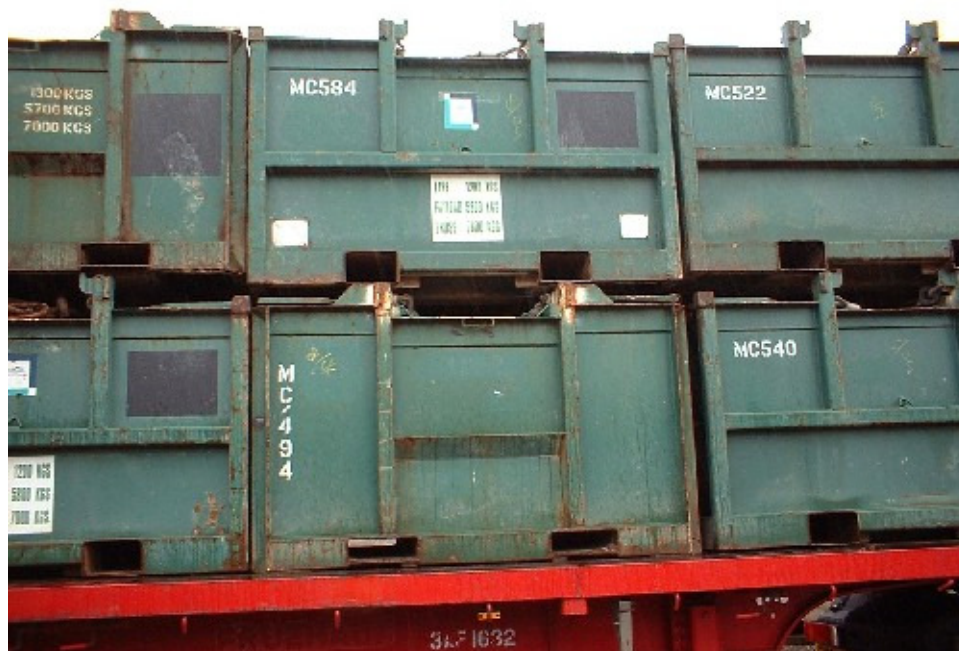
### Incompatible units MC584 & MC494 stacked

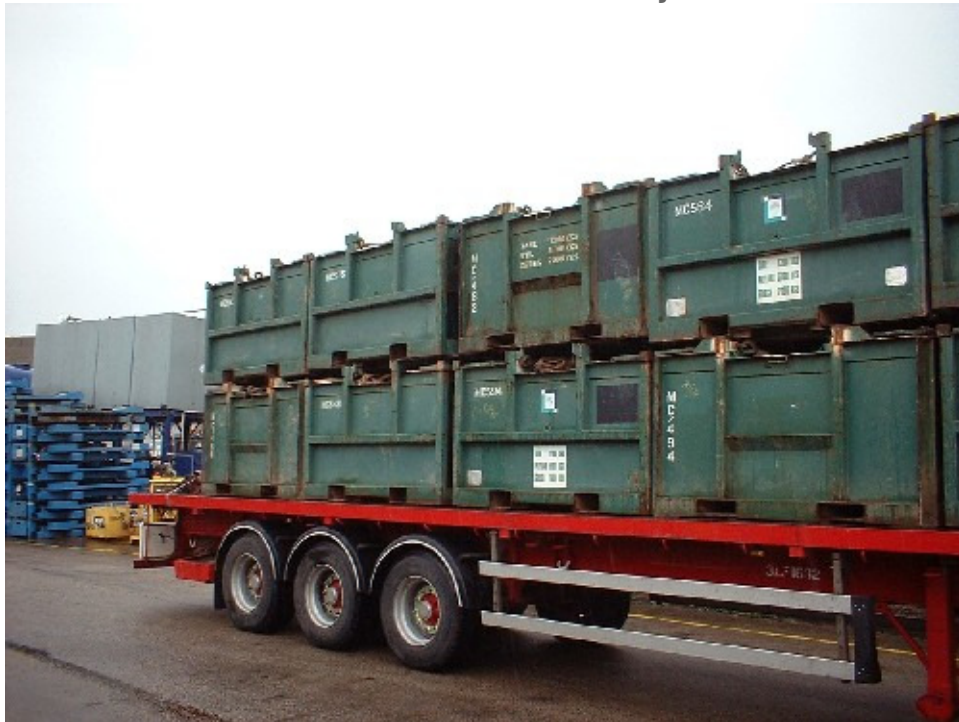
8 out of 10 units on load stacked incorrectly

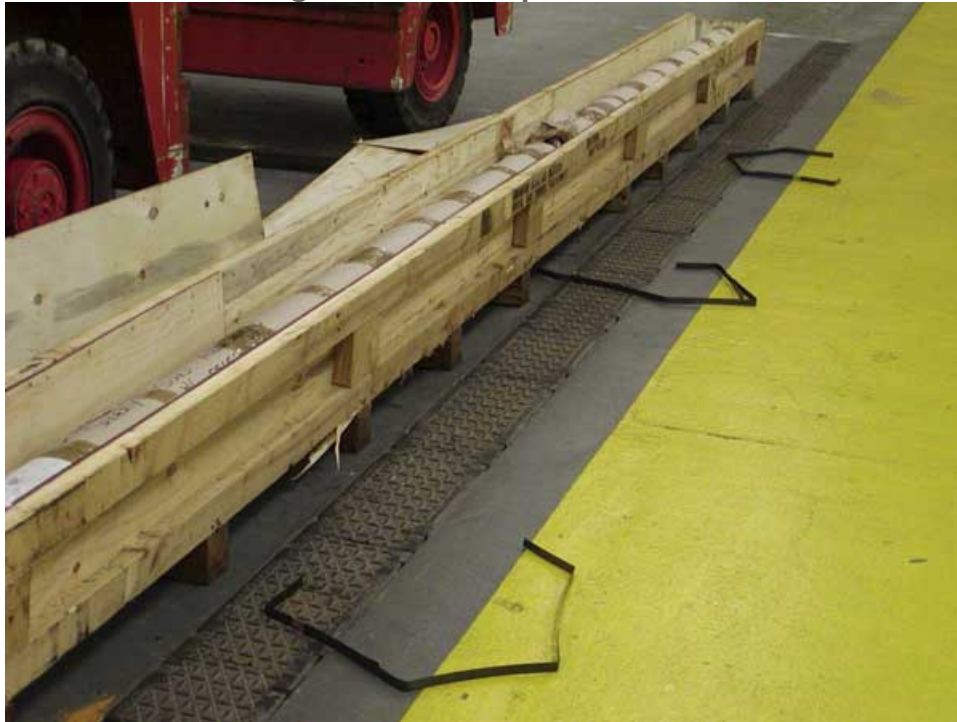
#### **Steel band securing around crate post incident**

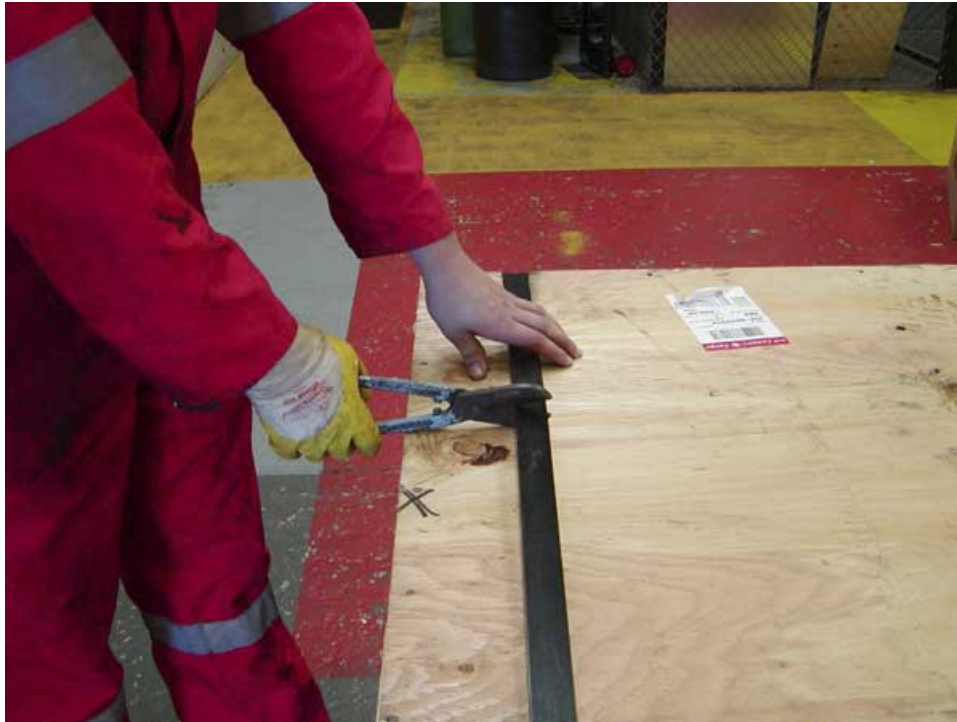
**Previous method used tin snips. There was no control over the band once cut. At the time of the incident the IP had only one glove on as illustrated**

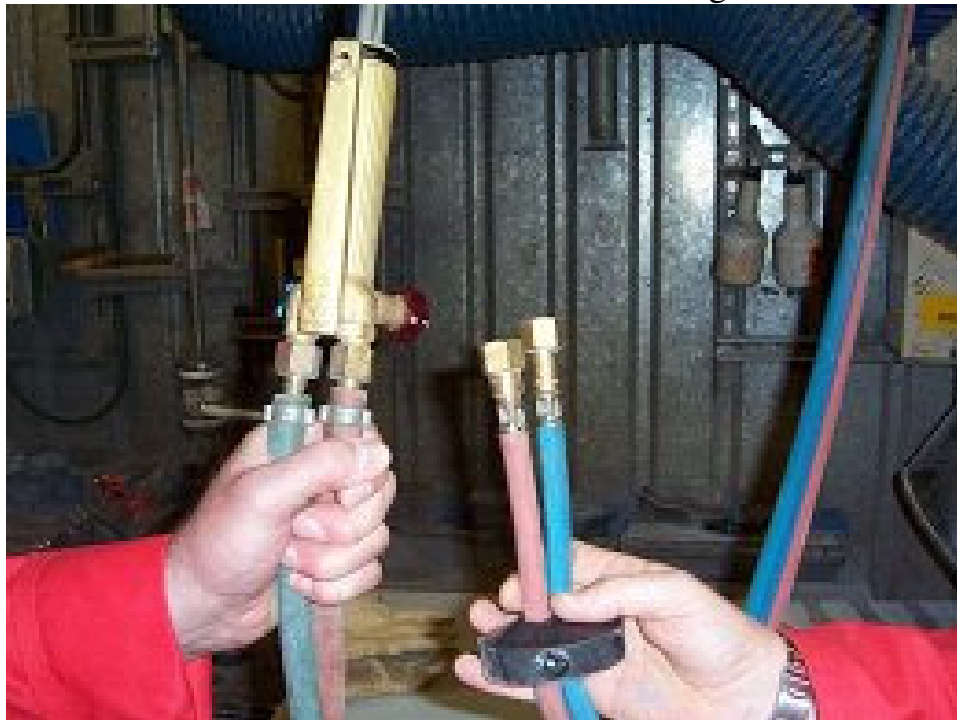
This picture shows a cutting torch of the same type as involved in the incident without NRV's and the hoses on the right show NRV's fitted.

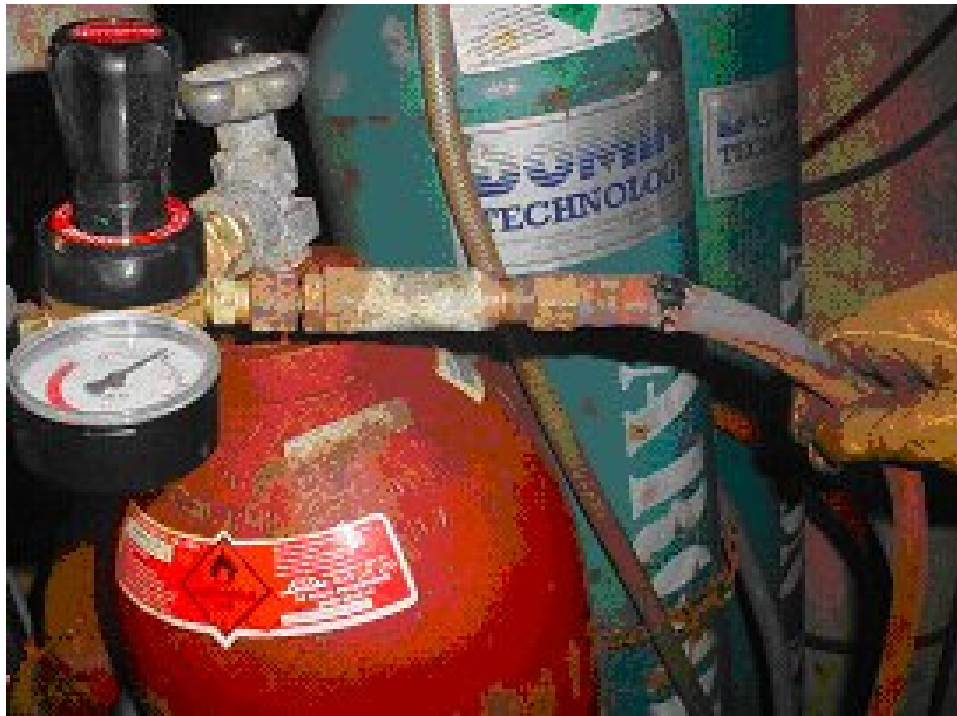
These show the burst hose and the flashback arrestor fitted to the bottle

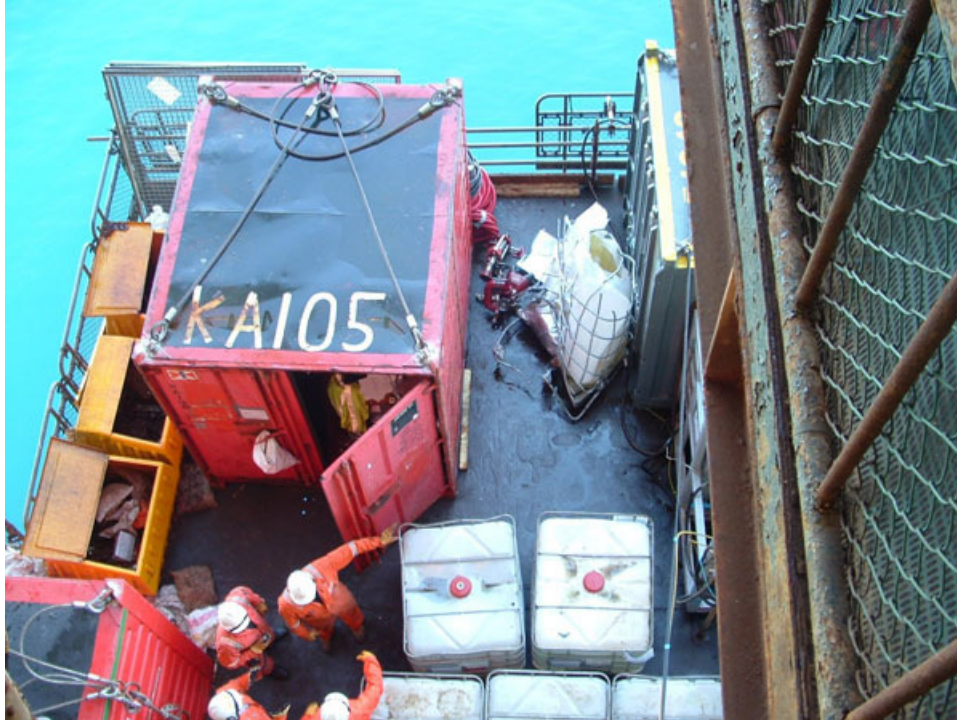
### Dropped Container

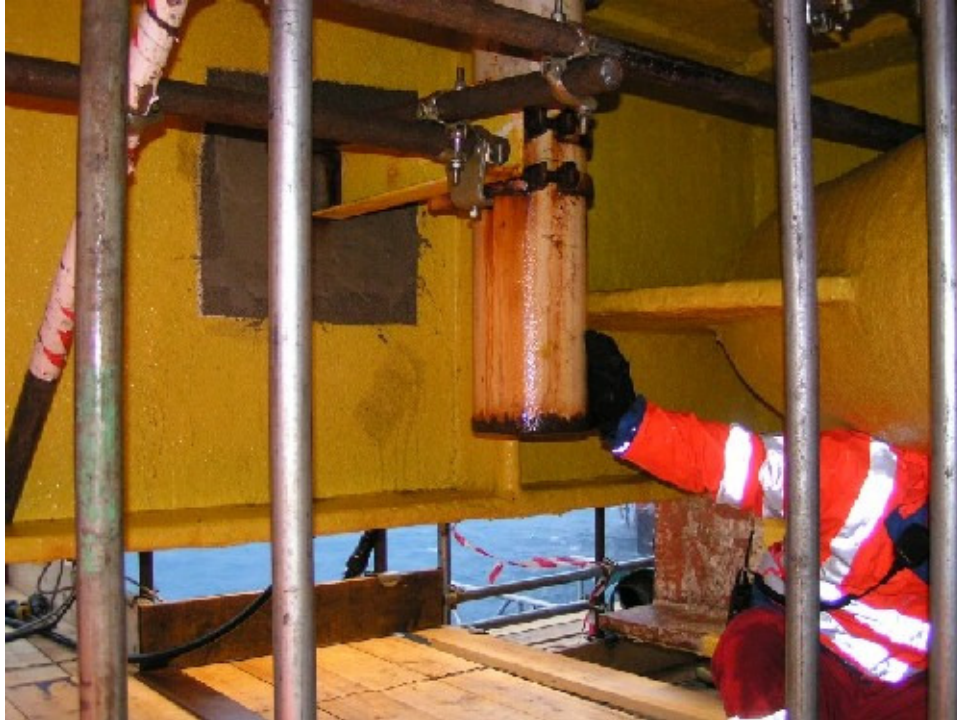
The position of the platform vent, the scaffold that had been erected below it and the handrails along the edge of the scaffold.

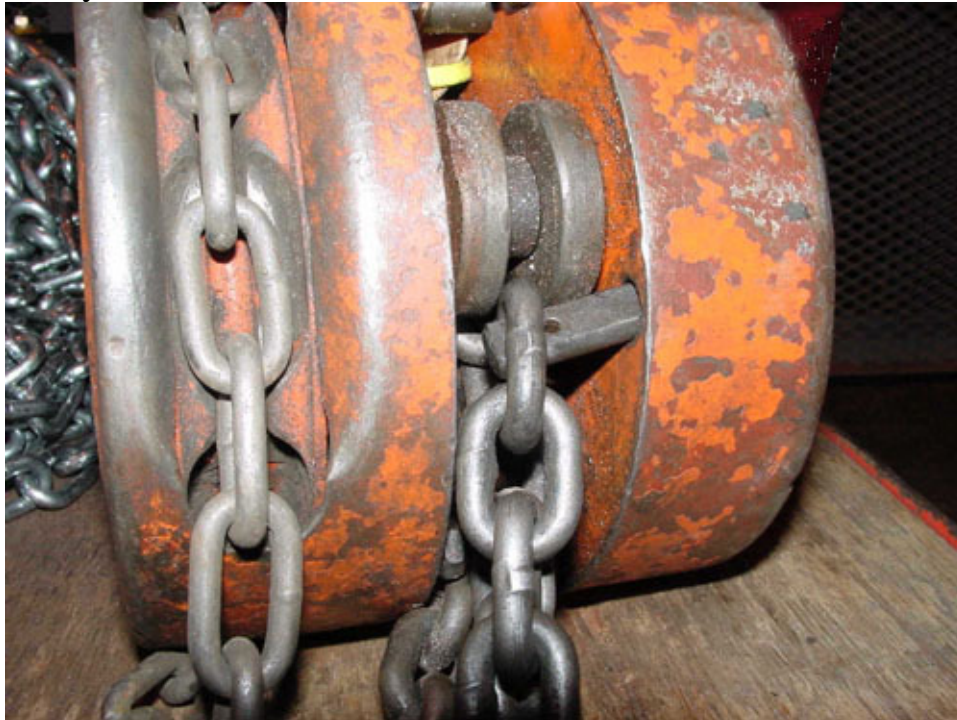
### Faulty Chain Anchor Point

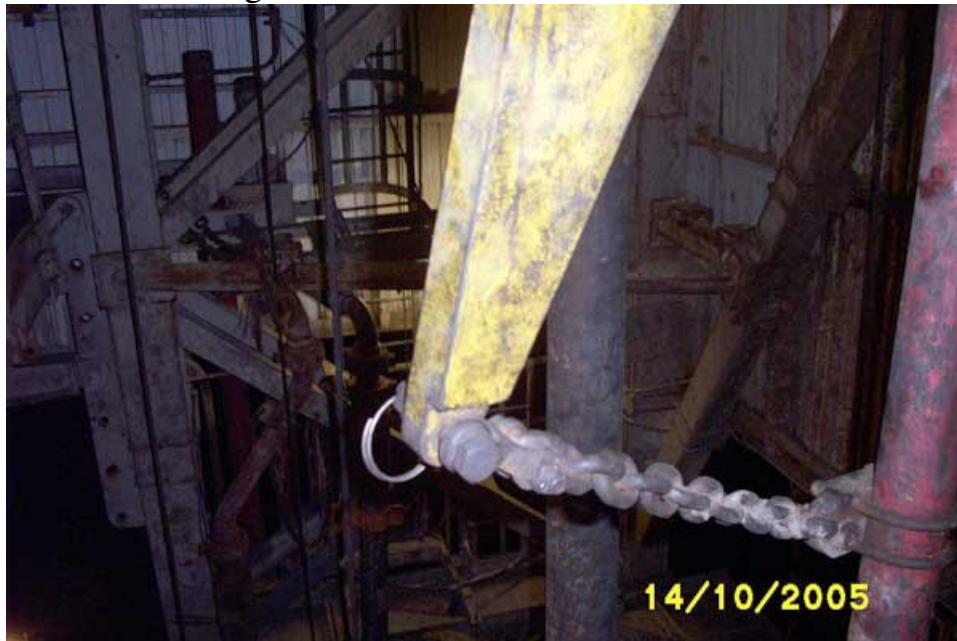
Link tilt showing nut.

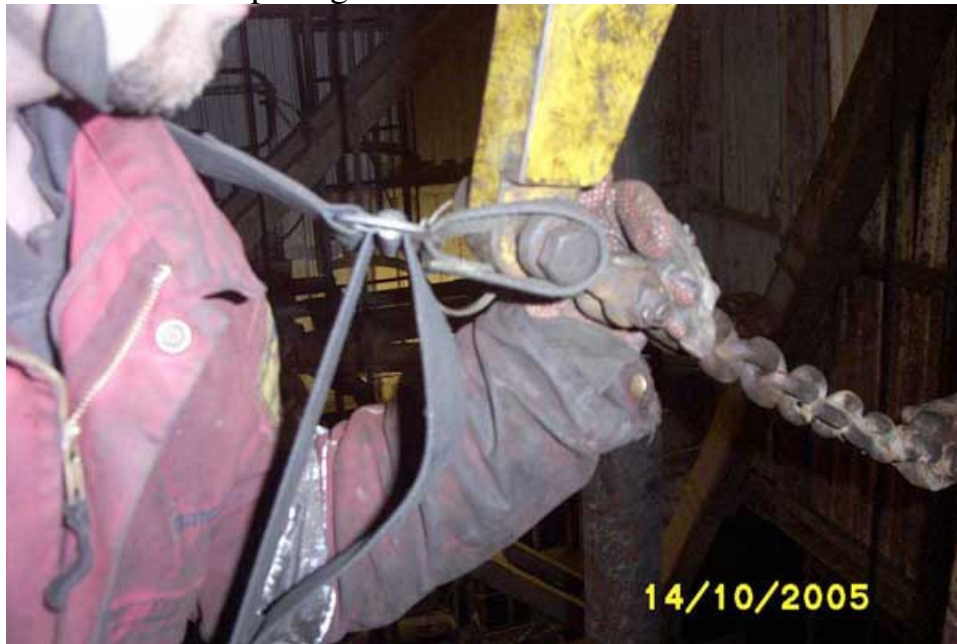
Linktilt with loop caught on nut

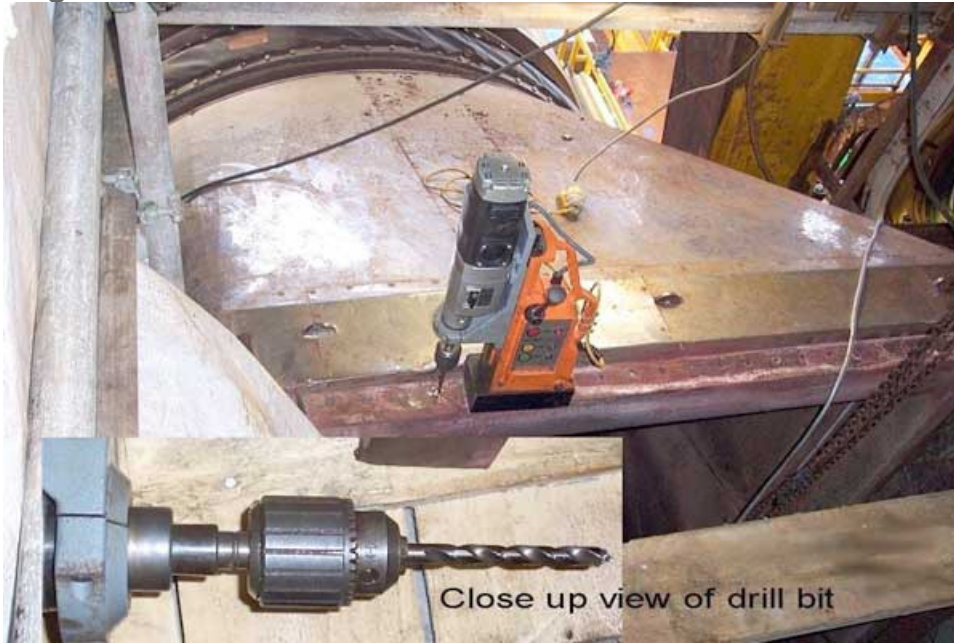
| Lessons Learnt: | <p>The drill had no drill bit guard attached to it as the guard was not found in the drill box.</p> <p>The operator was using his hand to wipe away the swarf when there are brushes available for this activity.<br/>The operator completed an unsafe act by approaching the hole with his gloved hand whilst the drill bit was still in motion.<br/>The operator was wearing non-company issued gloves that were not appropriate for the work activity - not the gloves that were issued to him by the company for the tasks to be completed for that particular project.</p> |

**Magnetic drill used in incident**

| Recommendations: | All equipment must be inspected before being issued to operators to ensure that all guards are present and |

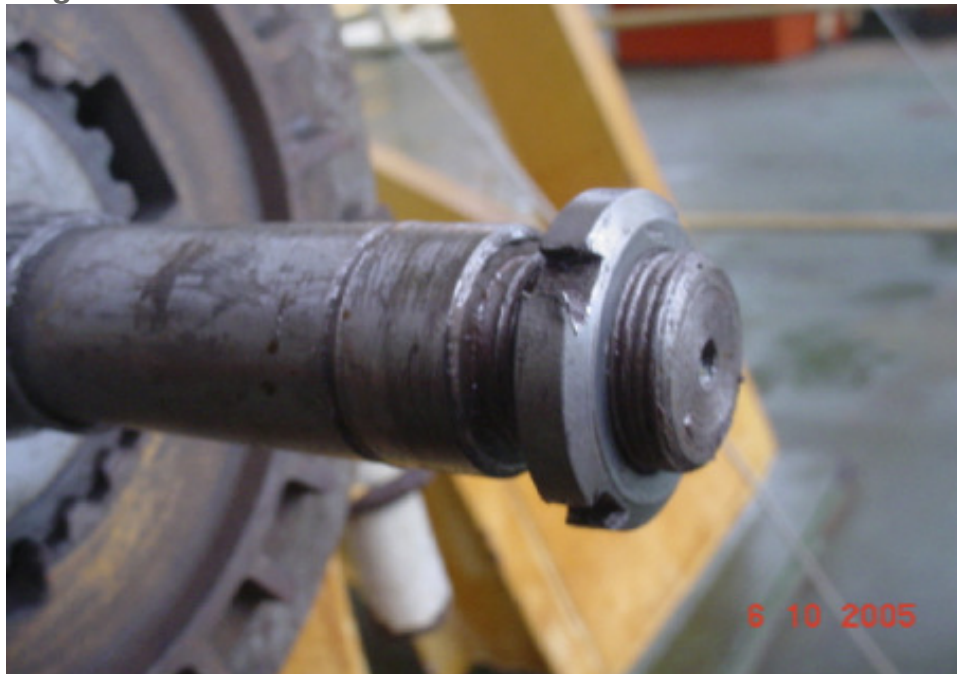
| Description: | During routine maintenance the brake shaft thread & retaining / lock nuts threads were found to be damaged. One of the lock nuts was lying within the cover of the brake mechanism, the other nut was still in place but the threads on both the shafts and the nuts were stretched and damaged. Due to this the brake disc mechanism had no reaction point to provide secure engagement. At the time the boat was secure in the davits and in no danger of dropping to the sea and, similarly, had the nuts failed while lowering the boat it's decent would have been controlled by the separate centrifugal brake assembly. Maintenance records indicate that the lock nuts on two boat winches had previously slackened off and been re-tightened. On inspection, a recently installed davit was found to have a modified and improved type of locking arrangement. The modified arrangement is being fitted to the installation's davits. |

#### **Original locknut**

Recommendations: Inspect all Davit International 18 kNm winches for this problem and repair/modify as appropriate

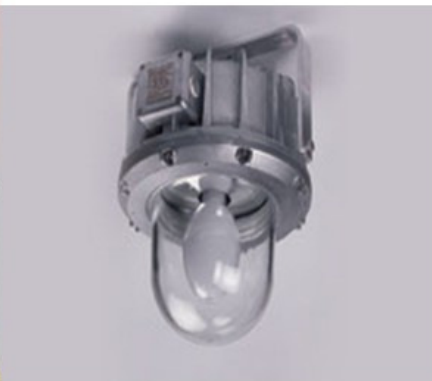
New Fitting

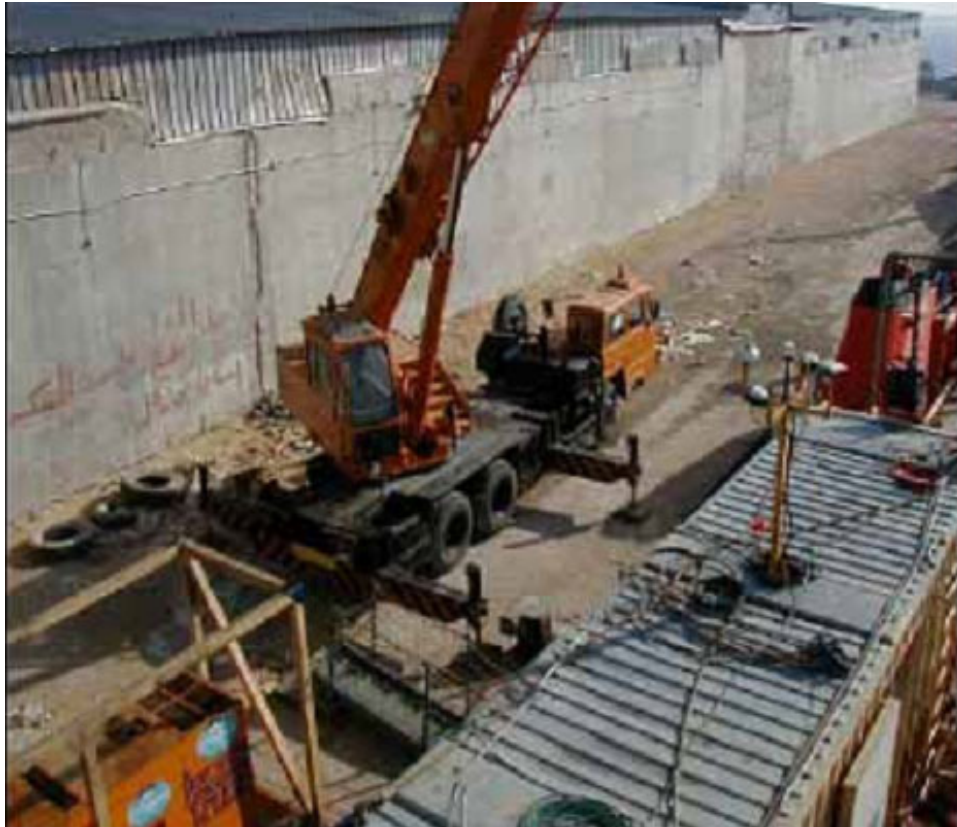
### Accident Scene 1

Summary: A member has reported an incident wherein a half inch HP fitting failed at 200 bar. Whilst no damage was sustained other than to the fitting and the whip check and no injury was sustained, the incident is believed to have had the potential for more serious consequences and was investigated as a high potential event.

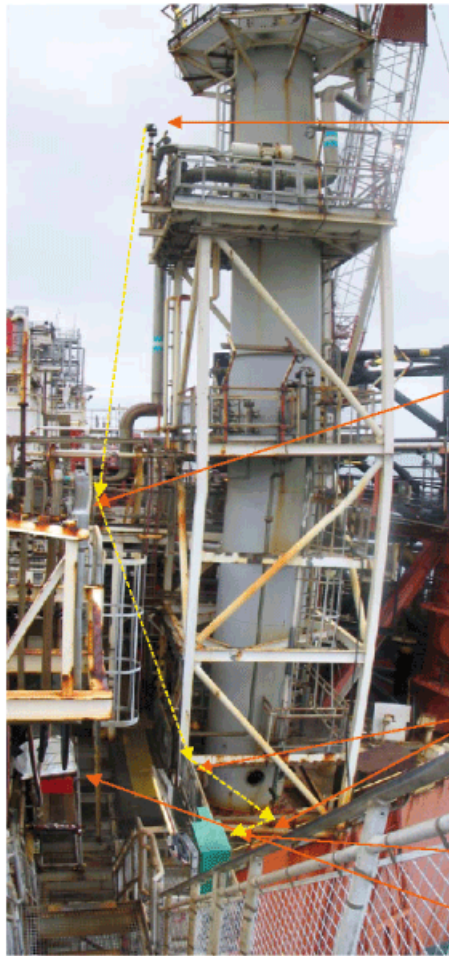
7 Fall Path of Camera DA-TD-403-01

Camera was positioned here looking towards DD. Weight 30kg. Height Approx 40 feet. See Pictures 1, 2, 3.

Hits pipework here. See Pictures 4, 5.

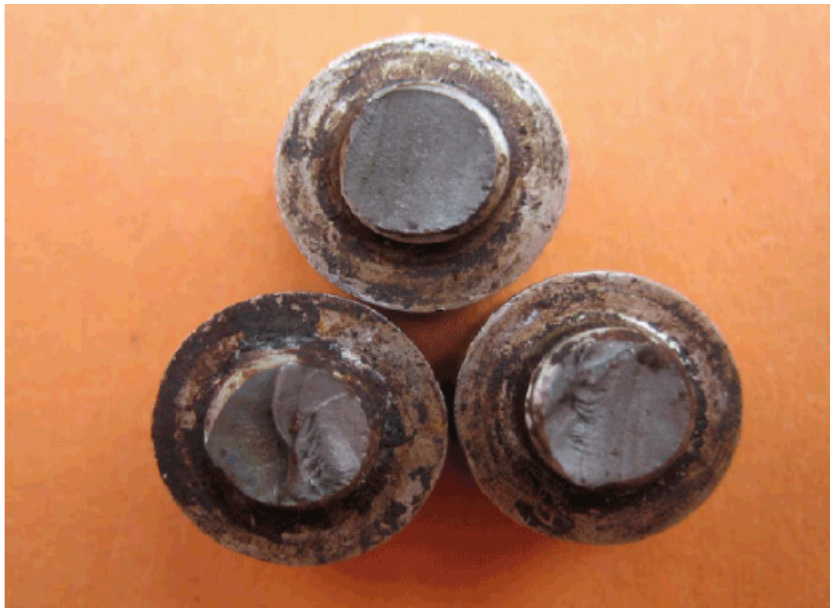
Pict 12. 30 kg camera is supported 3 off 6 mm bolts.

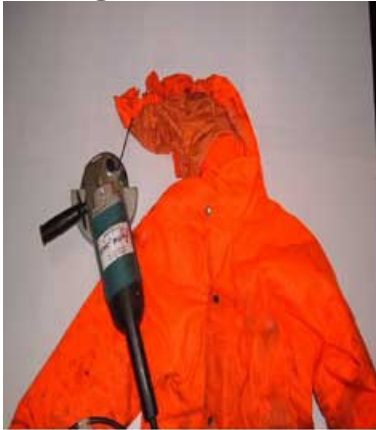
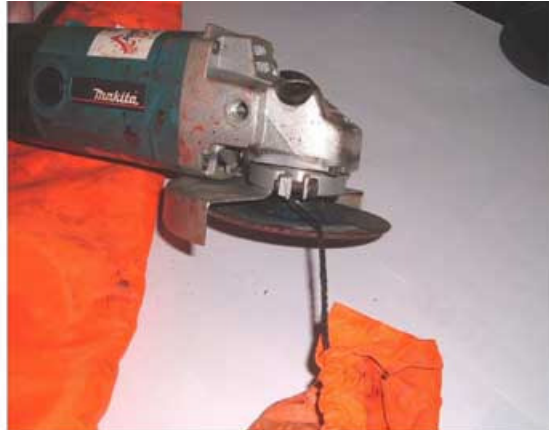
### Entangled Grinder

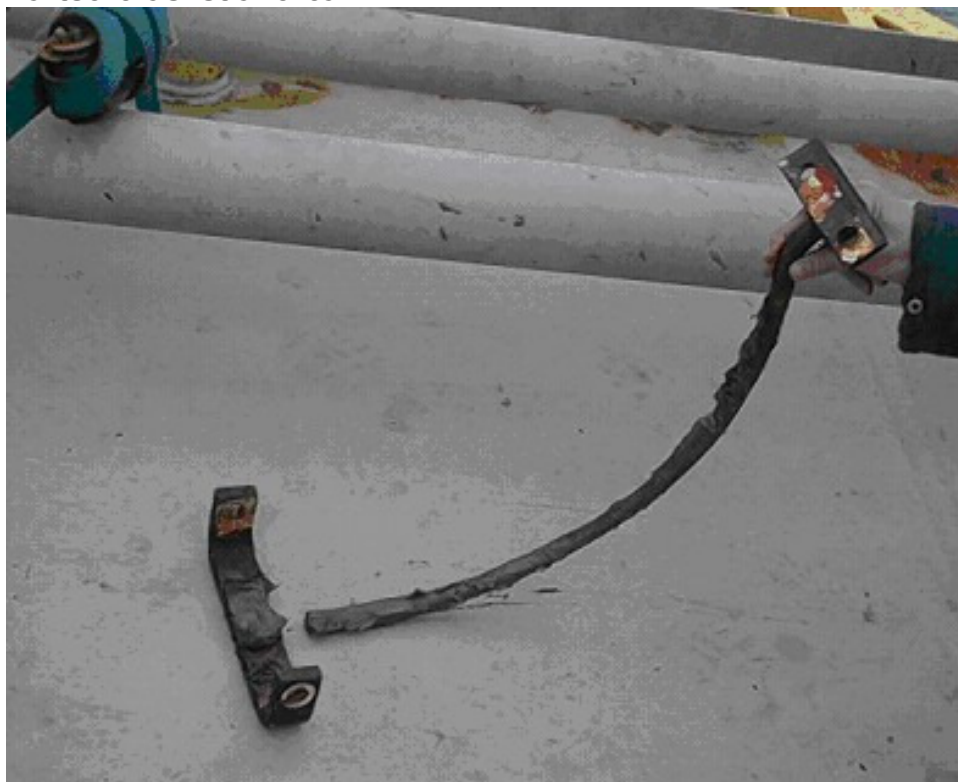
Parted bracket and bar

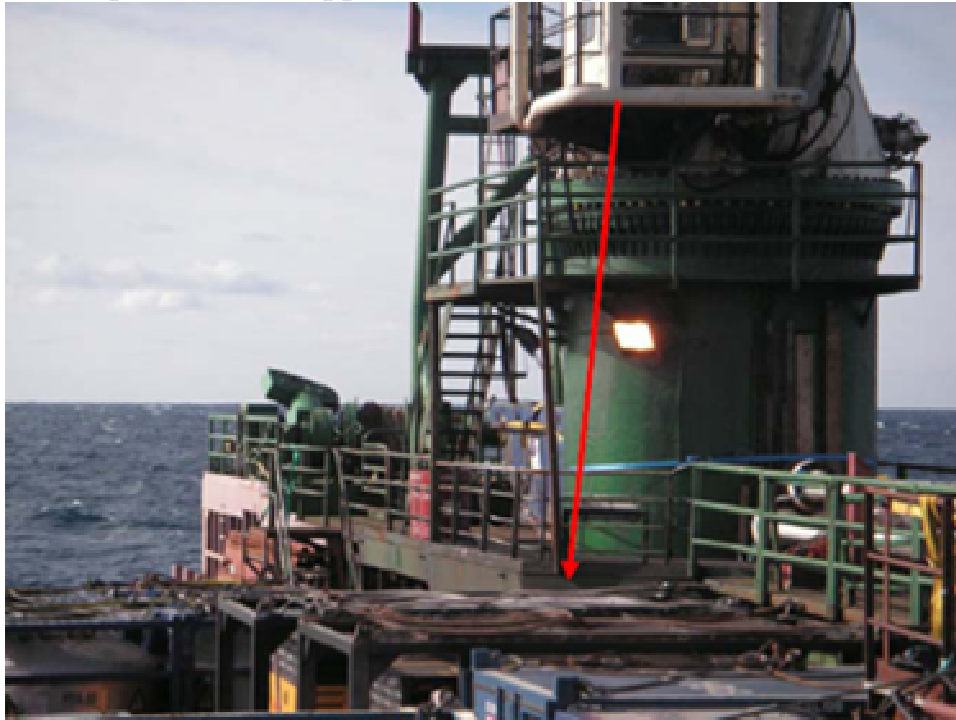
Window pain fell inboard side of lower cab, landed and smashed on top of compressor unit (approx 15 feet drop)

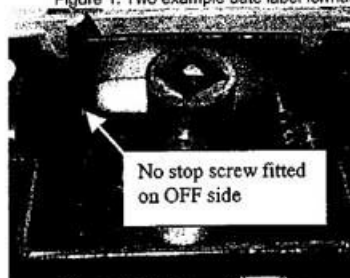
Figure 1: Two example date label formats used on non-mechanism end plate of at risk product.

| <div><b>###B5</b></div> <p>At risk switches with this format label have the last two characters (circled above) of A8, A9, B0, B1, B2, B3, B4 or B5. Where # can be any number. Products labelled B6 and above are not affected by this concern.</p> | <div><b>5B####</b></div> <p>At risk switches with this format label have the first two characters (circled above) of 8A, 9A, 0B, 1B, 2B, 3B, 4B or 5B. Where # can be any number. Products labelled 6B and above are not affected by this concern.</p> |

Recommendations: It is Eaton's strong recommendation that any such switches that are still in service should be replaced as soon as possible. Further given the nature of the risk of the operational failure of these switches - namely the

possibility of the switch remaining live when in the off position - it is strongly recommended that any replacement be undertaken by a suitably qualified person and that the details of this safety alert are communicated to the person prior to the work commencing. It is imperative that warning notices are affixed to the units pending replacement.

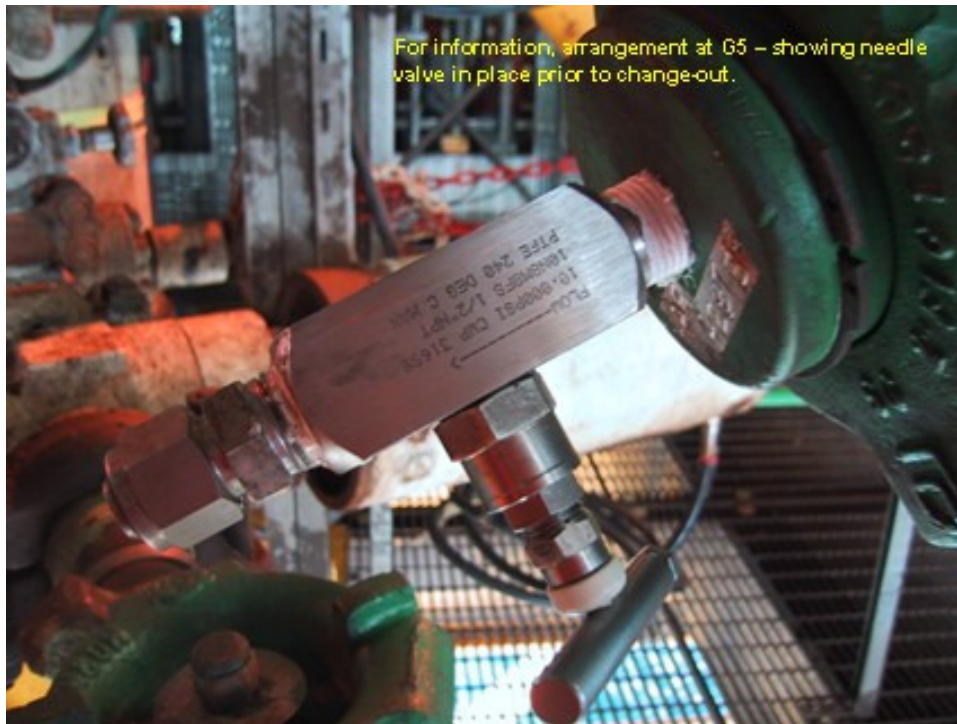
For information, arrangement at G5 – showing needle valve in place prior to change-out.

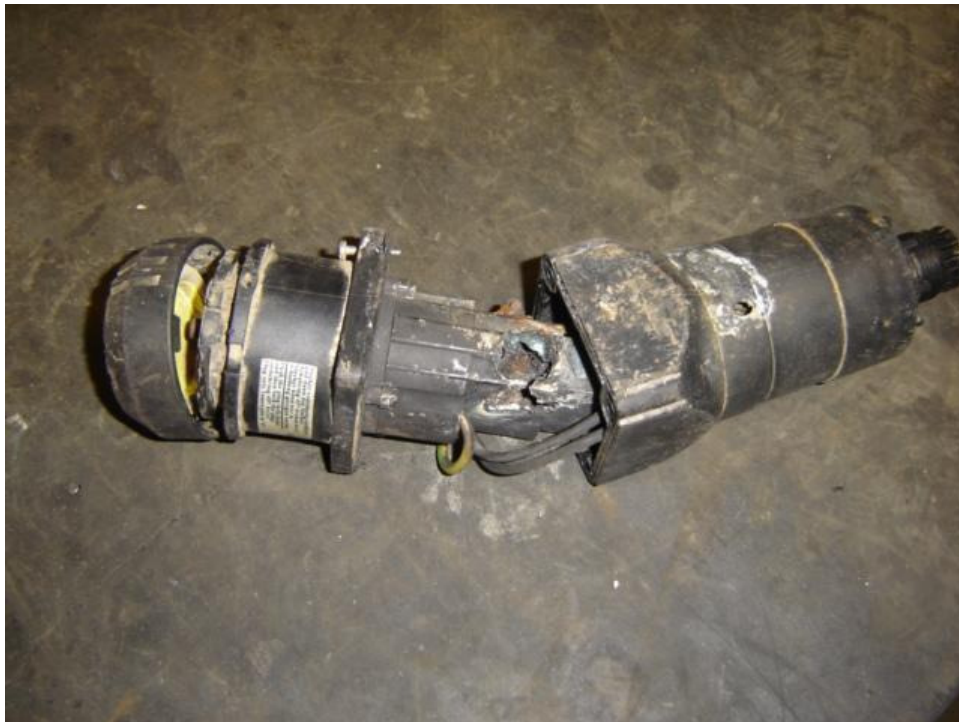
Summary: An 110v coupler plug was found melting / smouldering. It was part of a temporary electrical supply cable to a temporary shutdown air compressor.

Recommendations: Change out all 16 amp MCB's in all 110 Volt Dist Boards for a combined MCB and earth leakage protection that is compatible with 110 VAC Centre Tapped to Earth Systems.
