## 421: Waste Food Disposal

## 422: Risk Assessment

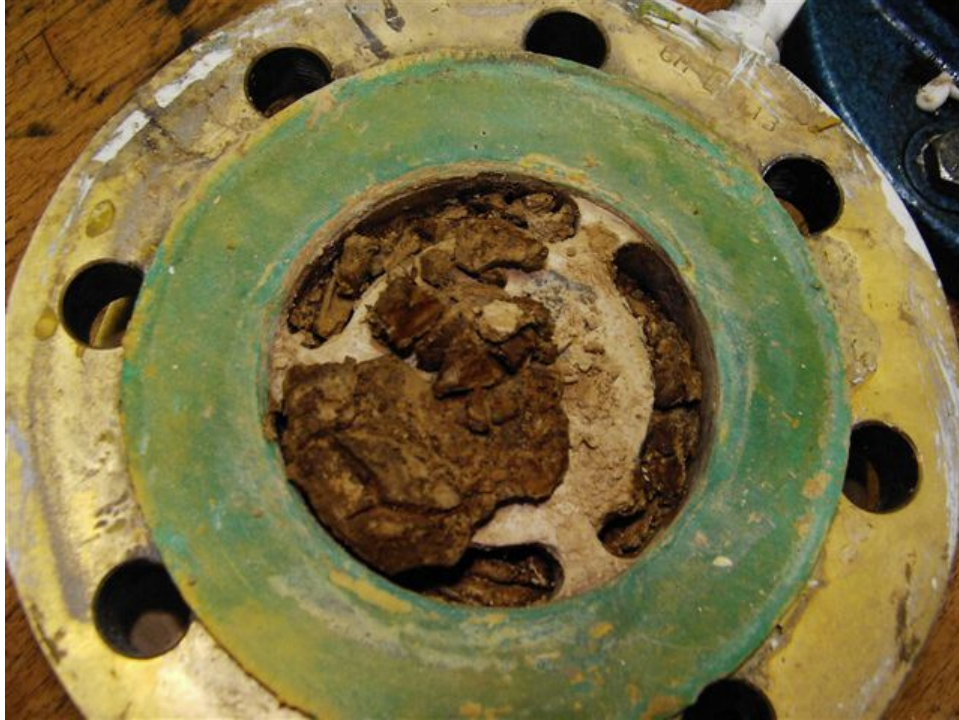
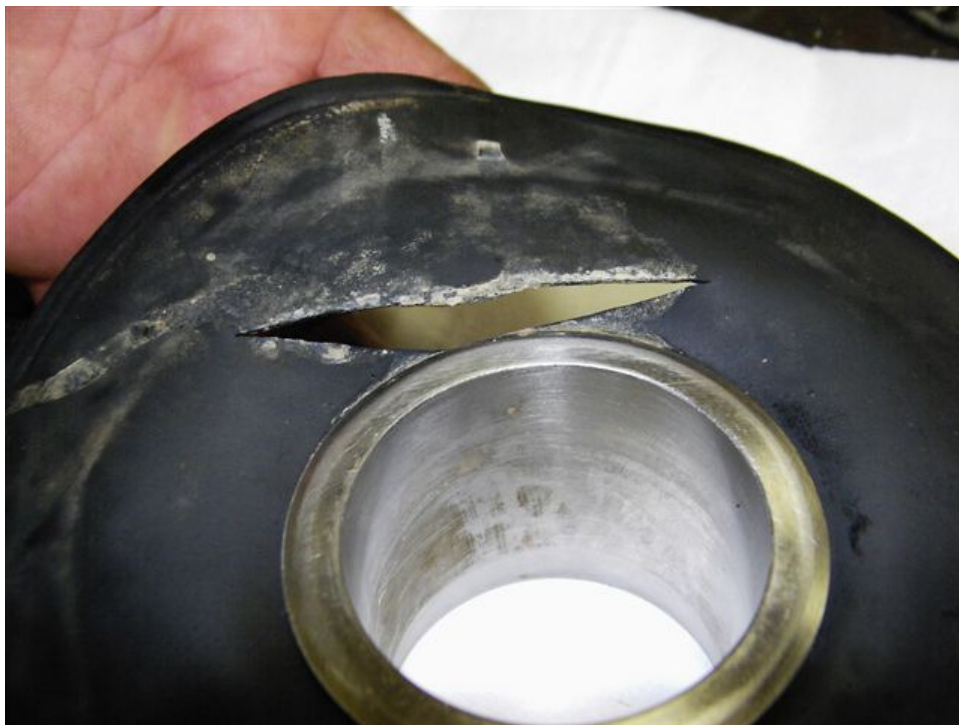
| Summary: | <p>Ships crew were working on foam compound pump and debris was observed to have caused damage to the unit. As a precaution the diaphragm valve which controls the foam compound/water mixture ratio was opened up. The valve was choked with debris identified as dried foam compound. The valve diaphragm was split rendering the system useless if required. Notification of two sister vessels fitted with the same equipment revealed another to be affected in the same way. System will now be flushed after each test.</p> |

| Recommendations: | Inspect diaphragms at earliest opportunity and leave system with freshwater plug after testing. |

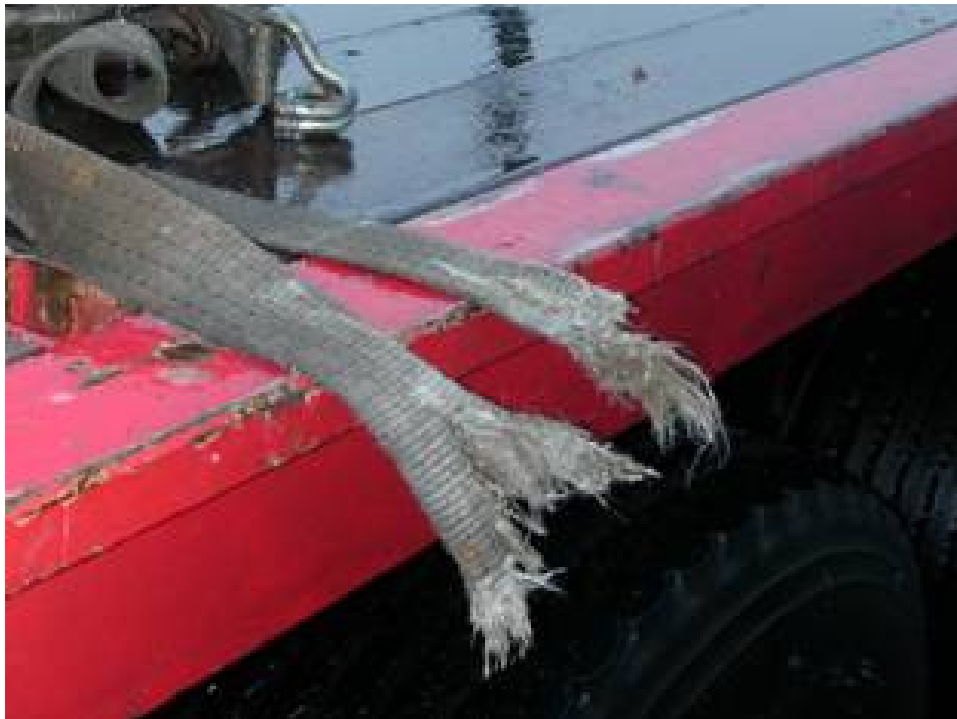
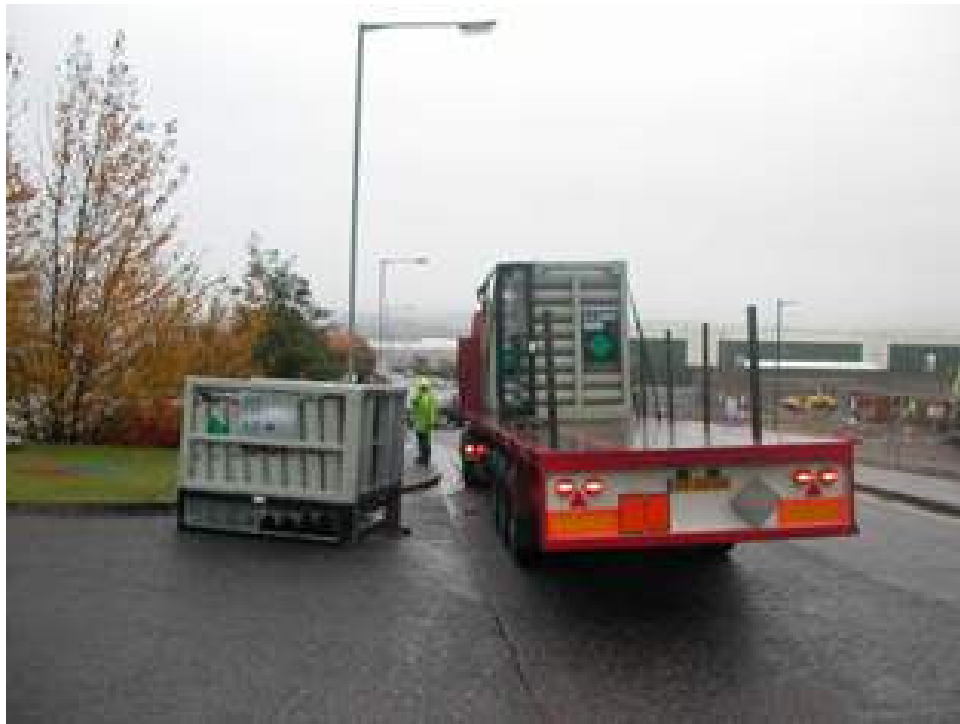
| Summary: | An incident occurred on 8th November 2006 which had the potential to cause a fatality. A 6 ton item fell from a vehicle as it reversed into a premises yard entrance. No one was injured and no gas loss occurred. |

Recommendations: Immediate / Underlying Causes:- This incident was caused by the use of badly worn securing straps. Securing straps to be checked for damage prior to each use. Where damage is identified, straps should be removed from service and destroyed.

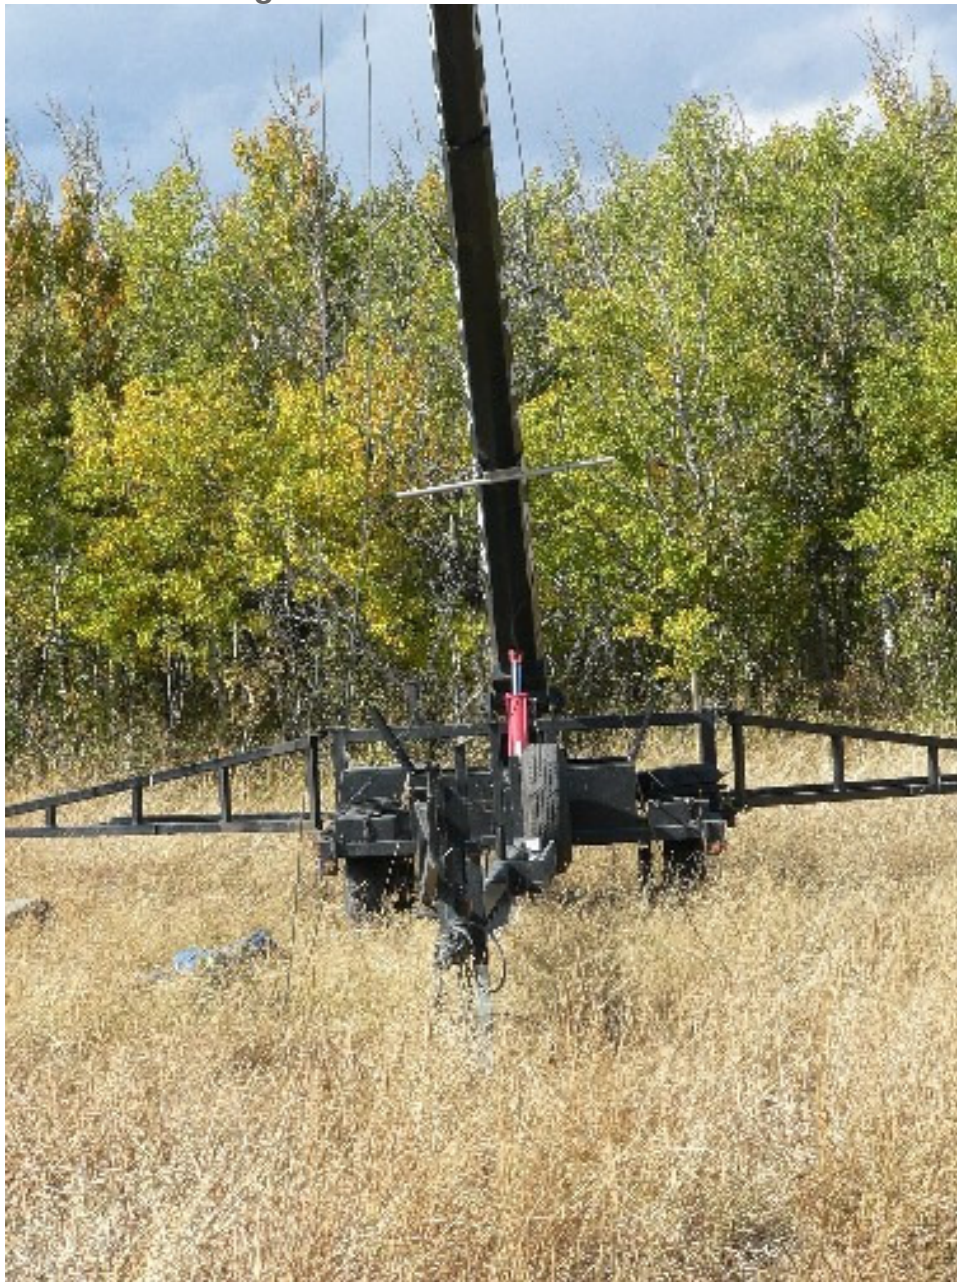
### **MET Tower Being Installed**

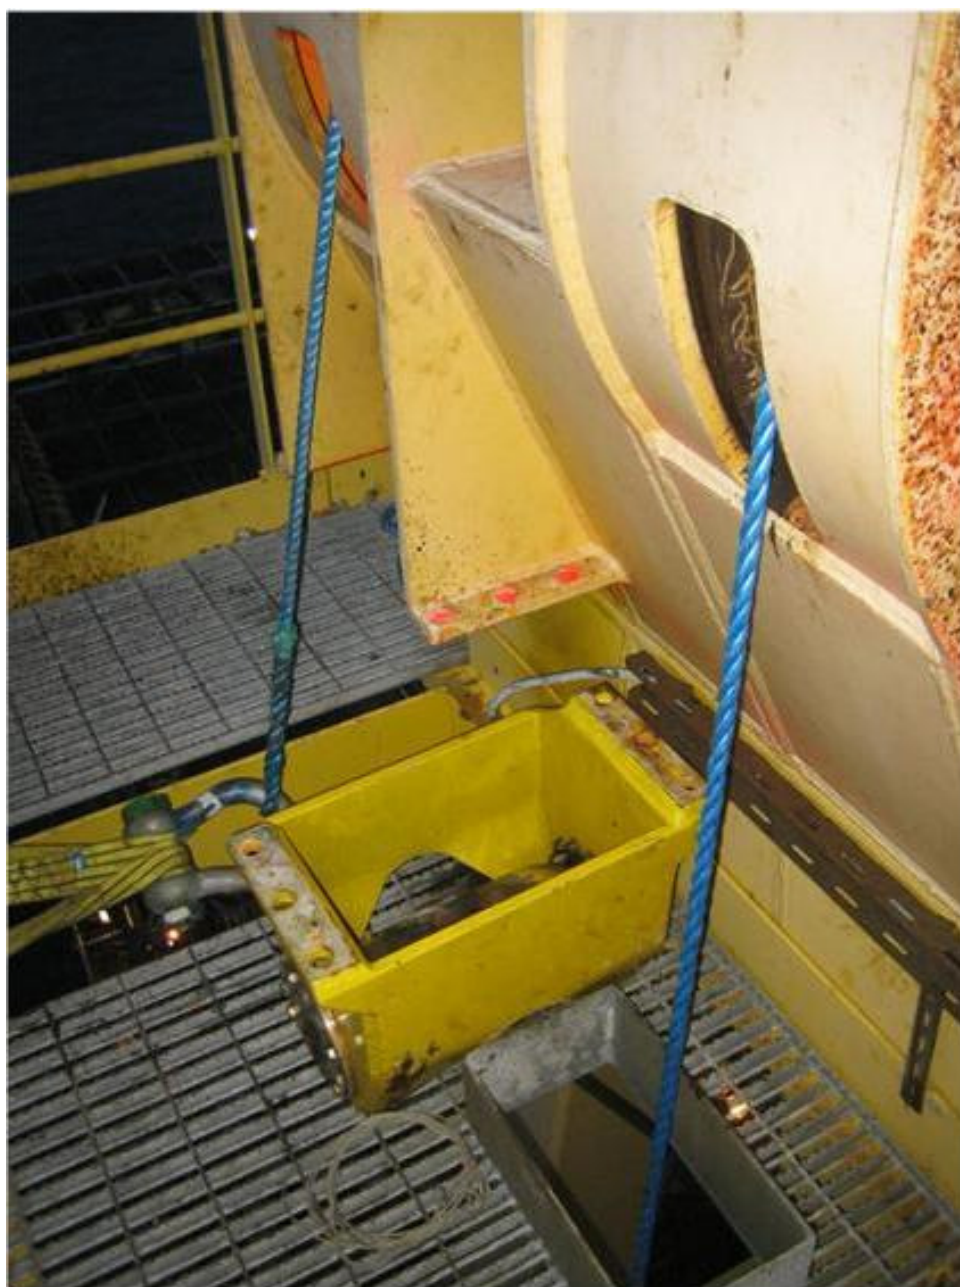
| Summary: | During a rope installation on an offshore pedestal crane, the rope became snagged. The IP received a serious injury to his hand when the rope suddenly released |

**Lessons Learnt:** A number of failures contributed to this serious incident:  
Lack of a documented and detailed procedure for the task in the approved workpack  
Incorrect selection of a shackle to guide the rope when there was a sharp change in the rope route  
Lack of identification of the snagging hazard during pre-job risk assessment, at toolbox talks and when awarding the permit to work  
Lack of awareness of the hazard of stored energy in the softline when the job was stopped and lack of understanding of what would happen when the snag freed  
Lack of effective communications to discuss the problem before intervening.  
Had there been a detailed procedure that could be talked through step by step during risk assessment then the snagging hazard would have been identified and better equipment selected such as a snatch block or roller guide. Even without the equipment choice available, the issue of snagging and a safe method of freeing it should have been discussed and made clear to the relatively inexperienced IP by the experience supervisor.

**Recommendations:** Ensure: Best practice information on rope chageout/installation is made aware to engineers  
Site specific work instructions are developed and included in the workpack and subject to senior engineer review and approval  
Guide rollers or snatchblocks are available and used when rope makes change in direction  
Awareness sessions held for all employees to highlight best practices for this task and for hazard identification and risk assessment

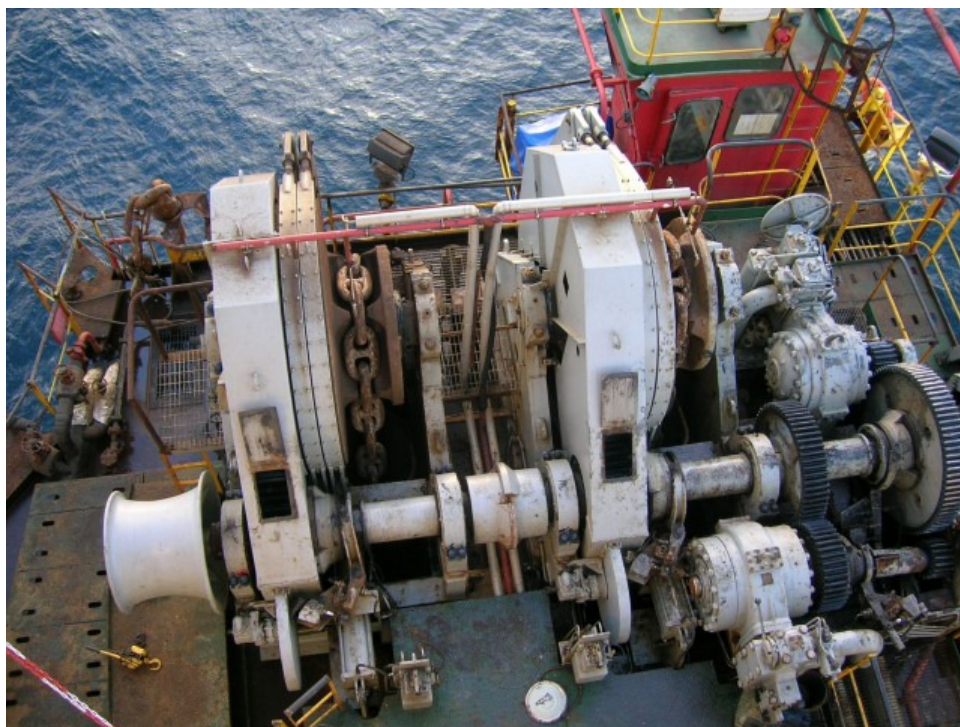
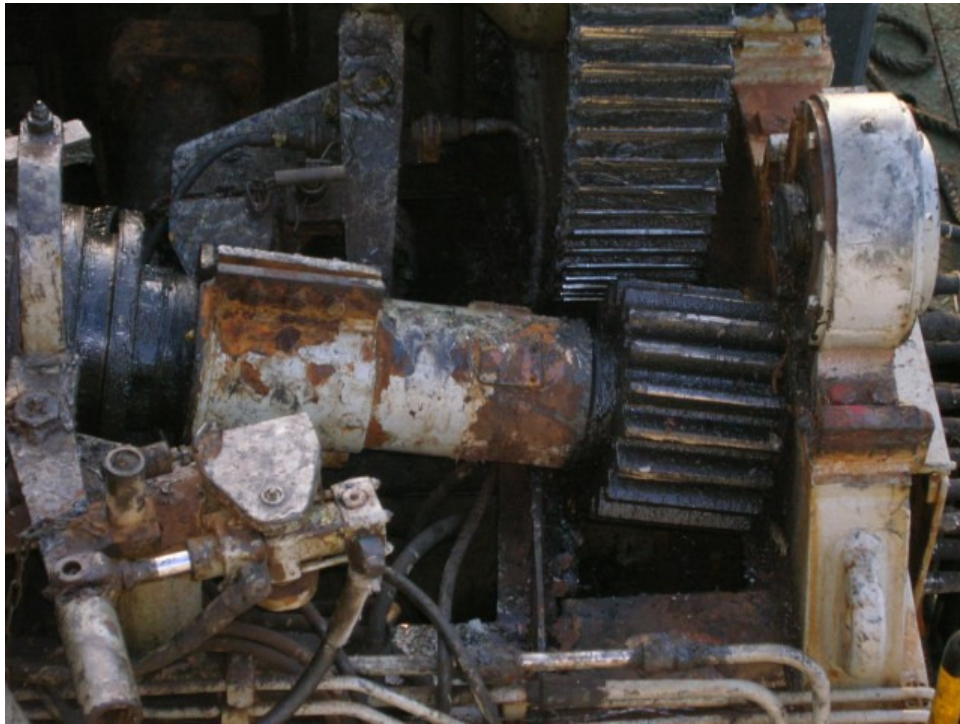
| Summary: | During running of anchors from MODU, failure of main winch shaft resulted in uncontrolled payout of anchor chain, brake system managed to stop chain before complete loss. Significant damage to winch resulted. |

free. As the winch was paying out at the time this shaft was bouncing about causing substantial damage to the gear wheel and bearings. There was also damage to the drive gear claw coupling and associated equipment.

Recommendations: Failed Shaft to be examined by metallurgist to establish cause of fracture PM of winch to be reviewed – possibly increase frequency – have individual item of visual inspection of shaft on PMNDT of Drive Shafts to be carried out at least once per year

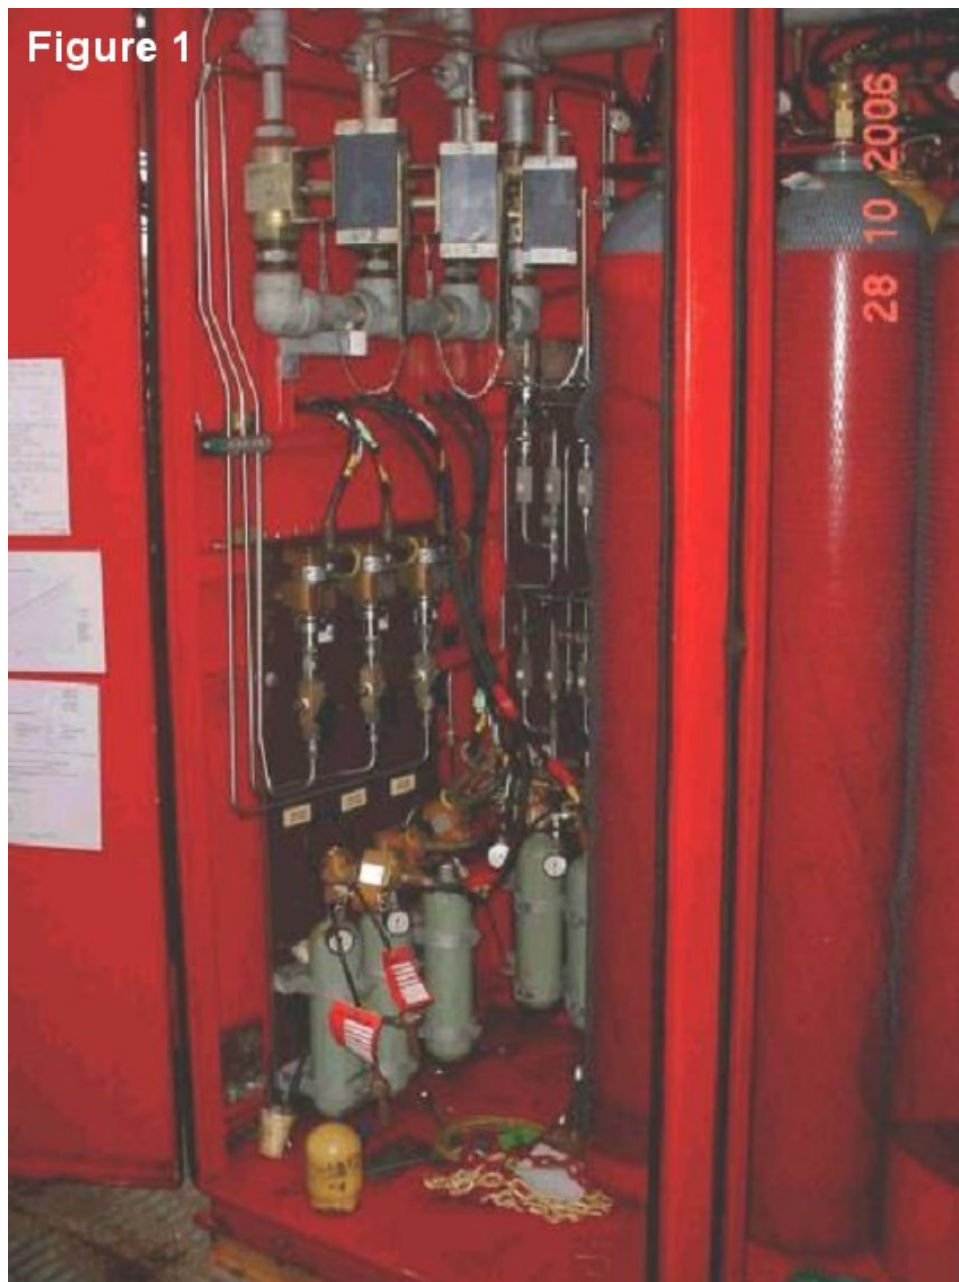
Figure 1

Summary: A fire within the enclosure of a gas turbine was caused as a result of hot air escape from the turbine bleed air line leading to ignition of lube oil and diesel in the base of the skid. The Fire and Gas/Shutdown system tripped the turbine and initiated the Platform GPA, closed the turbine enclosure dampers and initiated Inergen discharge as per the cause and effects design intent. The fixed suppression system (Inergen) was activated during as per the sequence of executive action from the shutdown system and appeared to operate as intended as observed from the main Control Room. Following the alarms clearing in the Control Room the Fire Team entered the Turbine Hall to find it still full of smoke and evidence the fire within the enclosure had not been extinguished. It appeared the Inergen system had failed to fully discharge as per design, and failed to extinguish the fire, which was eventually put out using hand-held CO2 extinguishers. System causes relate to a combination of original design inadequacies and lack of a suitable assurance routine on this safety-critical system, absent/inadequate and a lack of consistent understanding of how the system operated.

mechanisms may have been defective. The system has never been either fully function tested or used in anger previously. Understanding of the functionality of this system was limited. This unit was retro-fitted as a bespoke modification in c.1997 to replace the Halon systems. The design of the system is poor with no apparent evidence of suitability as a safety-critical system. It is complex and descriptions in the supporting documentation were lacking in detail and were ambiguous. Subsequently there was a general lack of knowledge and varied understanding of the system functionality by those expected to operate and maintain the Inergen system. The design relies on a signal from the Fire & Gas system triggering release of nitrogen from a small (70barg) cylinder (Figure 1). The pressure from this cylinder fires off the first cylinder of Inergen (Figure 2) and also holds open a spring loaded valve which diverts all the released Inergen from a main manifold to the relevant turbine enclosure (see Figure 3). The initial release of Inergen from the first cylinder backpressures the release mechanisms on the remaining 5 bottles (Figure 5). The conclusion is that the nitrogen pressure has bled away, causing the spring-return valve to close (the valve has no latch mechanism to keep it open) thereby preventing the full discharge of Inergen. Upon further review of the design of the package the investigation team and platform staff identified several potential single point failure mechanisms. System causes relate to original design inadequacies and lack of a suitable assurance routine on this safety-critical system. Documentation to support the design does not appear to have been subject to HAZOP review or FMEA analysis was not evident and it was unclear whether this had not been carried out or was just missing from the handover of information. Maintenance regime had focussed only on the Nitrogen trigger mechanism and a visual check of the pressure gauges for the Inergen Bottles and did not include a function test.
